# Augusta County Courthouse

Feasibility Study  
Vol. I

October, 2012

For:  
AUGUSTA COUNTY, VIRGINIA

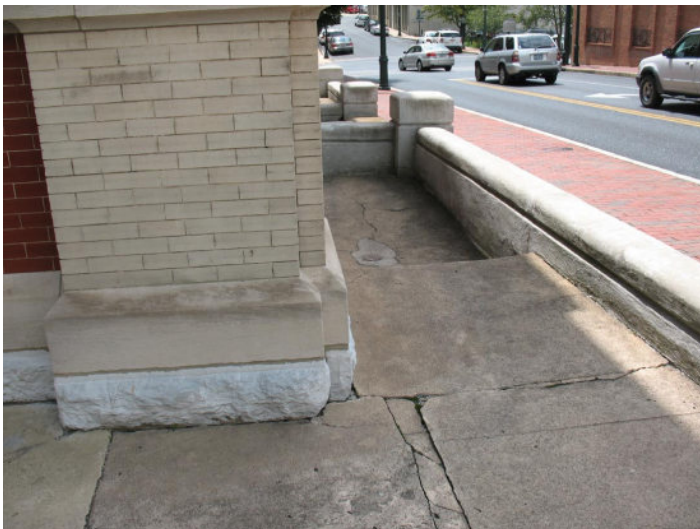
Low site walls along Augusta Street.

a better location that does not detract from the pedestrian experience around the building. The concrete sidewalks on this side of the building are severely deteriorated.

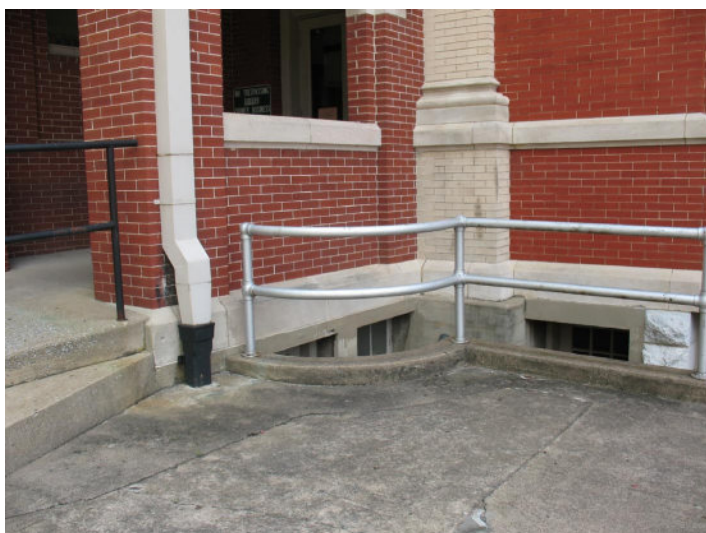
A change in brick at the intersection of the original building (left) and the 1939 addition (right). Also note the deteriorated concrete sidewalk.

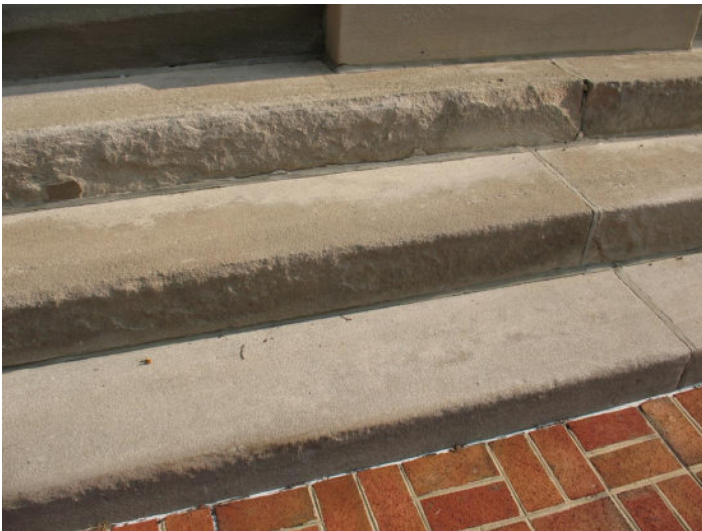
The granolithic steps at the front of the courthouse show signs of deterioration.

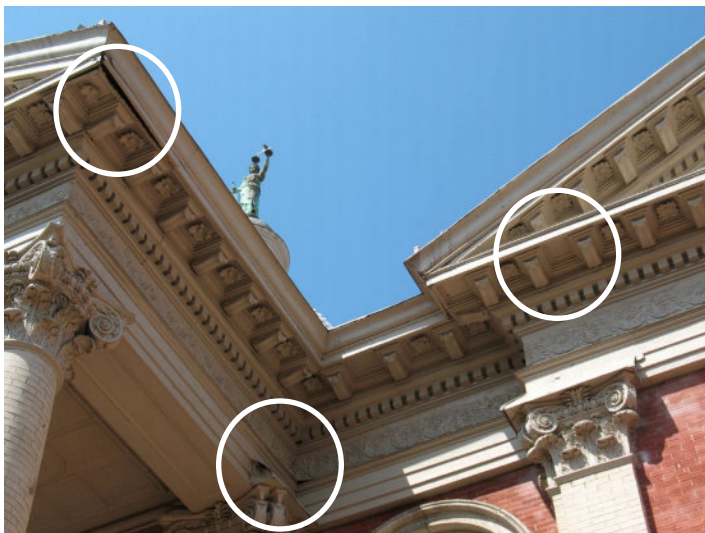
Detail of sheet metal cornice with circled areas showing typical deterioration and missing elements.

This decorative sheet metal entablature is showing signs of deterioration with rust at gaps that are opening up. Missing floral details were observed between the modillion blocks in some locations. There is what appears to be a wood cornice, in fair condition, on the flat roof sections of the rear addition.

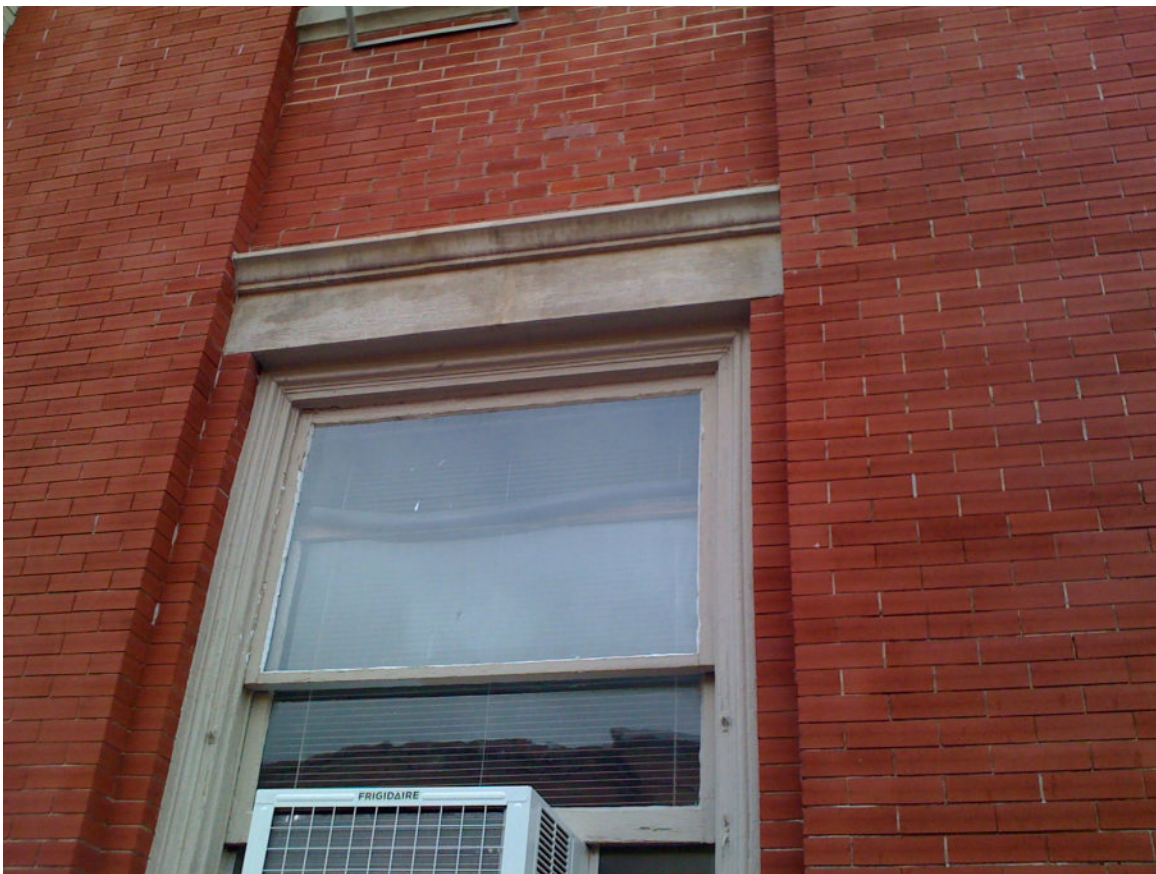
**Photo #2: Repaired exterior brick above 1<sup>st</sup> floor window**

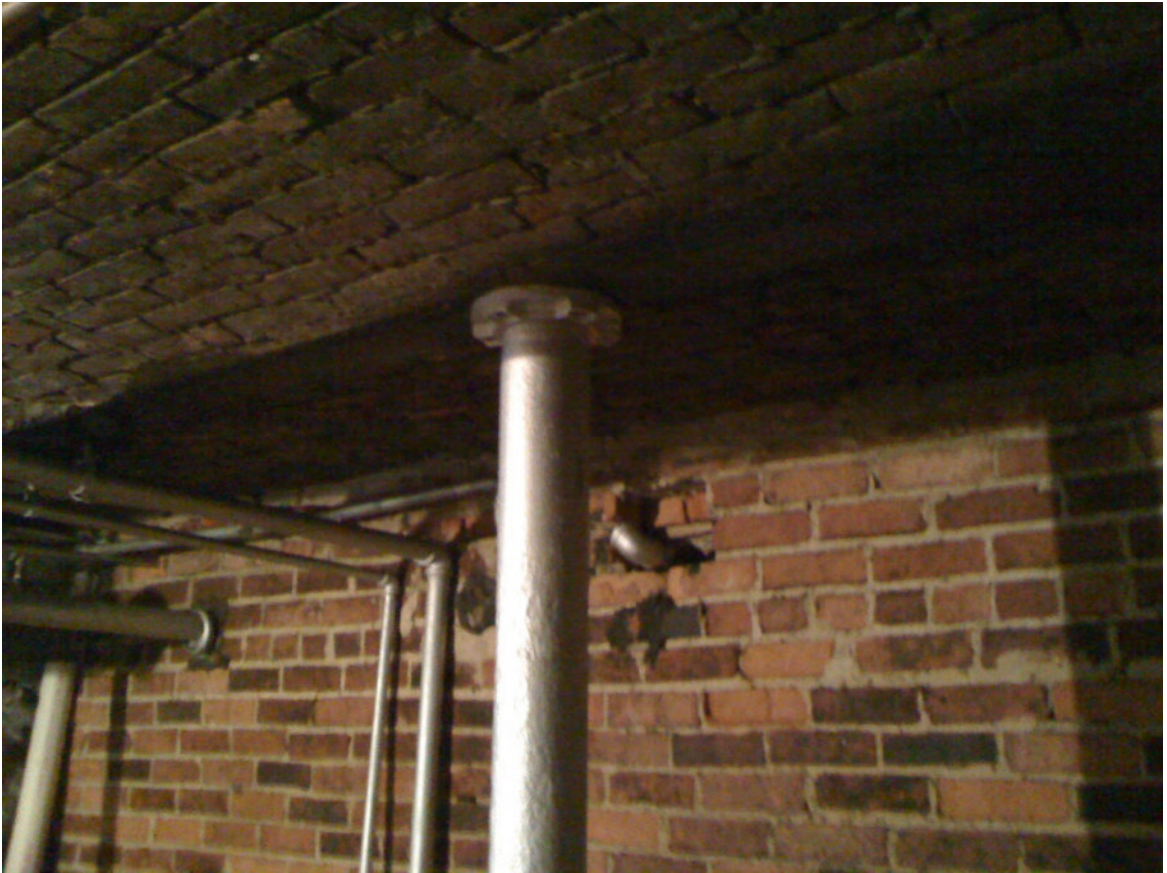
**Photo #3: Shoring post located beneath existing beam in basement ceiling**

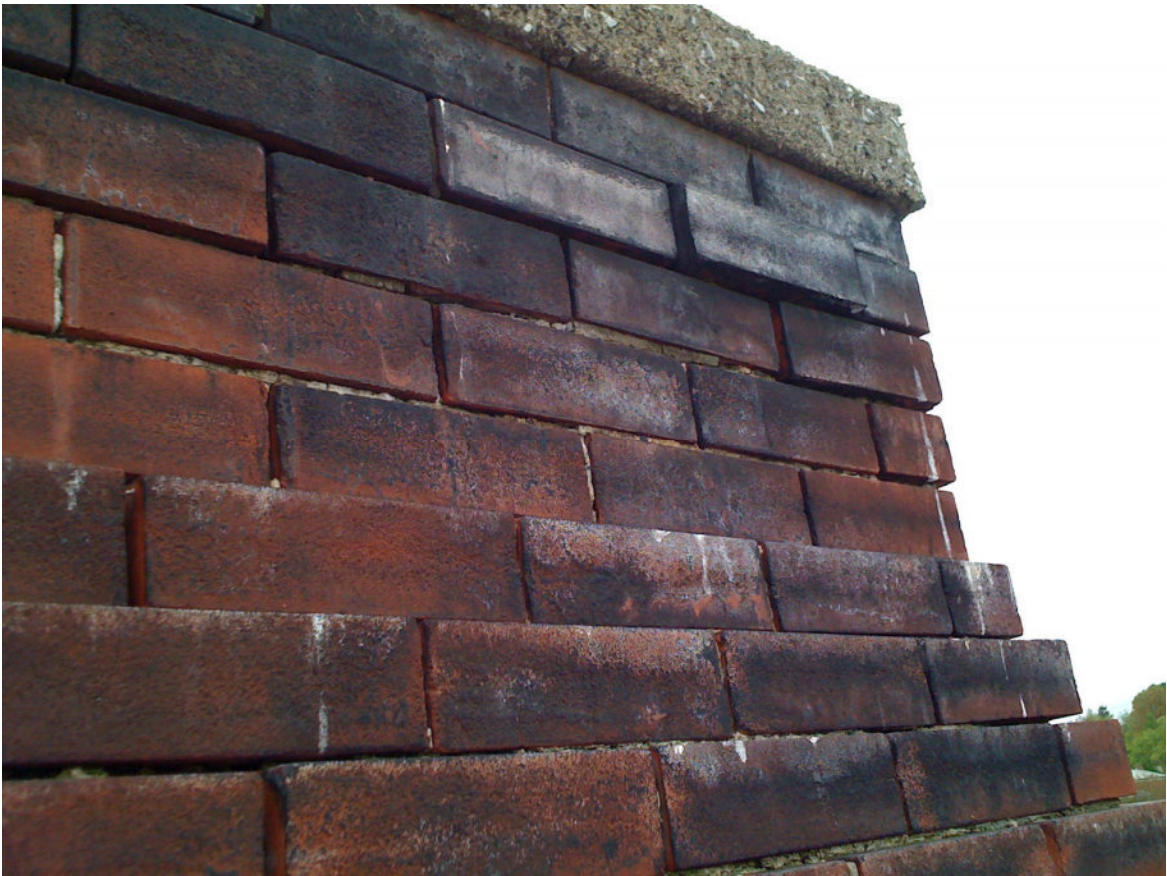
**Photo #7: Open brick joints and loose brick at top of chimney**

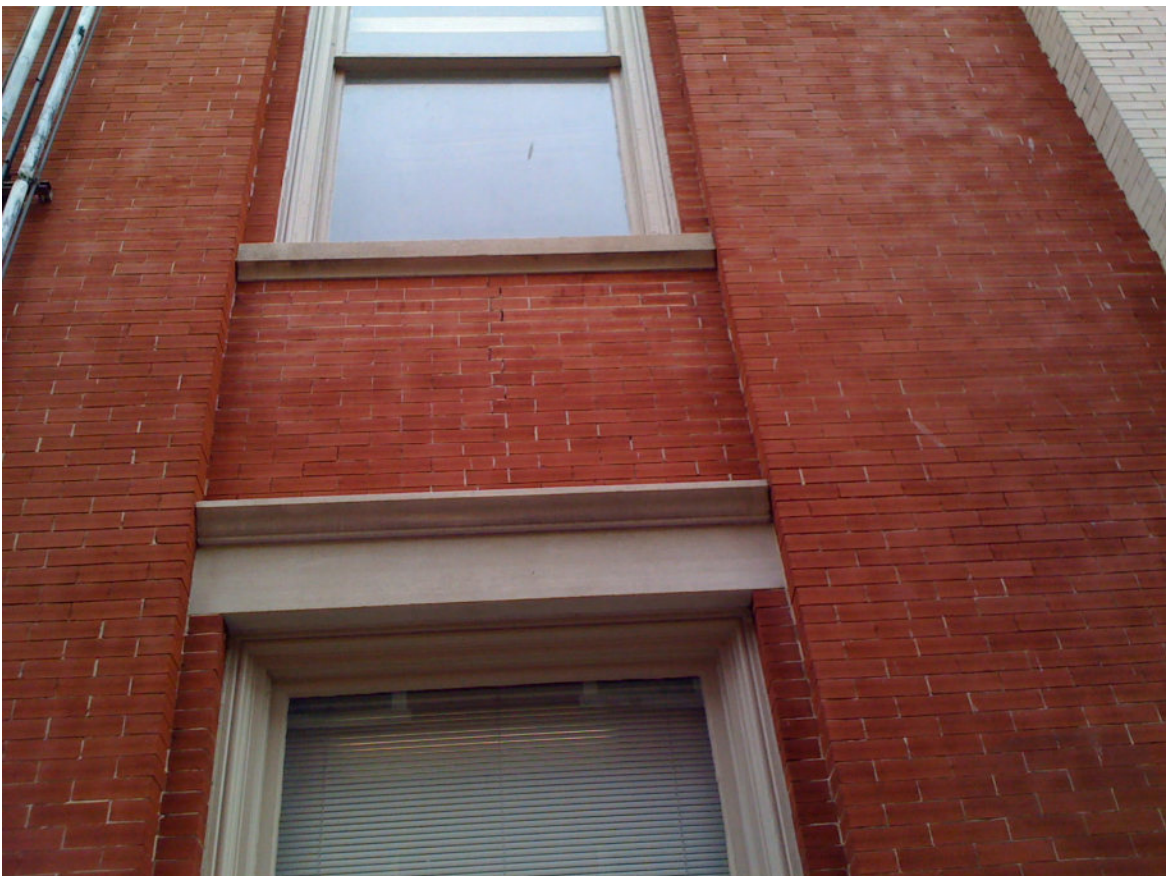
**Photo#8: Small vertical crack below 2<sup>nd</sup> floor window sill**

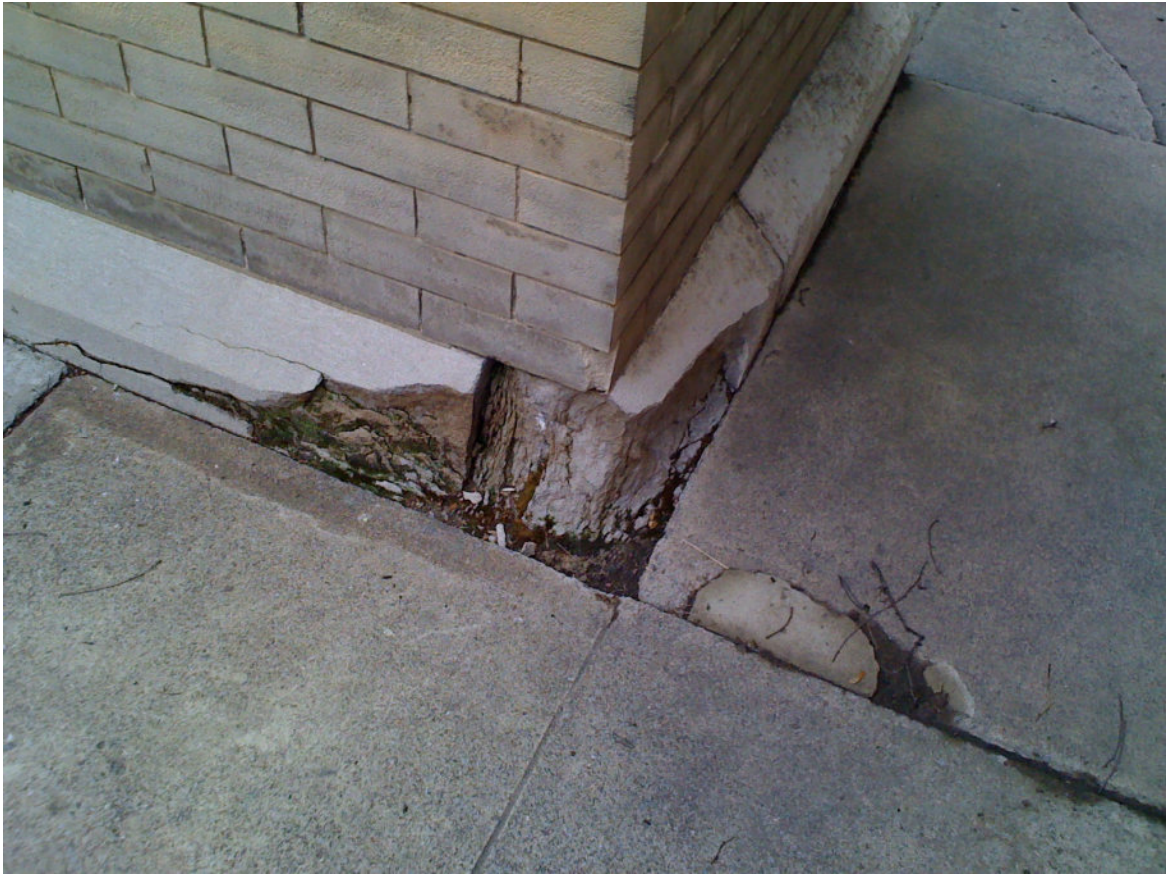
**Photo #11: Severe spall at base of exterior masonry column**
