# Augusta County Courthouse

Feasibility Study  
Vol. I

October, 2012

**FRAZIER ASSOCIATES**  
ARCHITECTURE ■ URBAN PLANNING ■ WAYFINDING

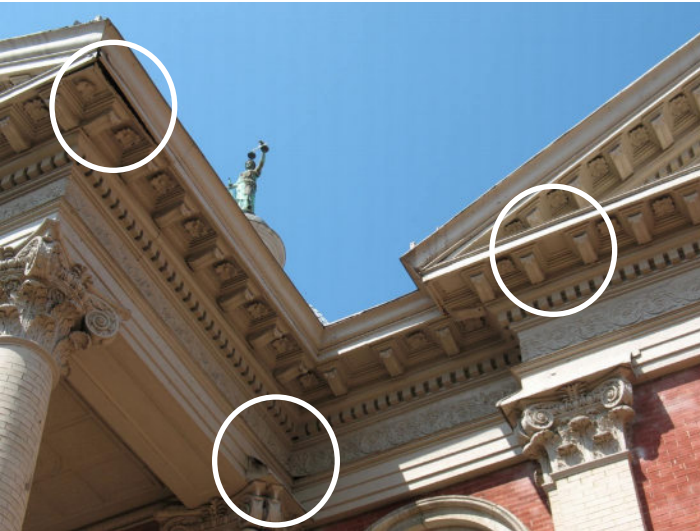
Detail of sheet metal cornice with circled areas showing typical deterioration and missing elements.

This decorative sheet metal entablature is showing signs of deterioration with rust at gaps that are opening up. Missing floral details were observed between the modillion blocks in some locations. There is what appears to be a wood cornice, in fair condition, on the flat roof sections of the rear addition.

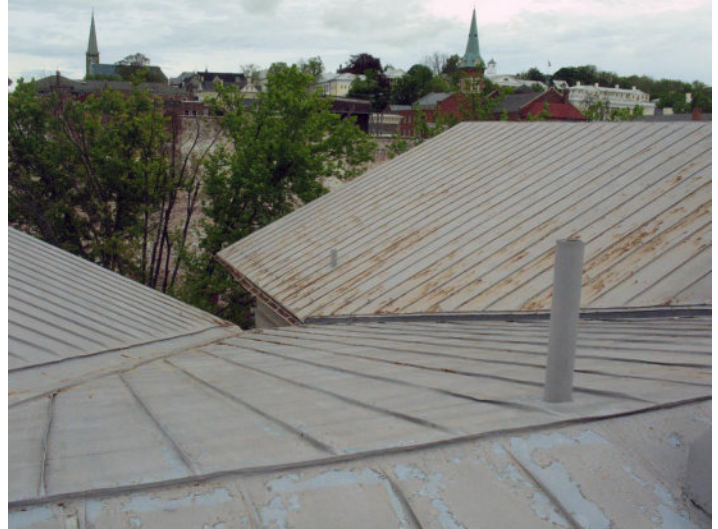
The complex standing-seam metal gable roof replaced the original slate roof early in the building's history. The roof is showing its age with paint peeling and visible rust in many areas. Valleys have been patched with rubber roofing in some locations.

View of roof of the addition showing rusted roof areas. Also, note half-round gutter.

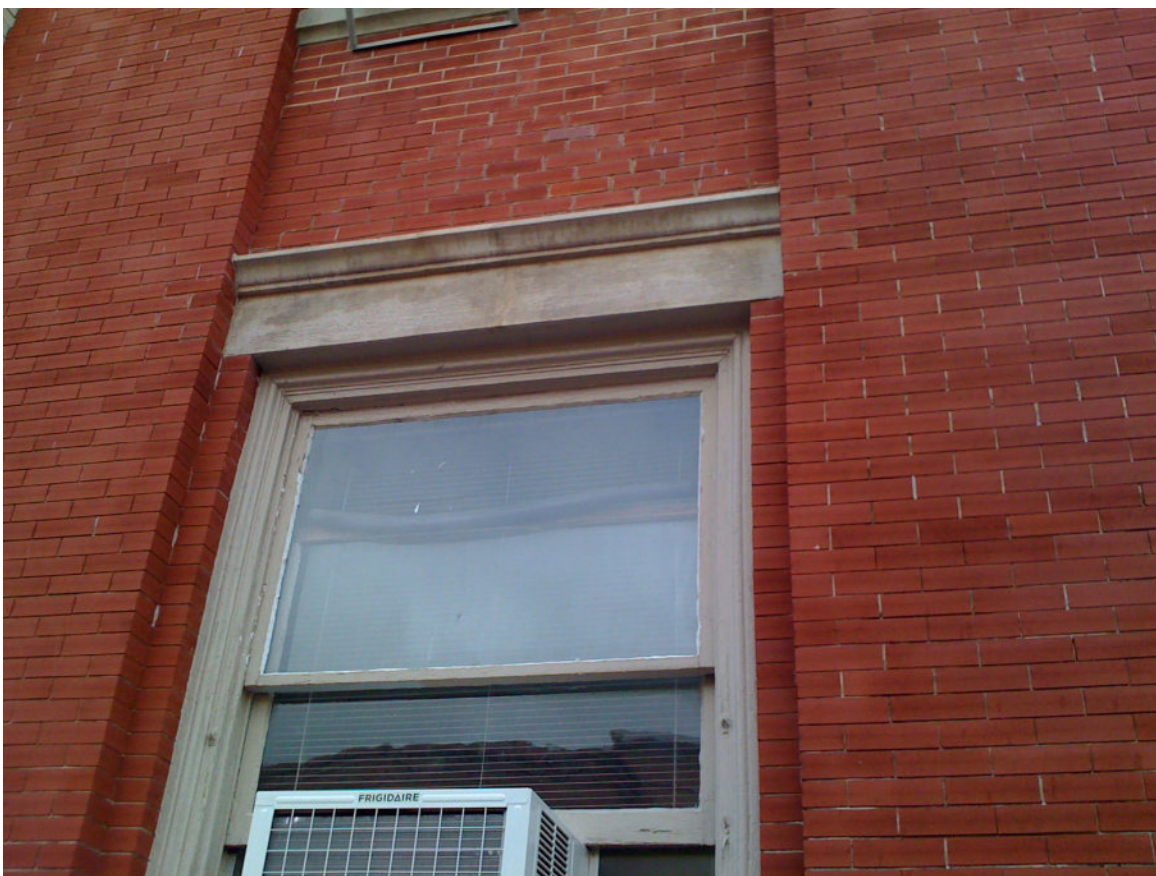
**Photo #2: Repaired exterior brick above 1<sup>st</sup> floor window**

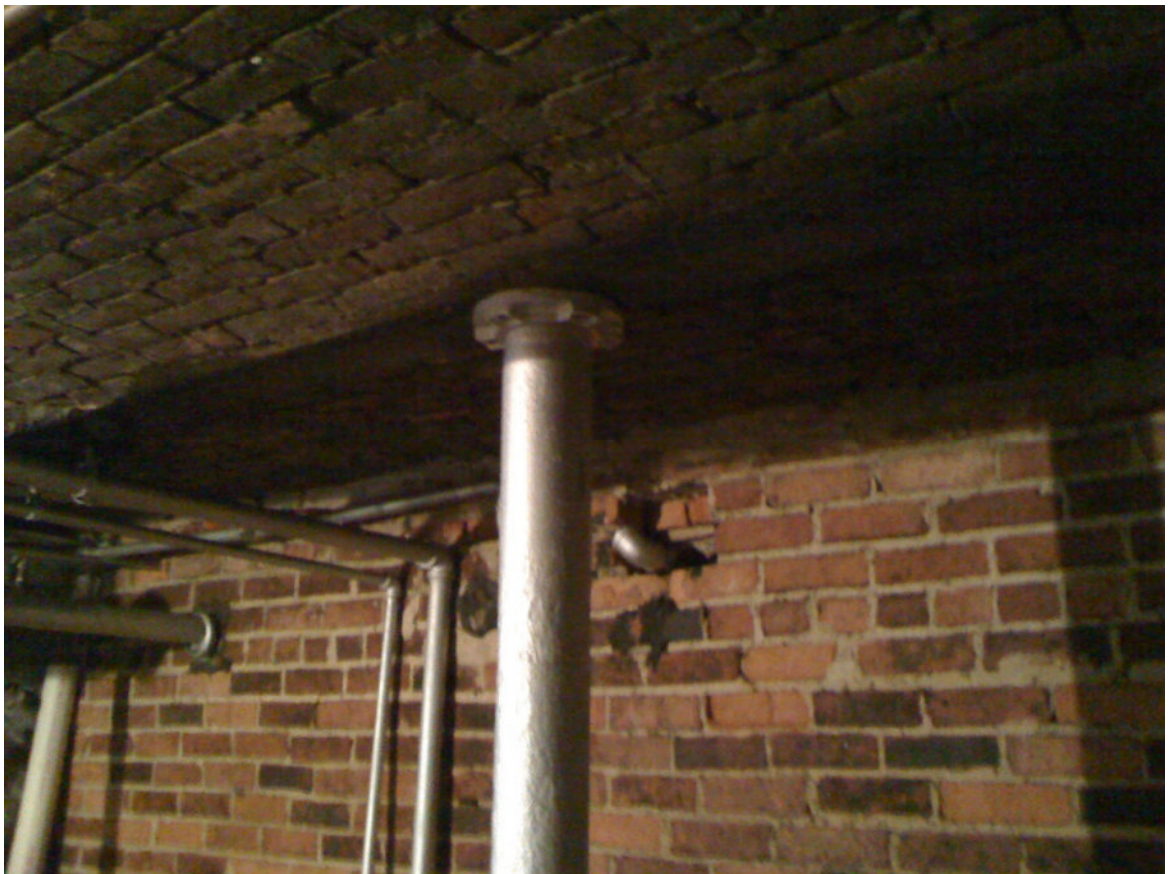
**Photo #3: Shoring post located beneath existing beam in basement ceiling**

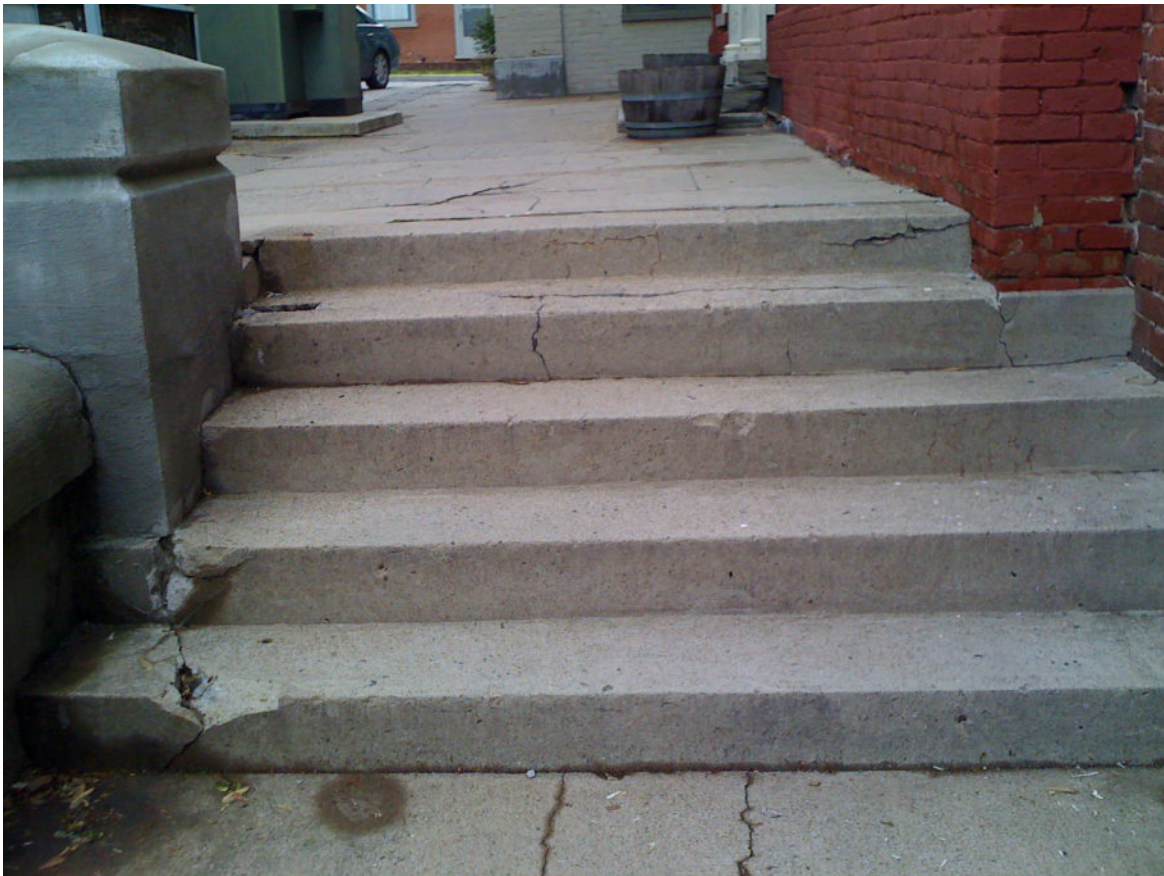
**Photo #9: Multiple stair cracks**

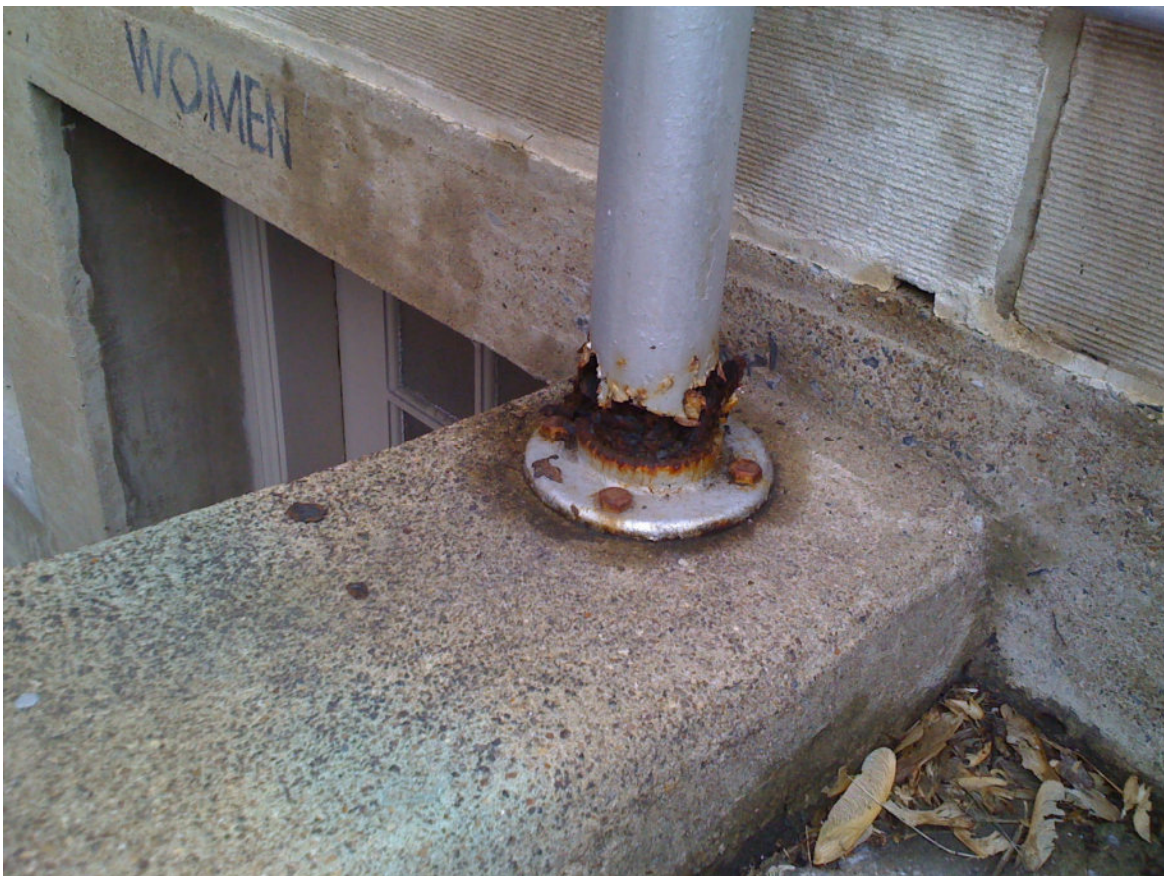
**Photo #10: Corrosion at base of steel guard rail**

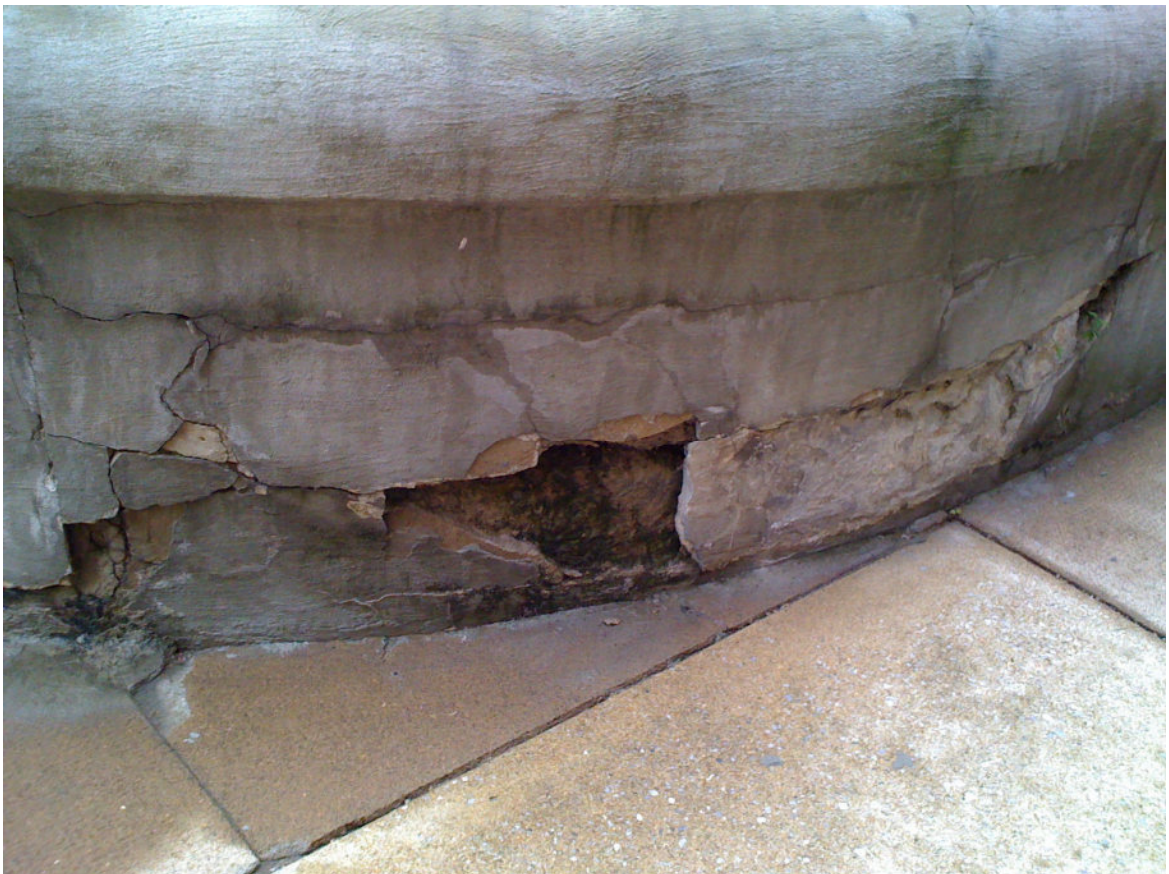
**Photo #12: Severe spall at base of landing wall**
