**REQUEST FOR QUALIFICATIONS  
CONSTRUCTION PHASE SERVICES  
JOHNSON STREET PARKING GARAGE  
and  
NEW STREET PARKING GARAGE

CITY OF STAUNTON, VIRGINIA**

Wiley|Wilson is pleased to submit this report detailing our findings, remedial repair recommendations, order of magnitude cost estimate, and estimated life of repairs for the City owned parking garage located on West Johnson Street between South Lewis Street and North Central Avenue in Staunton, Virginia.

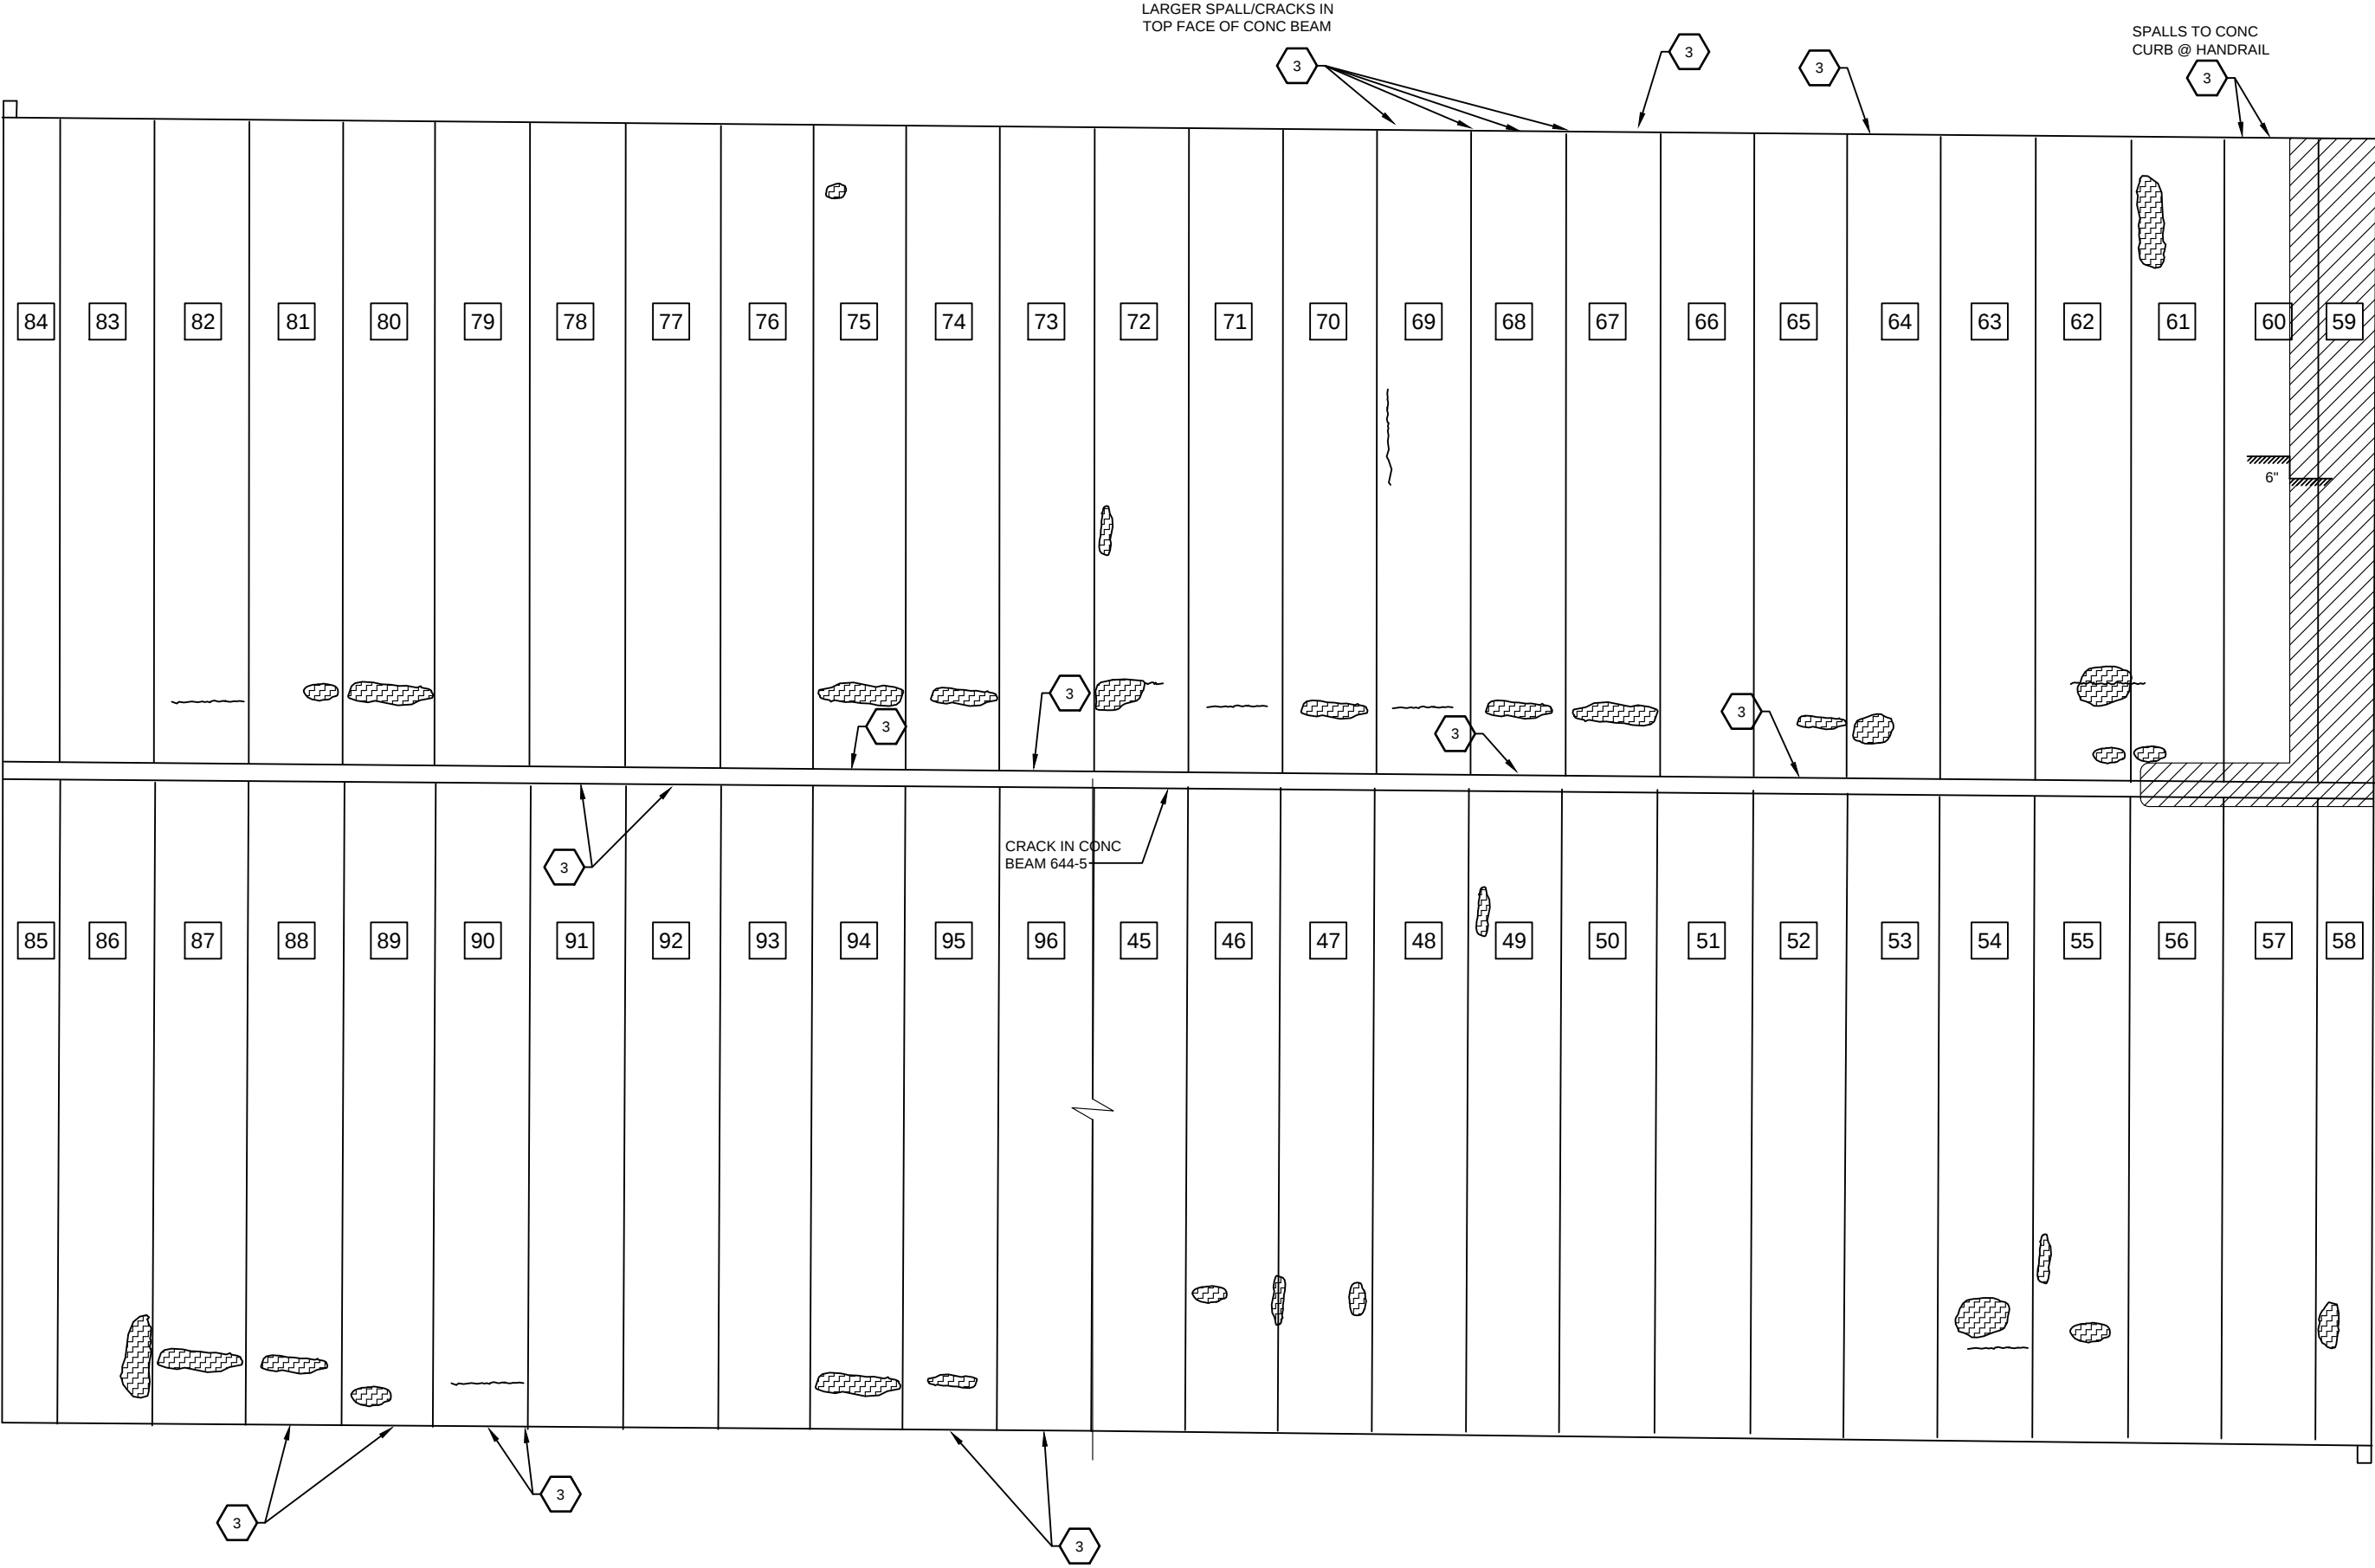
SHEET: SSK-1.2  
TITLE: 2ND LEVEL, TOP SURFACE OF  
SLAB FIELD NOTES

| KEYNOTES | | |
|---|--|---|
| 3 | | LARGER SPALL IN TOP OF CONCRETE BEAM |

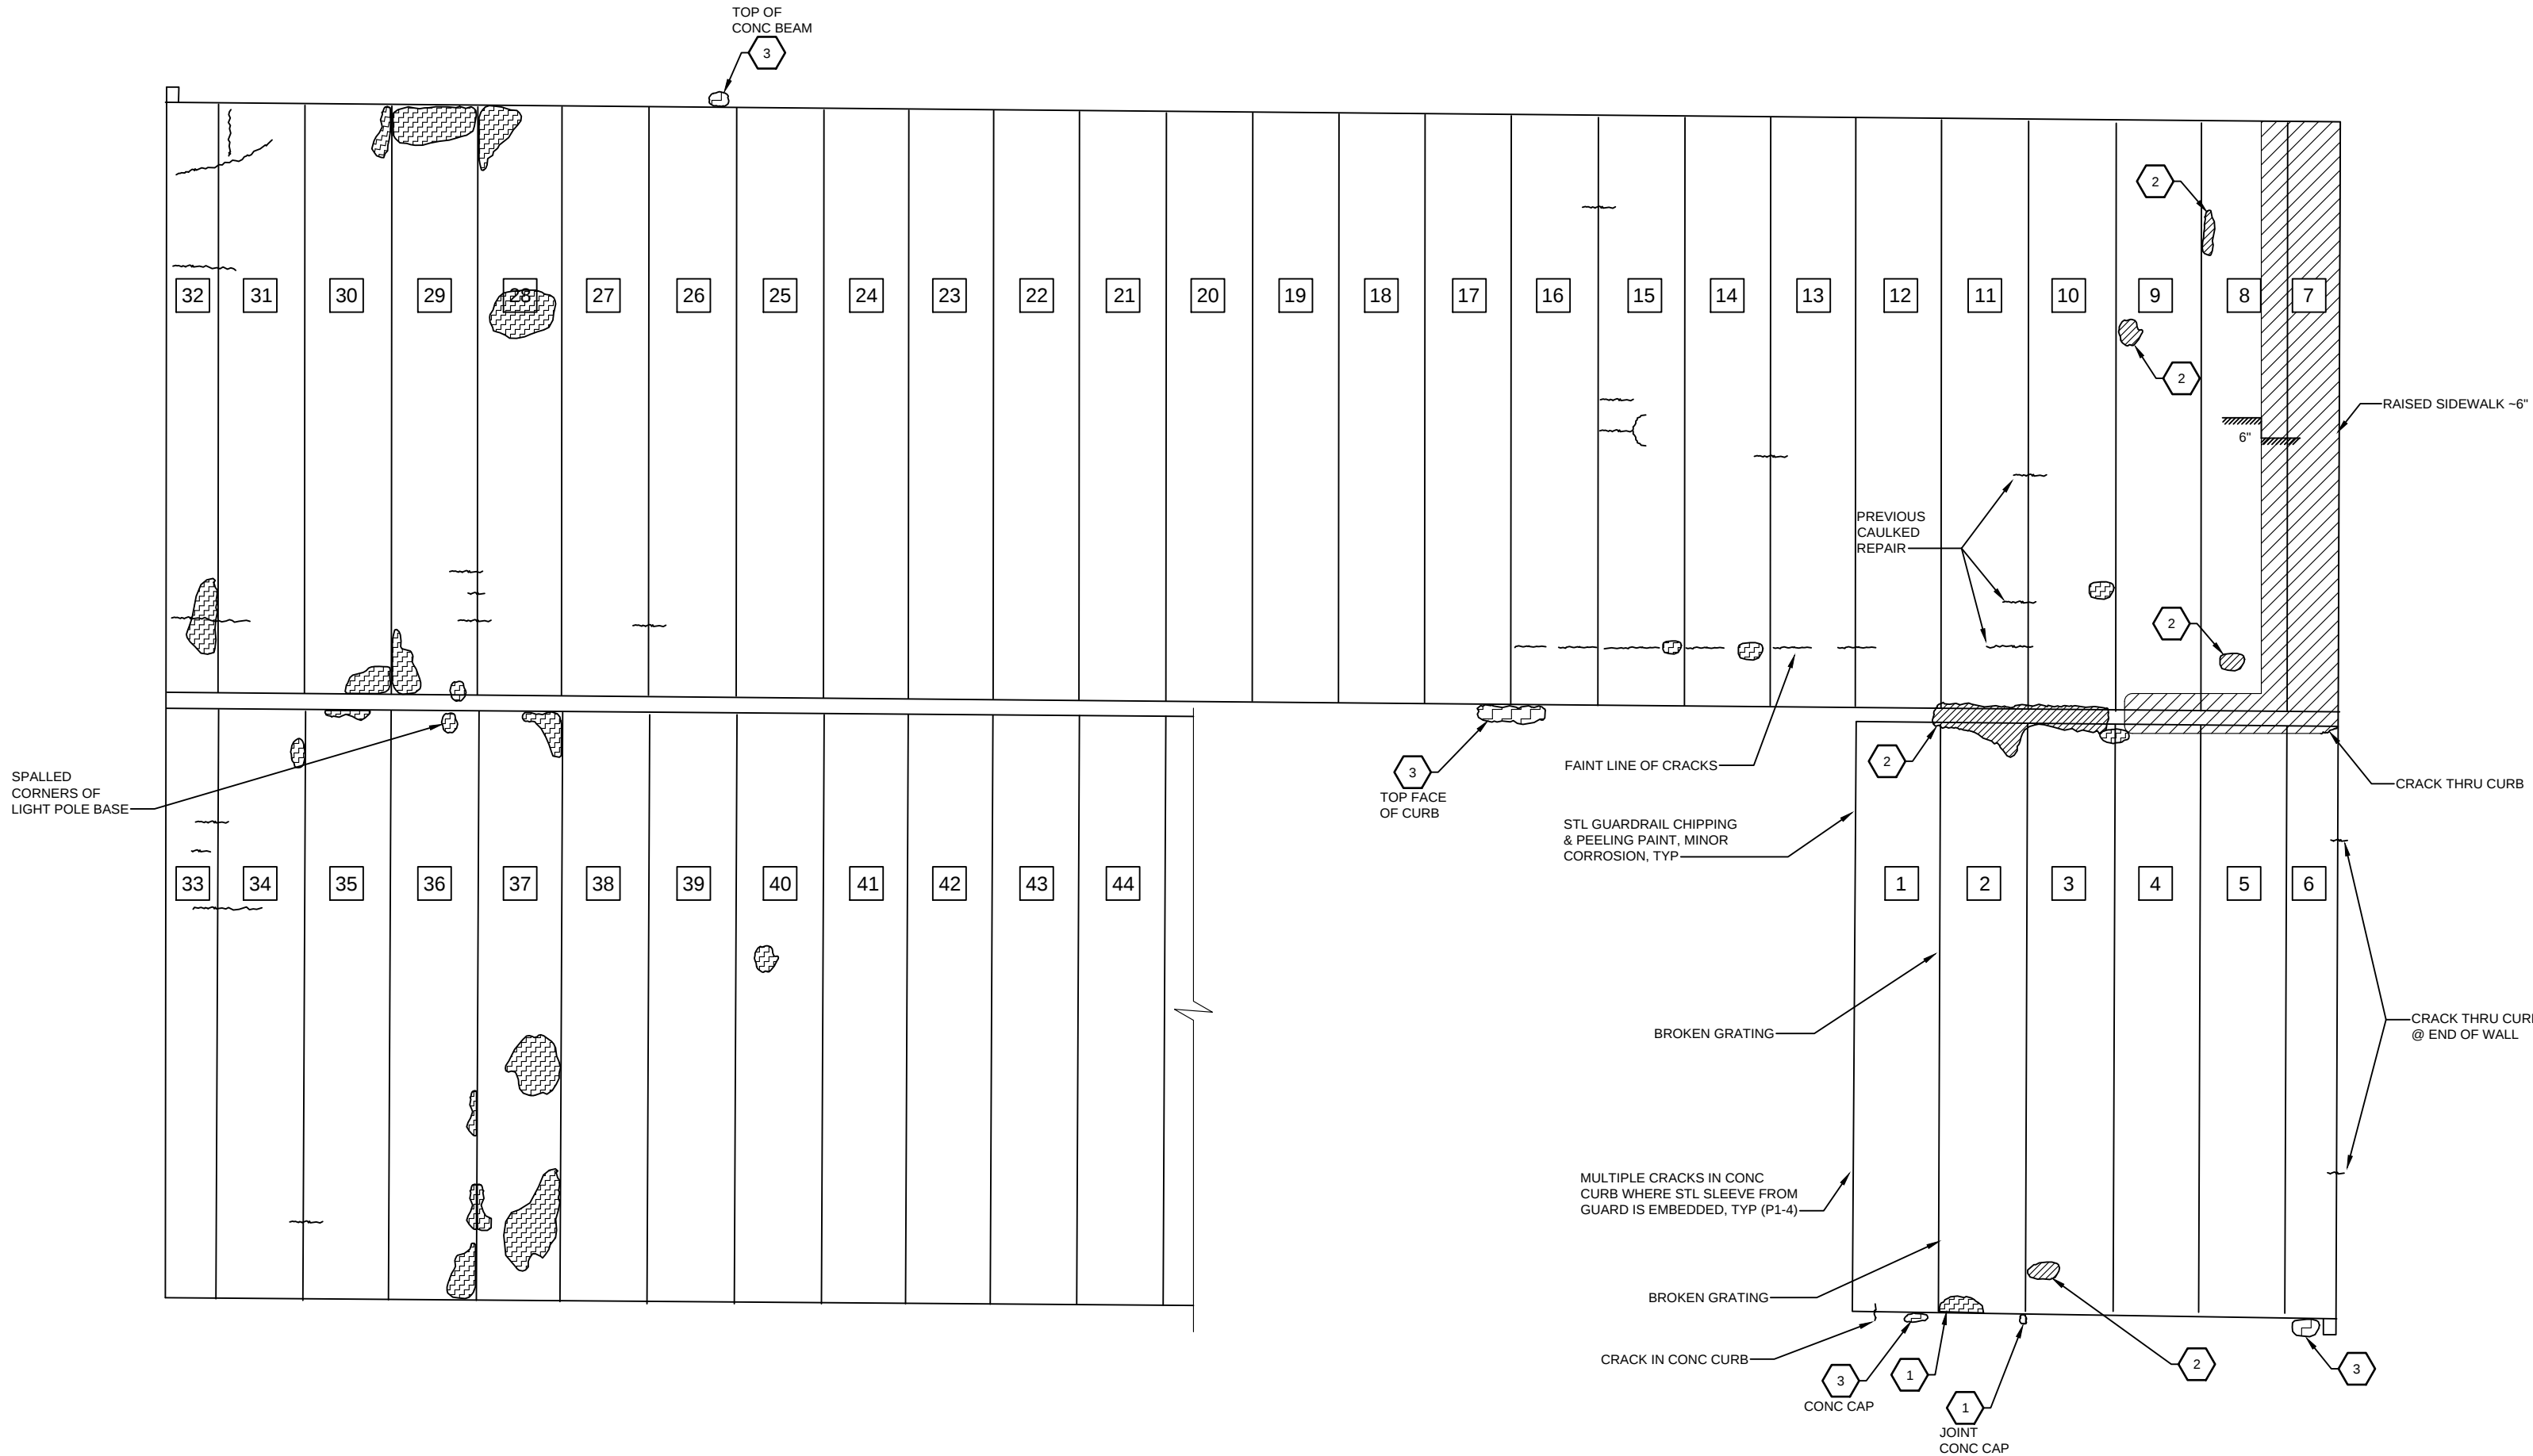
SHEET: SSK-1.3  
TITLE: 3RD LEVEL, TOP SURFACE OF  
SLAB FIELD NOTES

| KEYNOTES | | |
|---|--|---|
| 3 | | LARGER SPALL IN TOP OF CONCRETE BEAM |

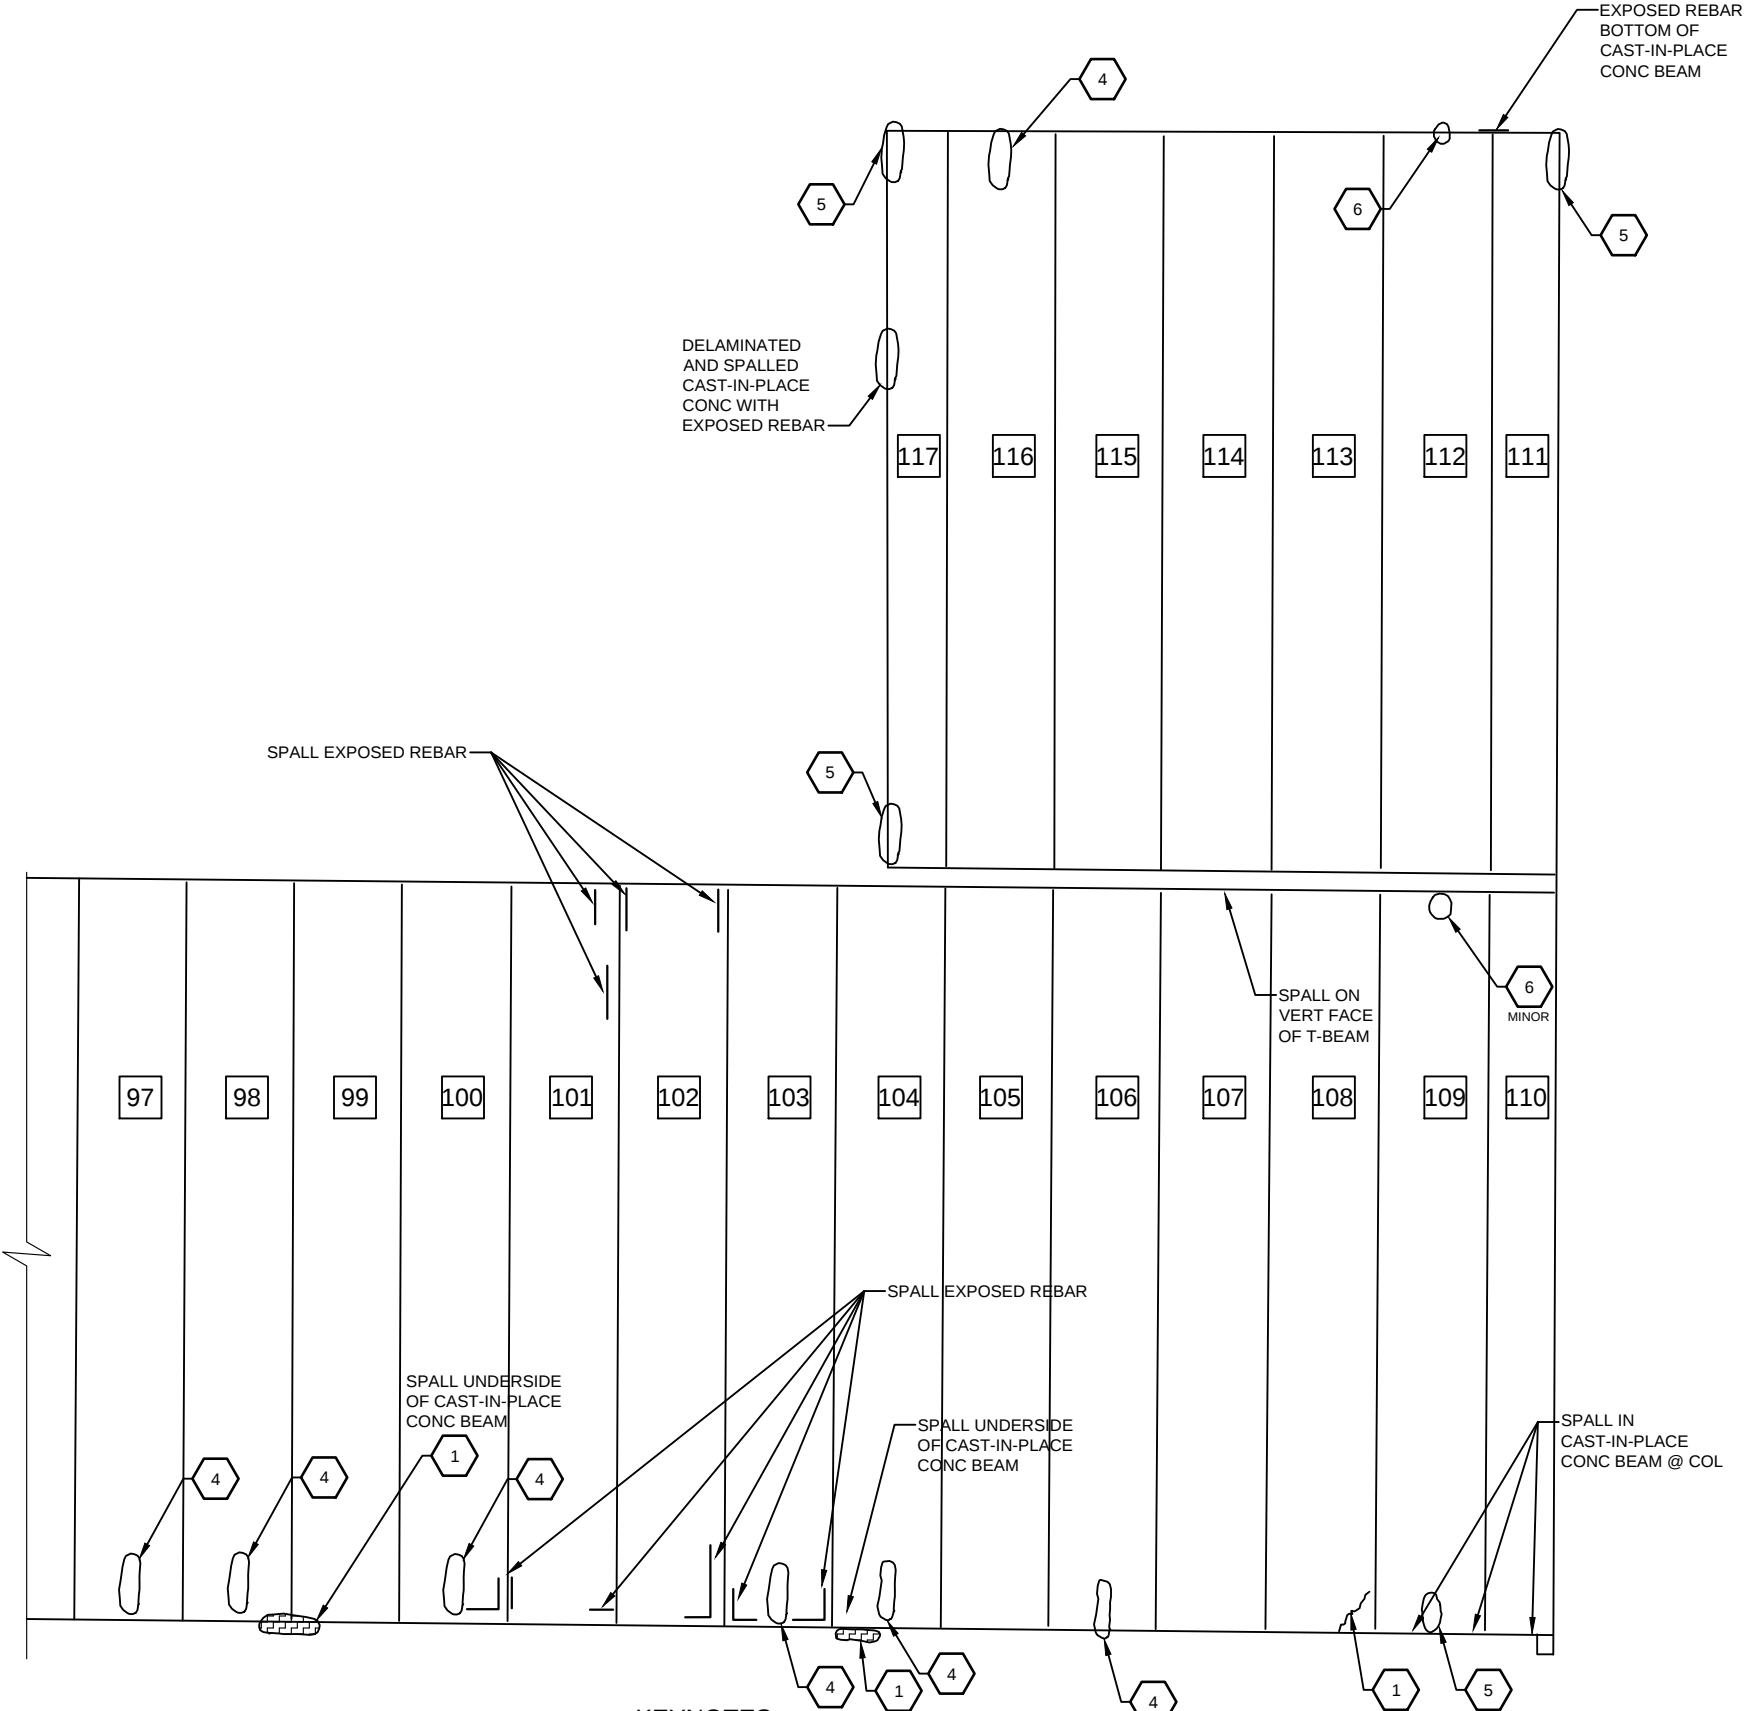
SHEET: SSK-1.4  
TITLE: 1ST LEVEL, BOTTOM SURFACE OF  
PRECAST CONCRETE FIELD NOTES

| KEYNOTES | |
|---|---|
| 6 | CONCRETE COLUMN SPALLED @ BEAM BEARING |

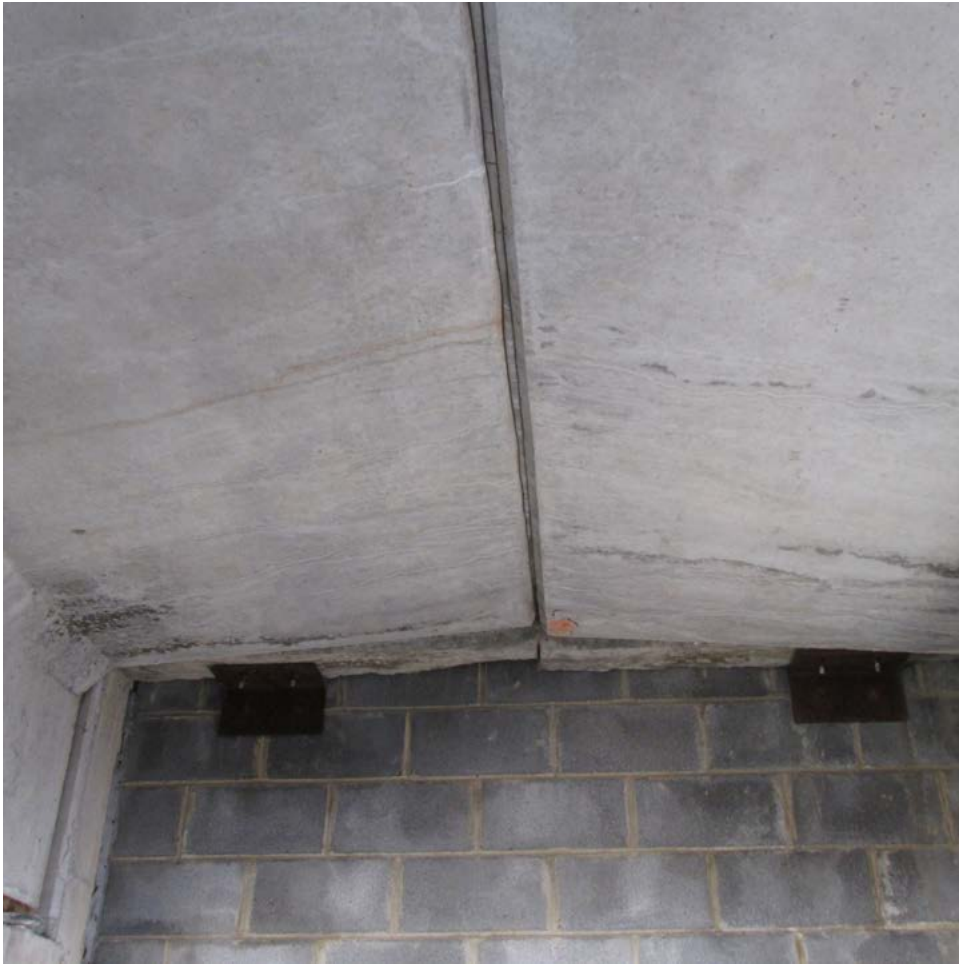
- The flanges of two adjacent precast concrete single tees at the upper level of the parking garage were vertically offset approximately 1 1/2 inches from each other. We also noted a spall in the precast concrete at the corner of the rightmost panel near the edge (See Photo 1).

Photo 1 - View of the underside of two adjacent precast concrete single tees at the upper level of the parking garage. This photo was taken looking towards the south end of the parking garage. The flanges of the single tees were vertically offset approximately 1 1/2 inches from each other. We also noted a spall in the precast concrete at the corner of the rightmost panel near the edge.

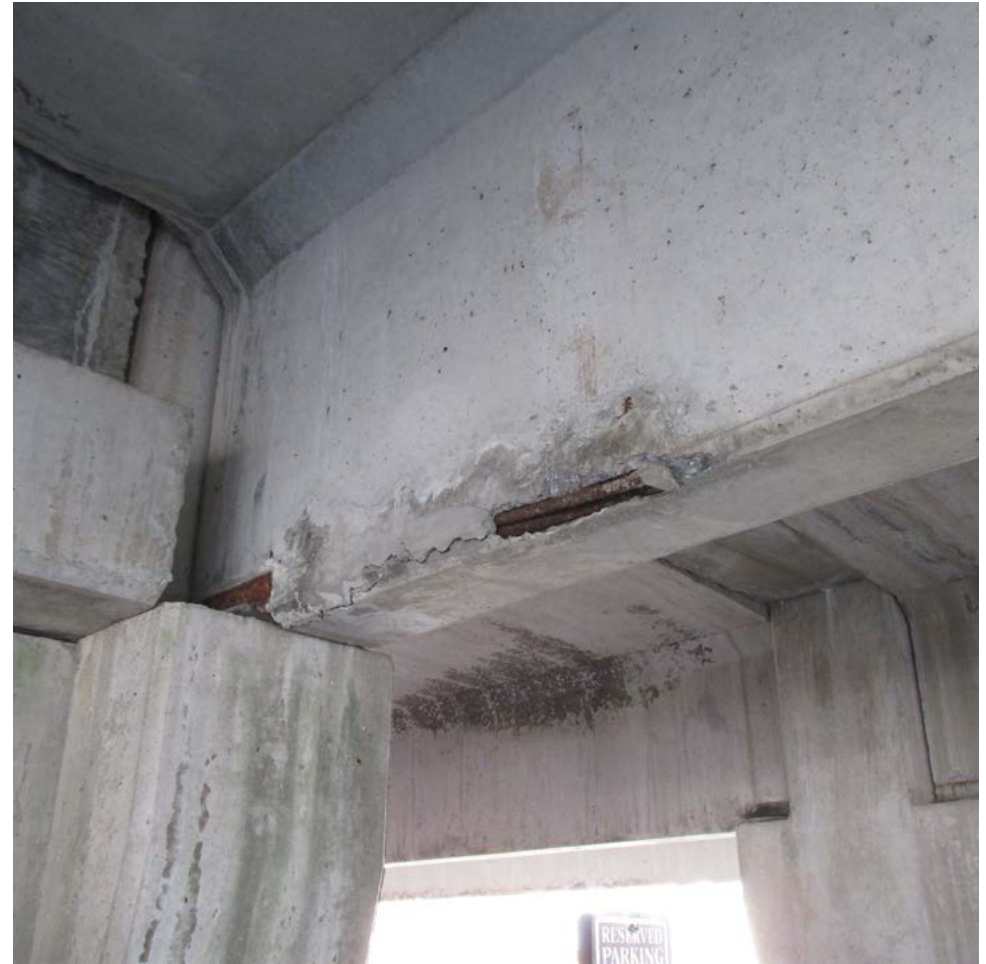
- A previous repair to the bearing end of a precast concrete single tee located at the upper level of the parking garage, near the east end, had spalled partially exposing the steel reinforcement (See Photo 2).

Photo 2 - View of the bearing end of a precast concrete single tee. We noted that a previous repair in the vicinity of the end of the tee had spalled partially exposing the steel reinforcement.

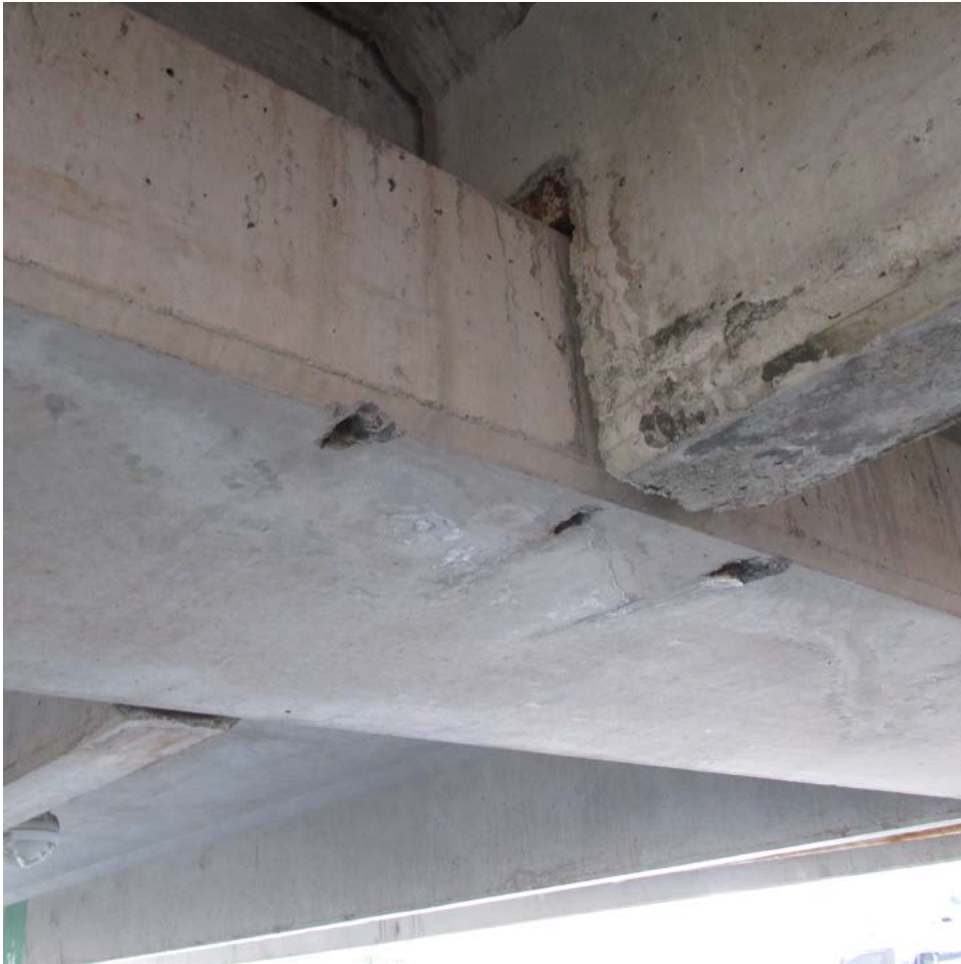
- There were several spalls in the precast concrete beam spanning above the drive lane at the upper level of the east end of the parking garage. We noted that the spalls partially exposed the steel reinforcing stirrups of the beam (See Photo 3).

Photo 3 - View of a precast concrete beam spanning above the drive lane at the east end of the parking garage. We noted the presence of several spalls in the precast concrete beam which partially exposed the steel reinforcing.

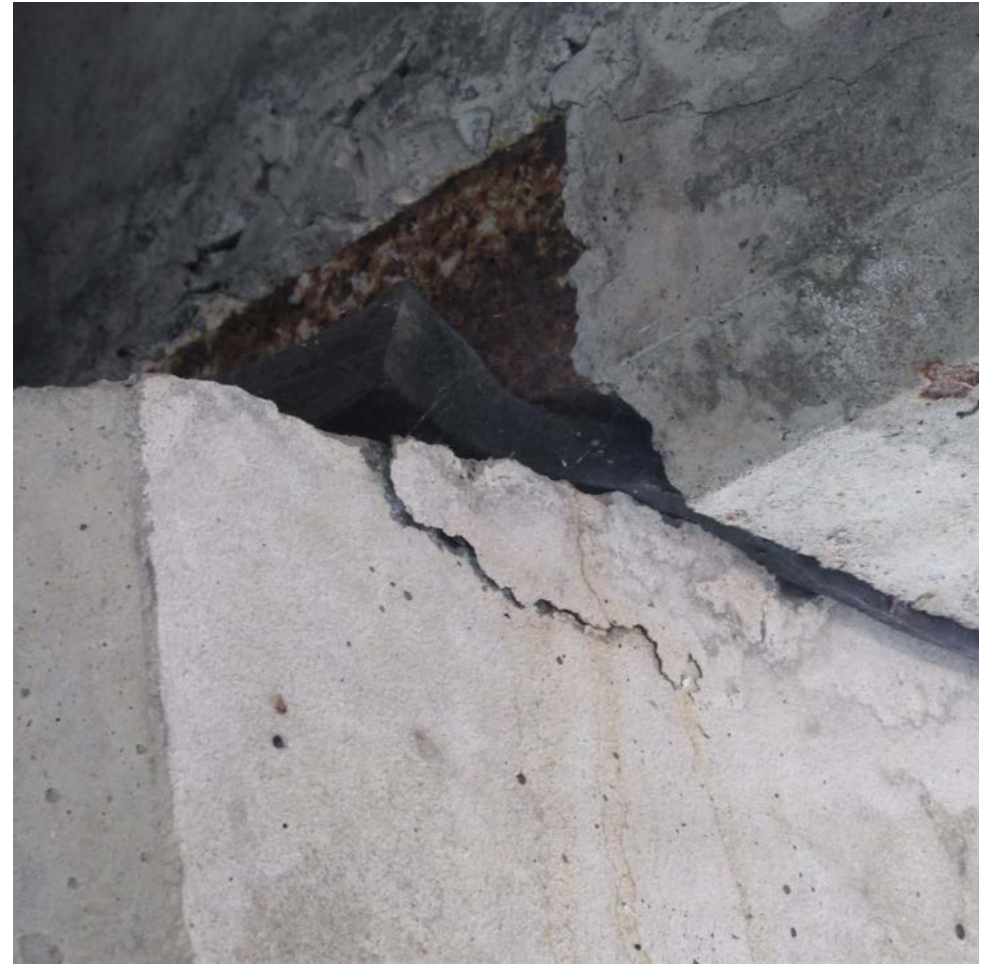
- The bearing pad beneath the bearing of a precast concrete single tee at the upper level on the east end of the parking garage was flattened and deformed. We also noted a spall in the precast concrete column at the edge of the bearing (See Photo 4).

Photo 4 - Close-up view of the bearing of a precast concrete single tee on a precast concrete column. We noted that the bearing pad was flattened and deformed. We also noted a spall in the precast concrete column at the edge of the bearing.

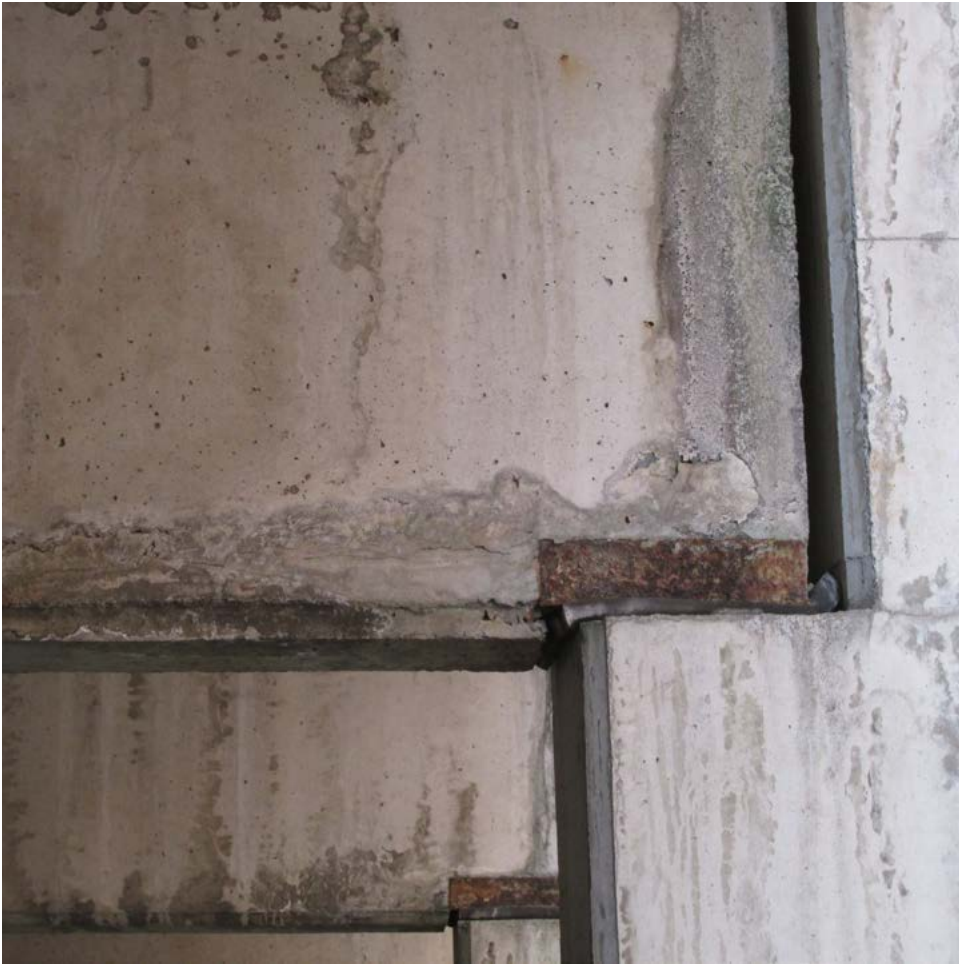
- The bearing end of the precast concrete single tee at the north end of the upper level of the parking garage had been previously repaired. New cracks have formed along the edge of the repair (See Photo 5).

Photo 5 - Close-up view of the bearing end of a precast concrete single tee. We noted that the bearing end of the tee had been previously repaired and that new cracks have formed along the edge of the repair.

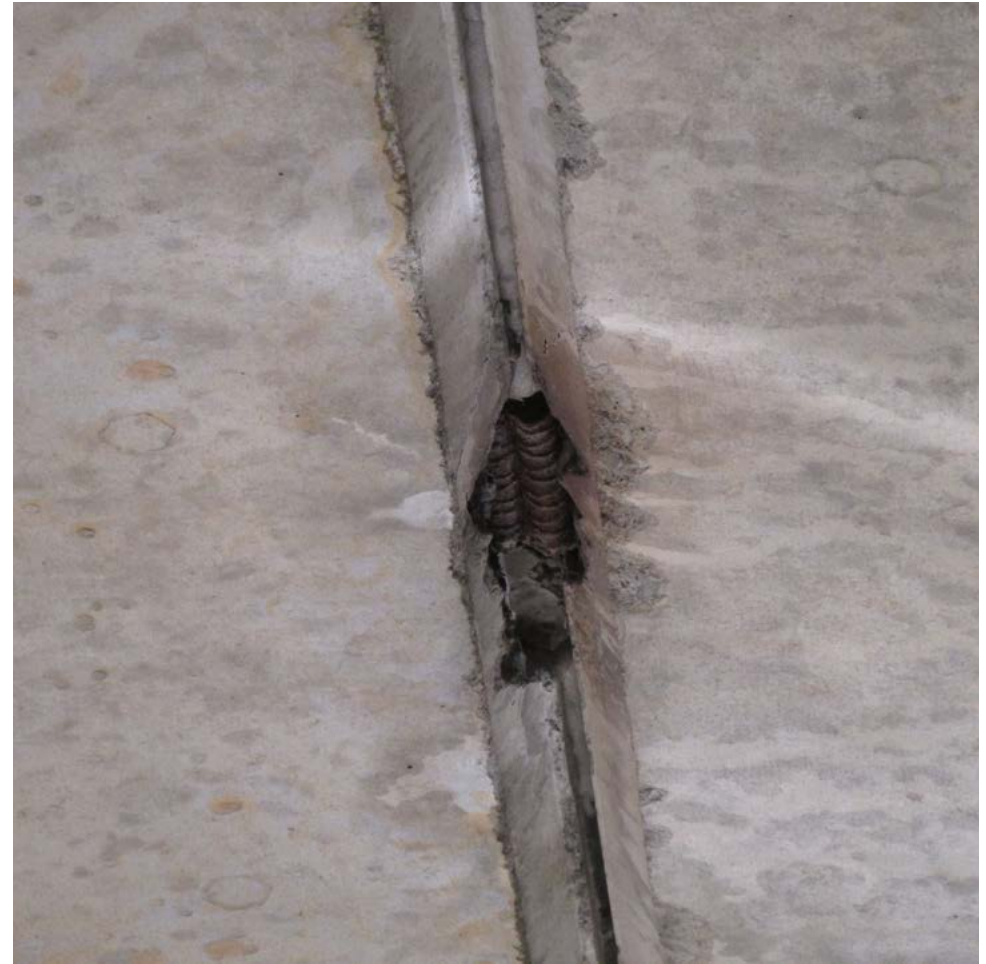
Photo 6 - Close-up view of the joint between two adjacent precast concrete single tees. We noted the joint connecting the adjacent tees consisted of a piece of steel reinforcement welded to a partially exposed piece of reinforcement embedded into the edge of each of the adjacent tees.

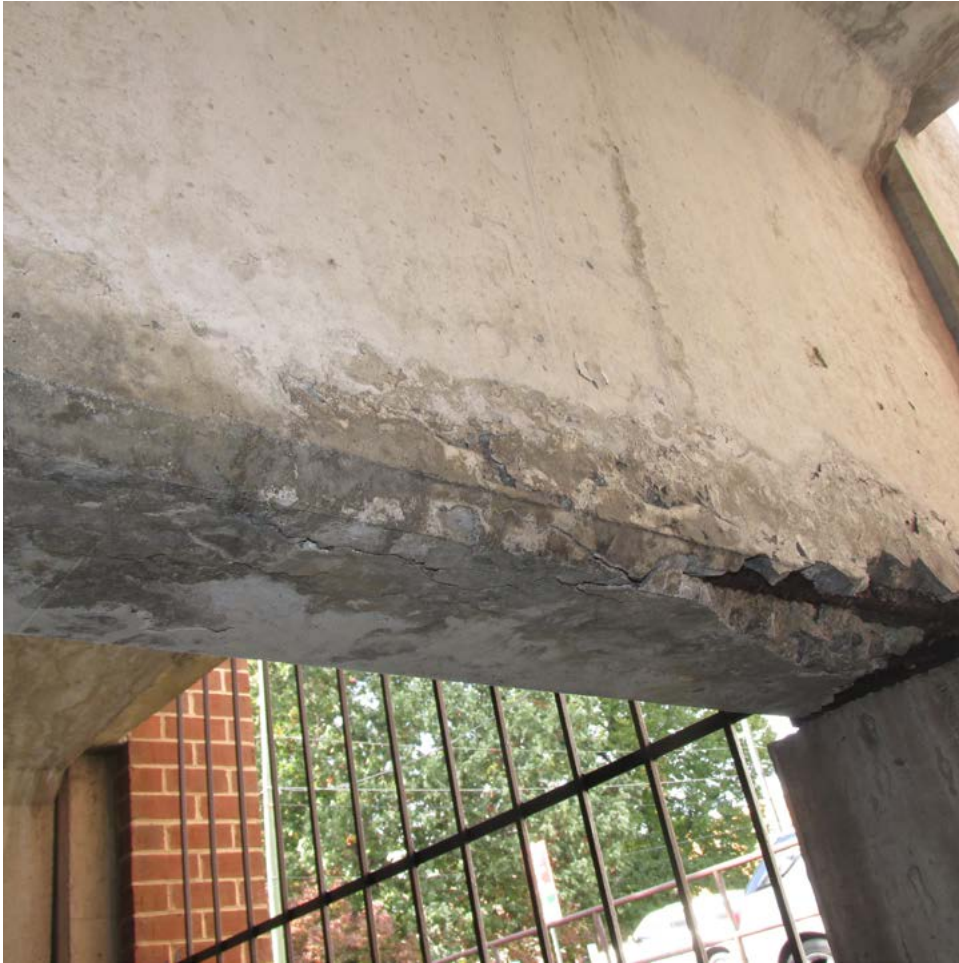
- The bearing end of the precast concrete single tee located at the north end of the upper level, towards the west side of the parking garage, had been previously repaired. Subsequent cracking and spalling of the repair had partially exposed the reinforcement (See Photo 7).

Photo 7 - Close-up view of the bearing end of a precast concrete single tee. We noted that the bearing end of the tee had been previously repaired and that cracking and spalling of the repair had partially exposed the reinforcement.

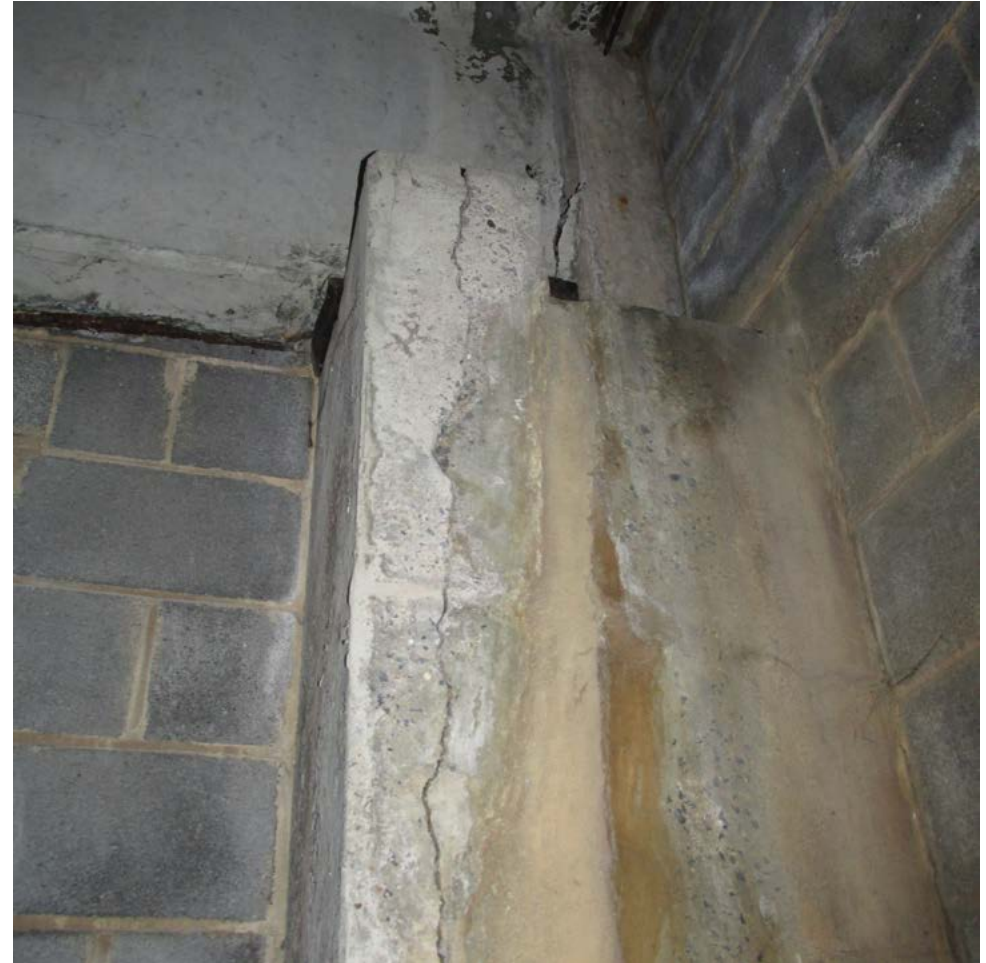
- There is a vertical crack in the precast concrete column at the north end of the parking garage, extending down from the bearing end of the precast concrete single tee. We also noted a spall on the far side of the precast concrete single tee which partially exposed the steel reinforcement at the bearing end (See Photo 8).

Photo 8 - View of the precast column at the north end of the parking garage. We noted the presence of a vertical crack in the precast concrete column extending down from the bearing end of the precast concrete single tee. We also noted a spall on the far side of the precast concrete single tee which partially exposed the steel reinforcement at the bearing end.

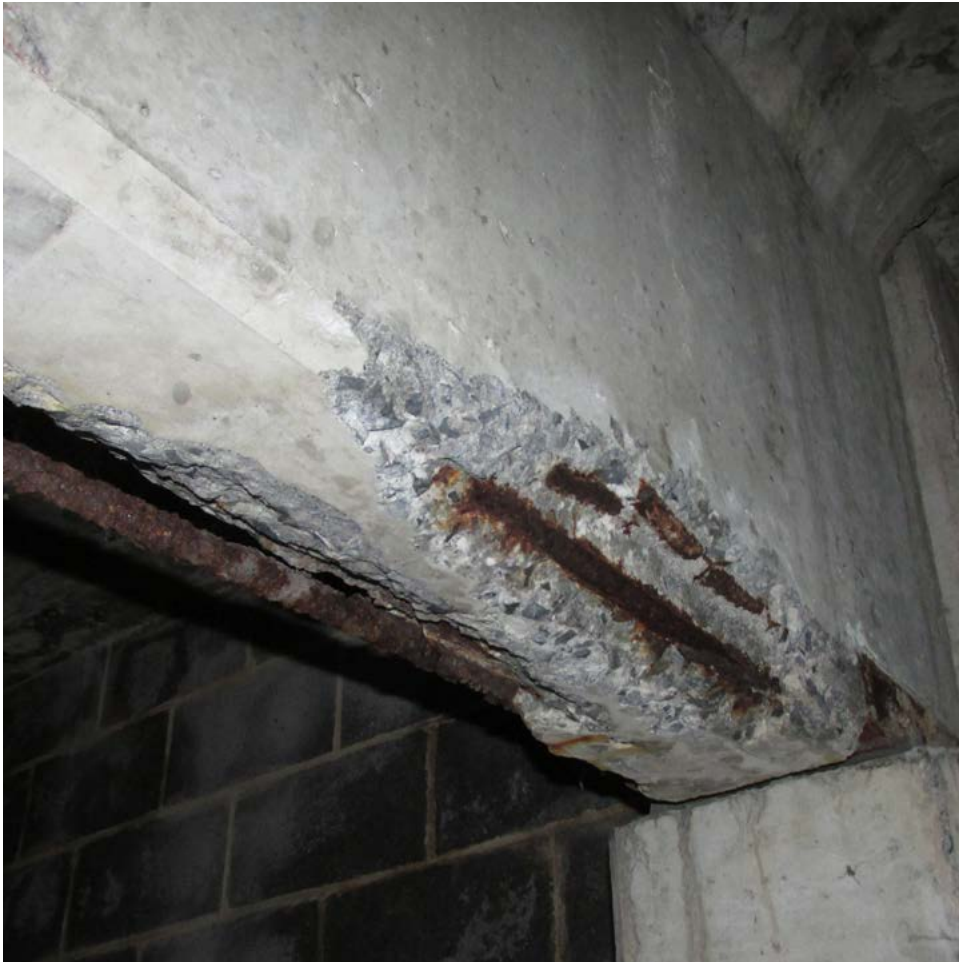
- Spalled concrete has exposed the steel reinforcement at the north bearing end of the precast concrete single tee located at the middle level of the parking garage, towards the northwest end of the garage. We also noted that the exposed steel reinforcement showed signs of corrosion (See Photo 9).

Photo 9 - Close-up view of the bearing end of a precast concrete single tee. We noted spalled concrete exposing the steel reinforcement at the bearing end of the tee. We also noted that the exposed steel reinforcement showed signs of corrosion.

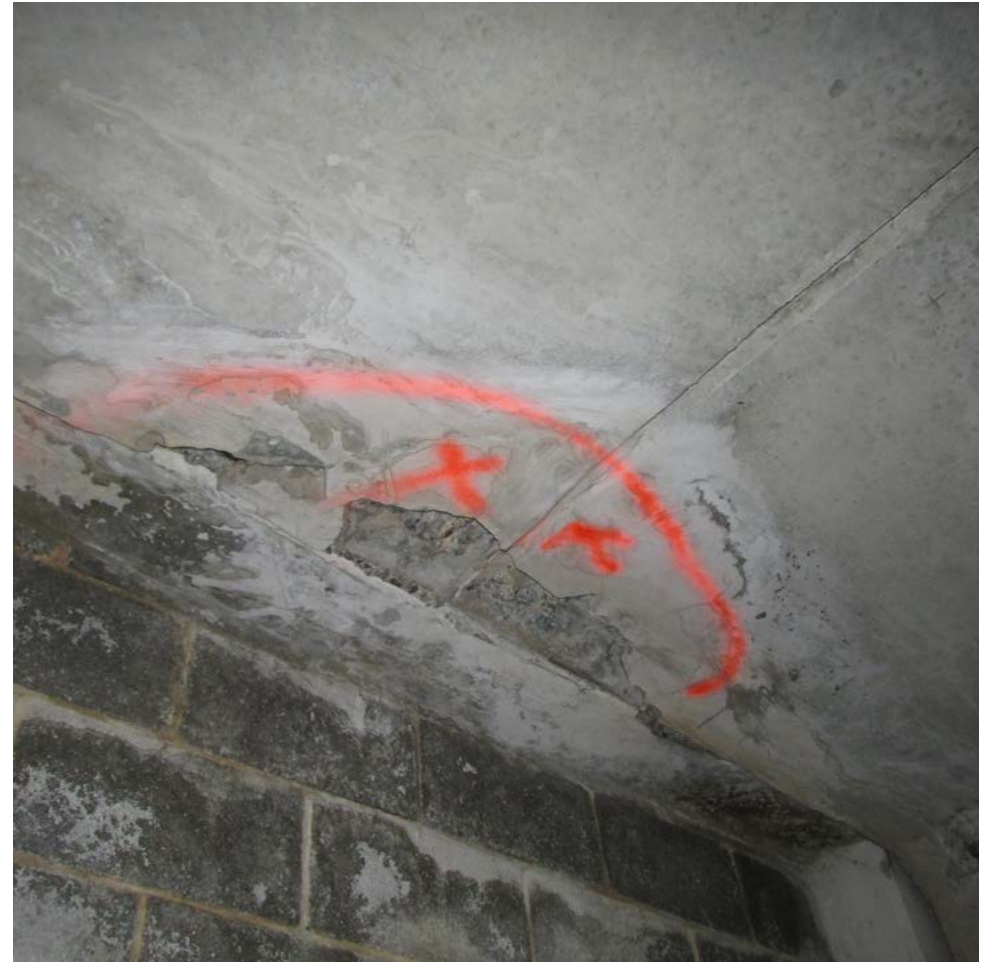
- Spalled concrete was noted on the underside of the flanges of two adjacent precast concrete single tees located at the middle level of the parking garage, at the north end of the tees. The concrete spall partially exposed the steel reinforcement in the flanges of the precast concrete tees near the end (See Photo 10).

Photo 10 - View of the underside of two precast concrete single tees. We noted spalling of the concrete which partially exposed the steel reinforcement at the end of the two tees.

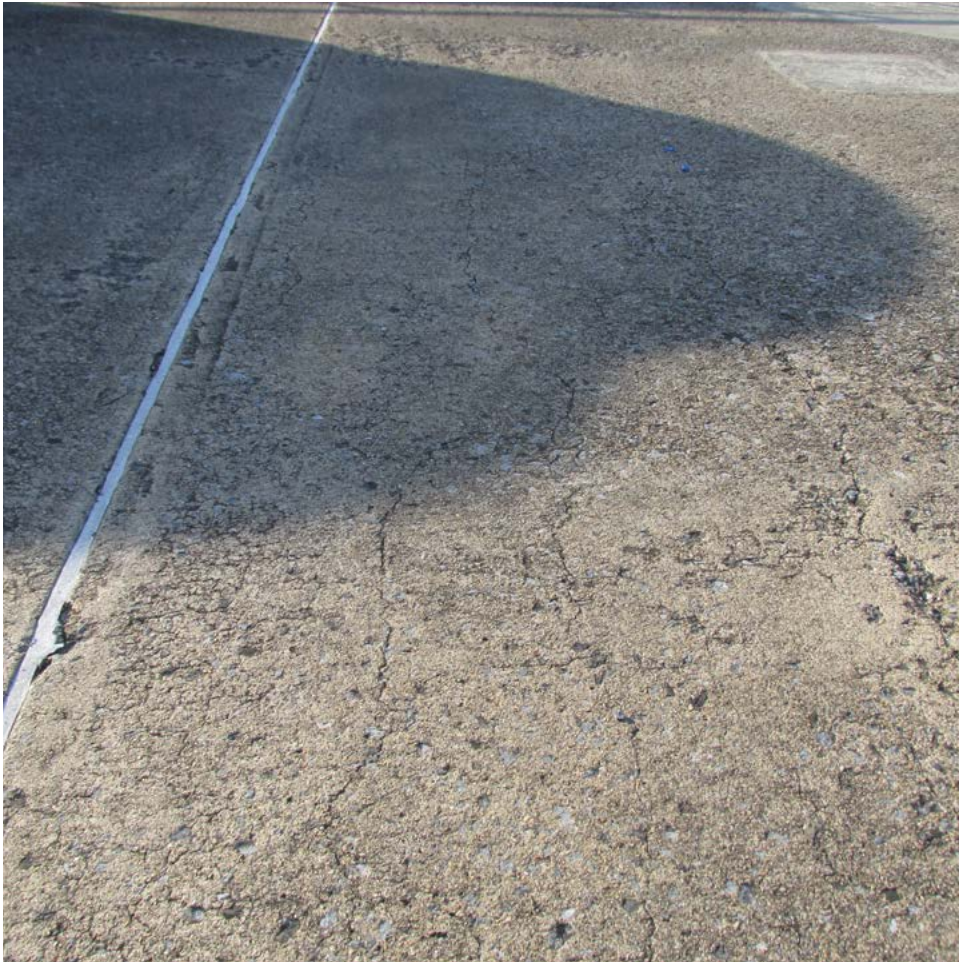
- The topping slab at the upper level of the parking garage showed signs of loss of cement paste at the surface partially exposing the aggregate. Several cracks and spalls were present in the topping slab (See Photo 11).
- At a number of locations, spalled concrete topping slab and/or cracks in the concrete topping slab existed approximately 7'-0" from the end of the precast concrete single tees (See Photo 12).
- Close-up view of the joint in the topping slabs between two adjacent precast concrete single tees. We noted a spall that extended the full depth of the topping slab, exposing a gap between the adjacent precast concrete single tees on the ramp leading up to the upper level of the parking garage to the south of the center row of columns of the parking garage (See Photo 13).

Photo 11 - View of the topping slab of the parking garage at the upper level of the garage. The topping slab showed signs of loss of cement paste at the surface partially exposing the aggregate. Several cracks and spalls were present in the topping slab.
