**REQUEST FOR QUALIFICATIONS  
CONSTRUCTION PHASE SERVICES  
JOHNSON STREET PARKING GARAGE  
and  
NEW STREET PARKING GARAGE

CITY OF STAUNTON, VIRGINIA**

Wiley|Wilson is pleased to submit this report detailing our findings, remedial repair recommendations, order of magnitude cost estimate, and estimated life of repairs for the City owned parking garage located on West Johnson Street between South Lewis Street and North Central Avenue in Staunton, Virginia.

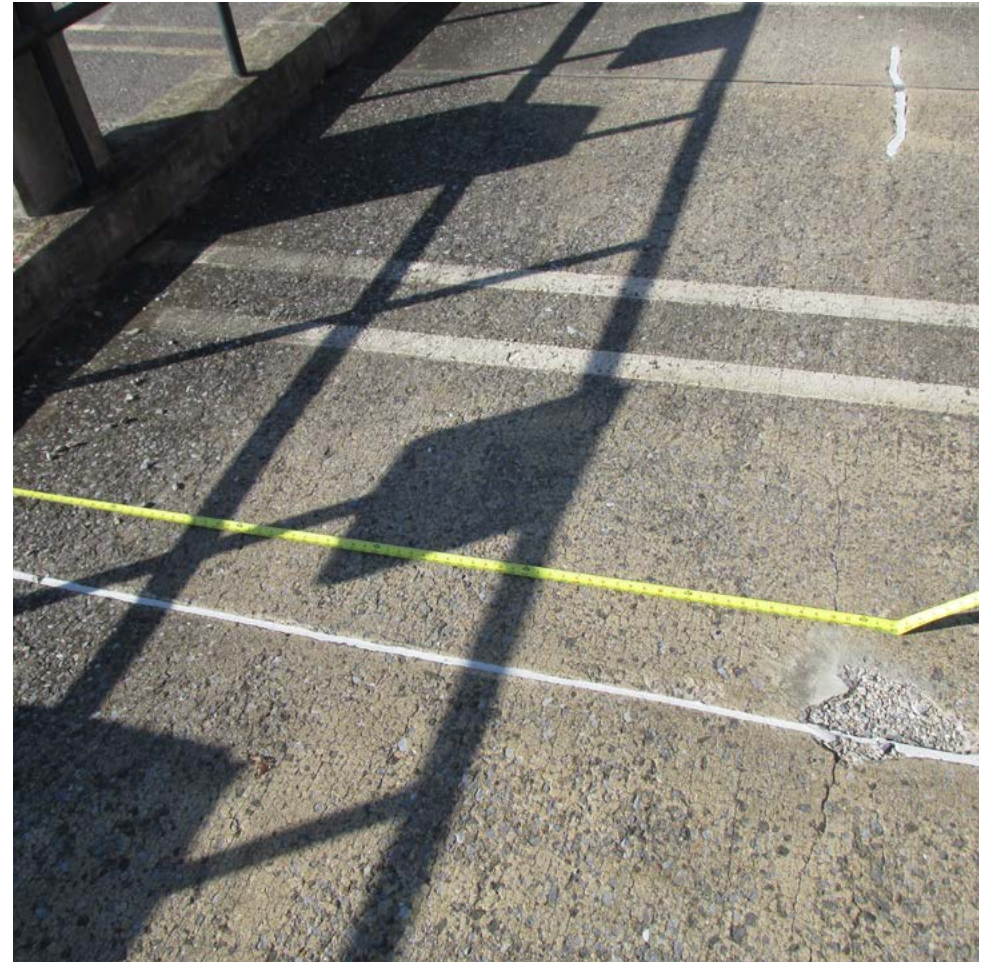
Photo 12 - View of the topping slab of the parking garage along the ramp from the upper level down to the middle level. This picture was taken looking towards the southwest. We noted that at a number of locations spalled concrete topping slab and/or cracks in the concrete topping slab existed approximately 7'-0" from the end of the precast concrete single tee planks.

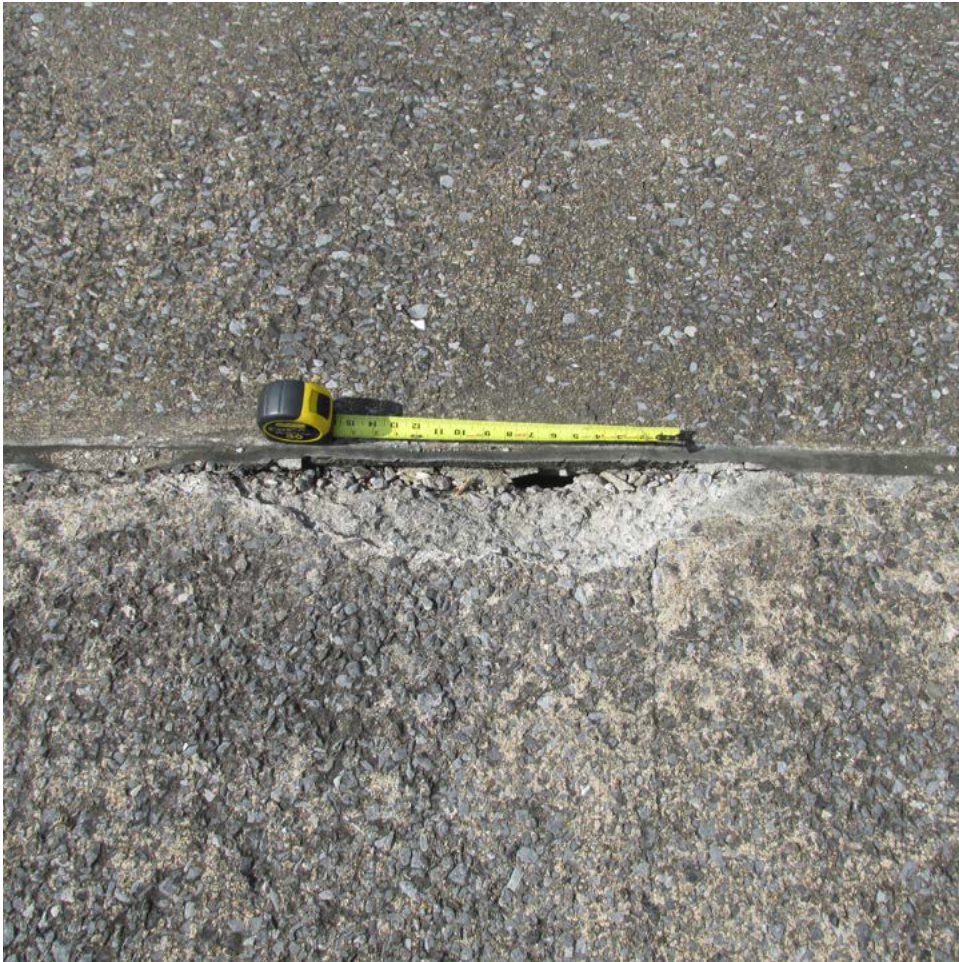
Photo 13 - Close-up view of the joint in the topping slabs between two adjacent precast concrete single tee planks. We noted a spall that extended the full depth of the topping slab exposing a gap between the adjacent single tee planks.

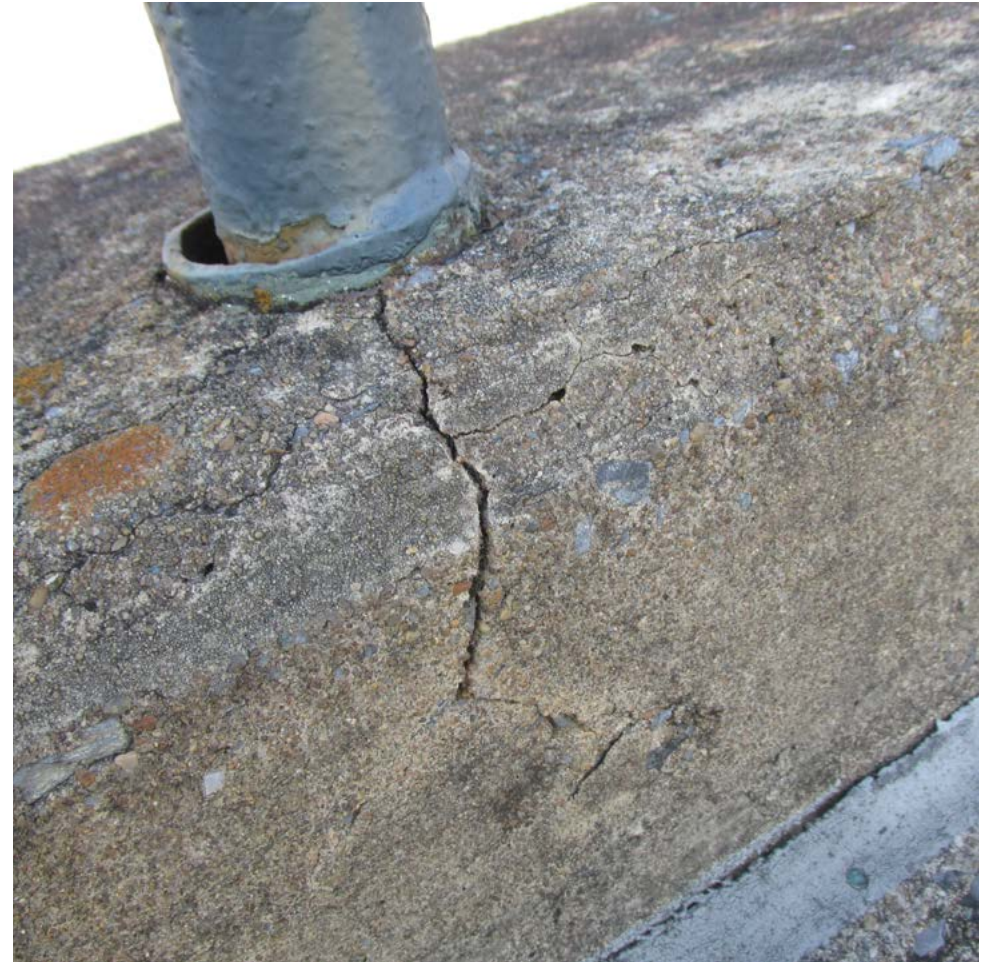
- A vertical crack extending out from the embedded guardrail post and continuing down both sides of the cast-in-place concrete curb, at the curb separating the upper level from the middle level of the parking garage near the east end (See Photo 14).

Photo 14 - Close-up view of a steel guardrail post embedded in the cast-in-place concrete curb separating two levels of the parking garage. We noted a vertical crack extending out from the embedded guardrail and continuing down both sides of the cast-in-place concrete curb.

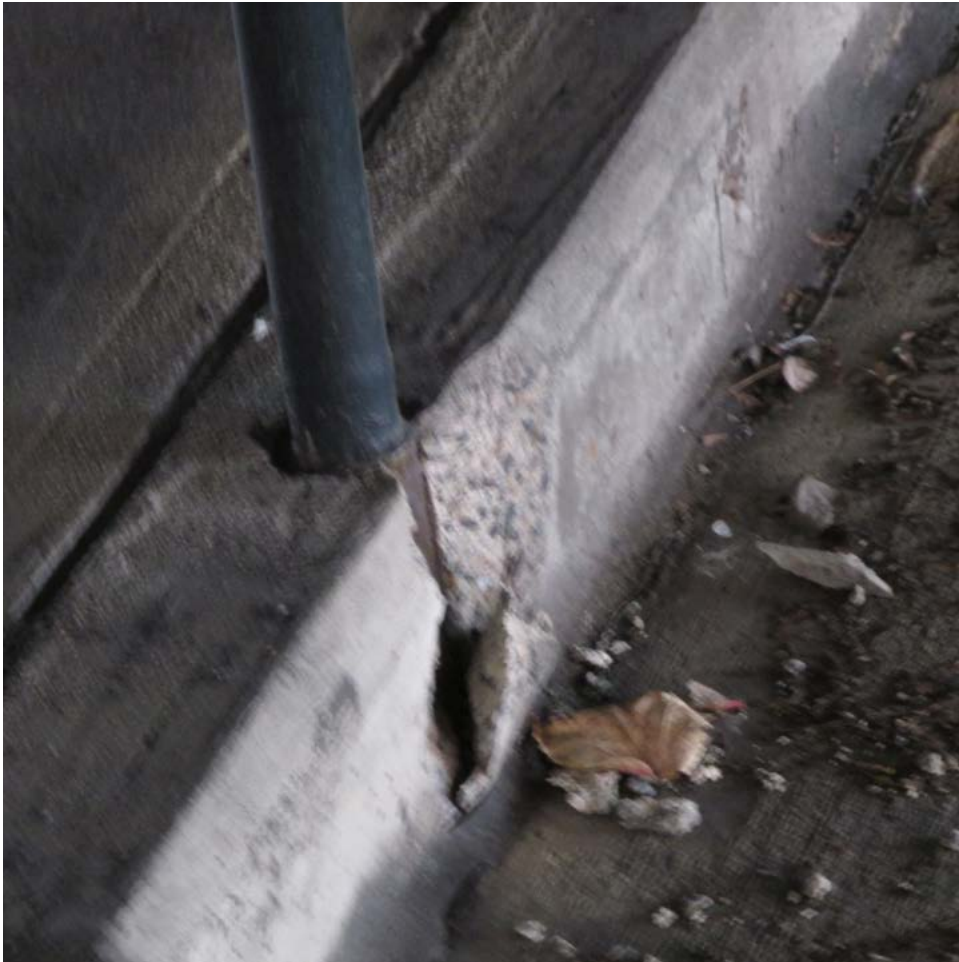
- A steel guardrail post embedded in the cast-in-place concrete curb separating two levels of the parking garage. The face of the concrete curb had spalled at the location of the sleeve embedded into the concrete for the guardrail post (See Photo 15).

Photo 15 - Close-up view of a steel guardrail post embedded in the cast-in-place concrete curb separating two levels of the parking garage. We noted the face of the concrete curb had spalled at the location of the sleeve embedded into the concrete for the guardrail post.

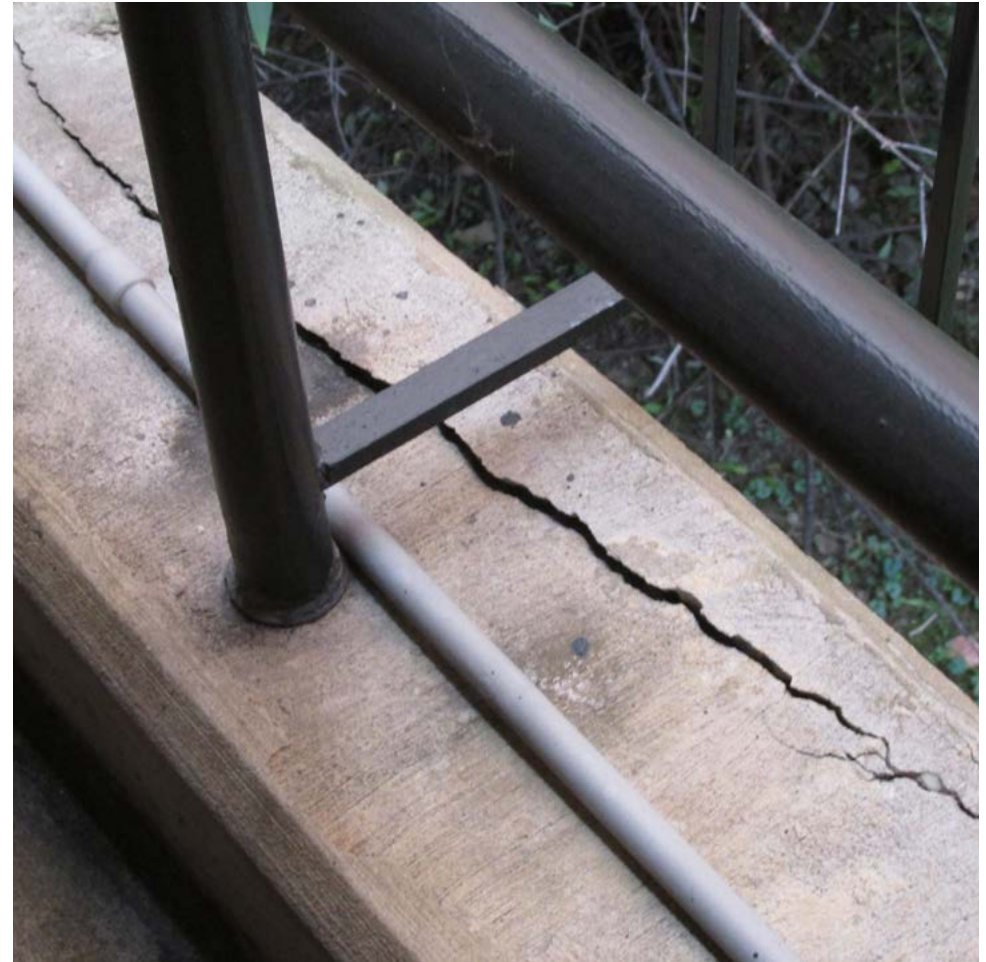
- The cast-in-place concrete edge beam was cracked and spalled along the north side of the parking garage at the middle level (See Photo 16).
- The underside of the cast-in-place concrete beam along the north side of the parking garage at the upper level had spalled, partially exposing the steel reinforcement. Additionally, the exposed steel reinforcement showed signs of corrosion (See Photo 17).

Photo 16 - Close-up view of the cast-in-place concrete edge beam along the north side of the parking garage. We noted that the concrete beam was cracked and spalled along this section of the parking garage.

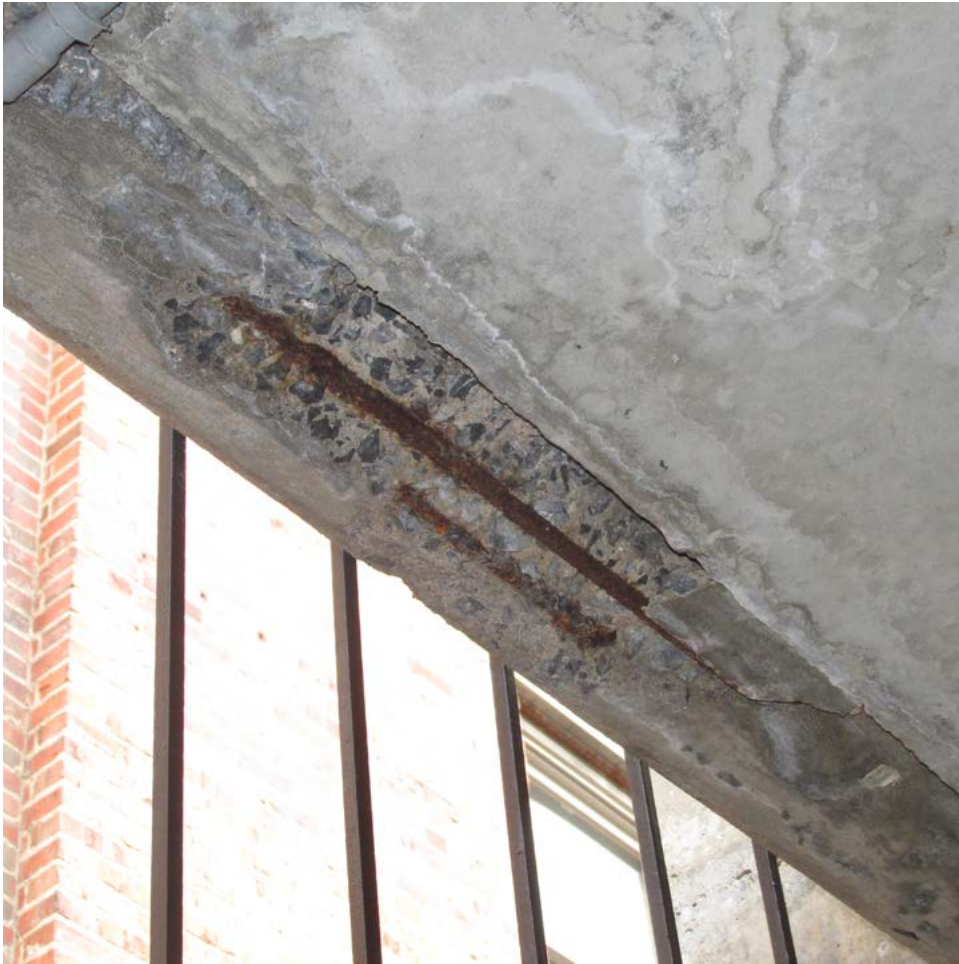
Photo 17 - View of the underside of the cast-in-place concrete beam along the north side of the parking garage. We noted spalling of the concrete which partially exposed the steel reinforcement. Additionally, the exposed steel reinforcement showed signs of corrosion.

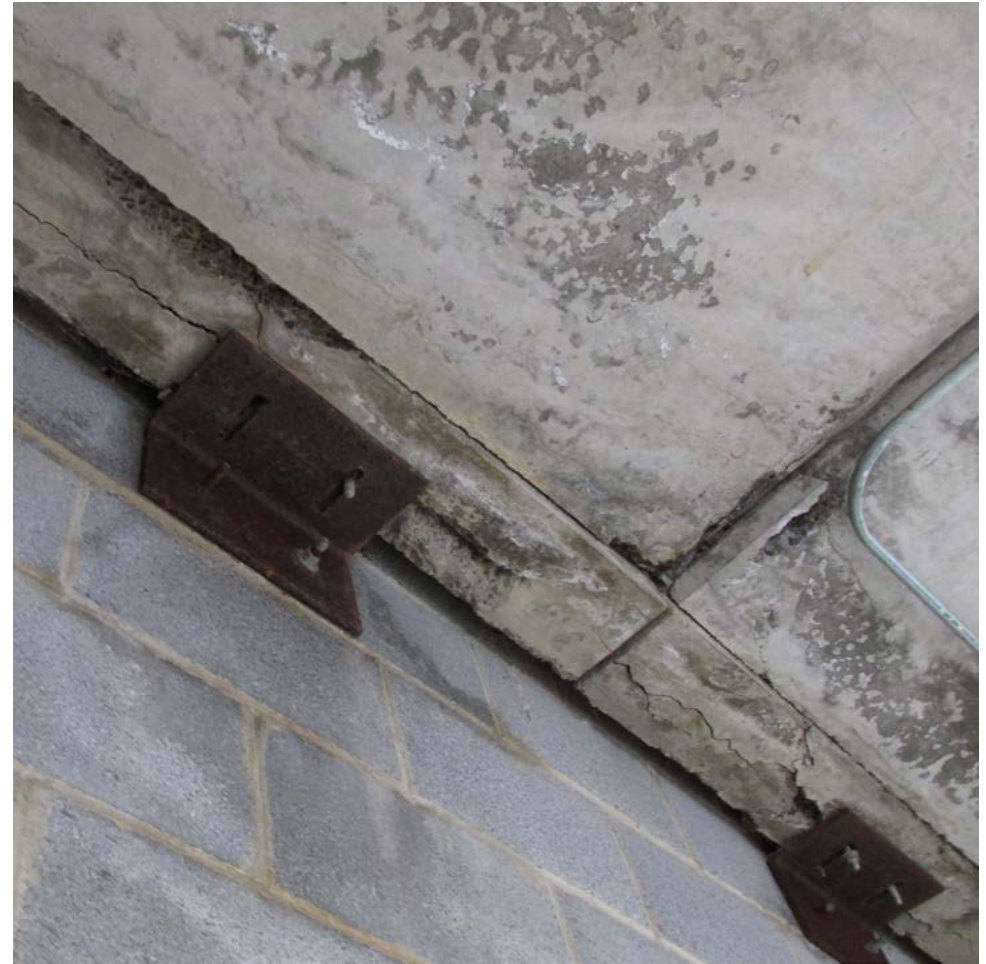
- The cast-in-place concrete beam at the upper level along the south side of the parking garage showed signs of cracking and spalling of the concrete, which partially exposed the steel reinforcement. Additionally, several rusted steel brackets anchoring the wall to the cast-in-place concrete beam were observed. Loose and/or missing anchor rods and nuts were observed at several of the holes in the steel brackets (See Photo 18).

Photo 18 - View of the underside of the cast-in-place concrete beam along the south side of the parking garage. We noted cracking and spalling of the concrete which partially exposed the steel reinforcement. Additionally, several rusted steel brackets anchoring the wall to the cast-in-place concrete beam were observed. Loose and or missing anchor rods and nuts were observed at several of the holes in the steel brackets.

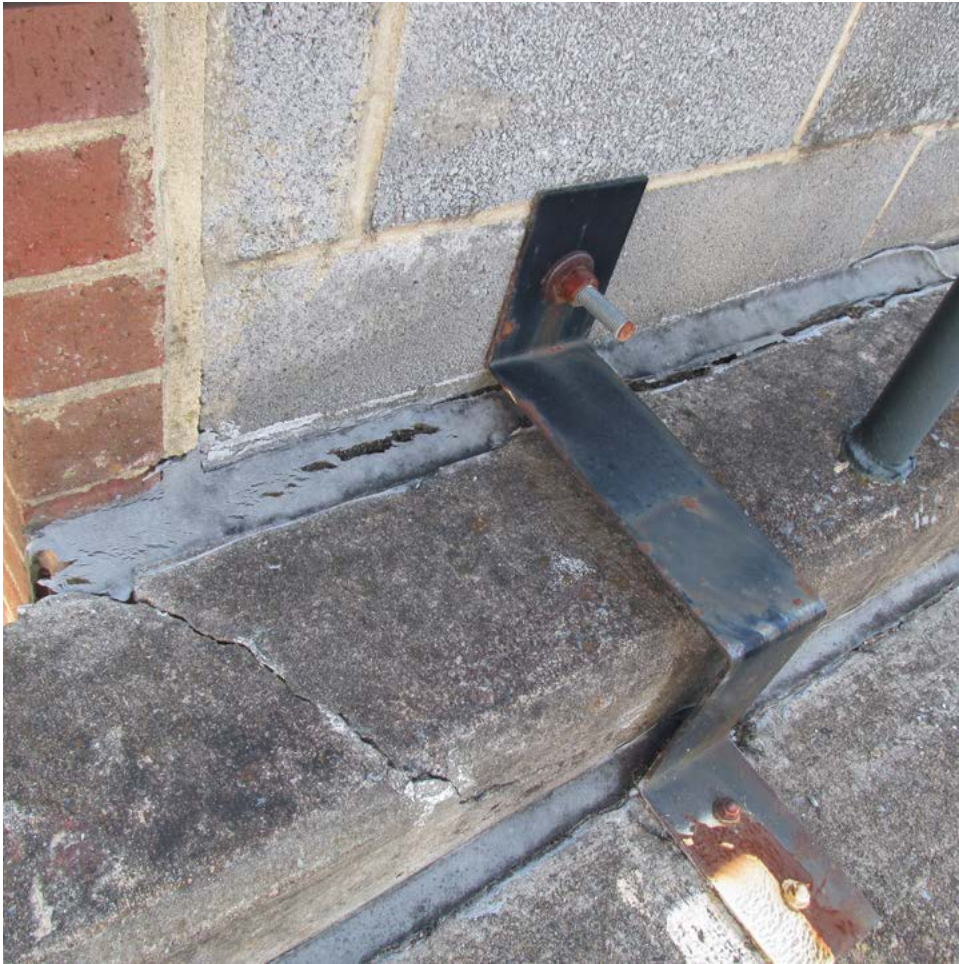
Photo 19 - Close-up view of bent steel strap anchor bolted into the masonry wall at the southeast corner of the parking garage at the upper level. Note the large caulk joint between the wall and the cast-in-place concrete curb. Additionally we noted a crack in the cast-in-place concrete curb adjacent to the end of the masonry wall.

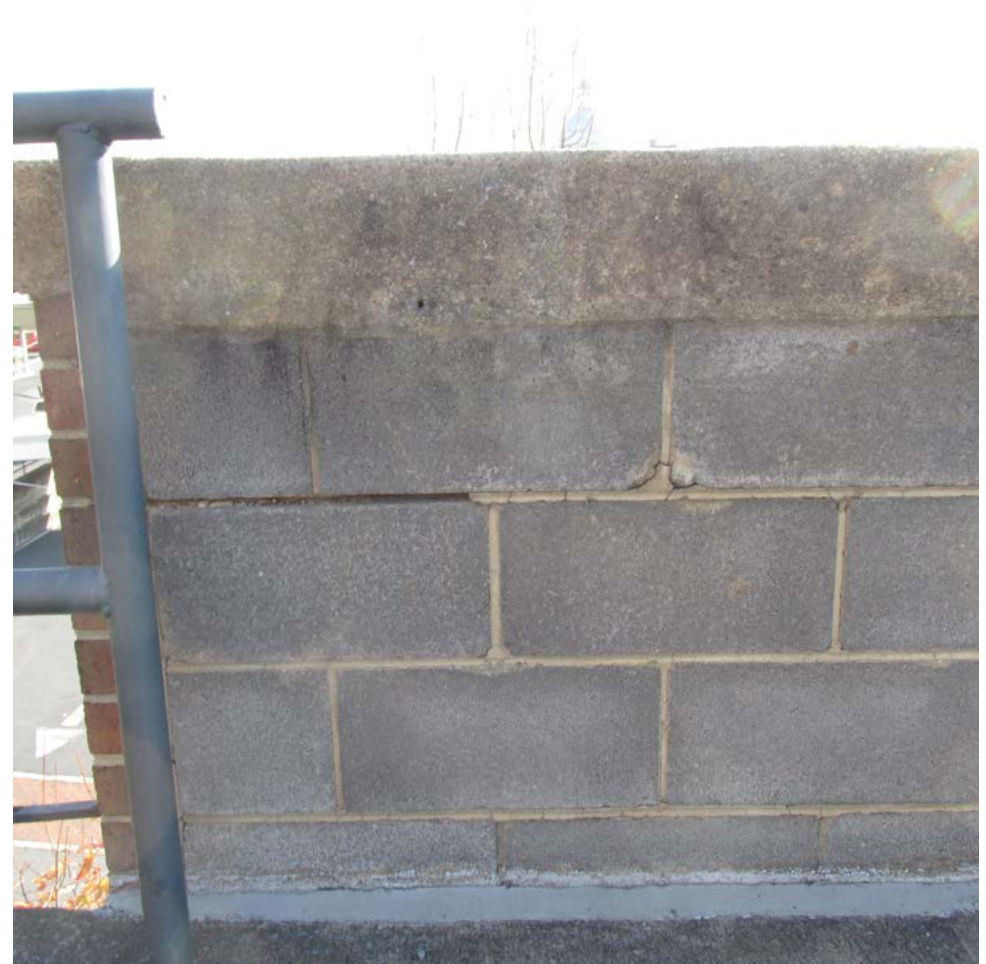
Photo 20 - View of the interior face of the top of the masonry wall at the east side of the parking garage. We noted horizontal cracks in the mortar joints. Additionally, we also noted missing and loose mortar.

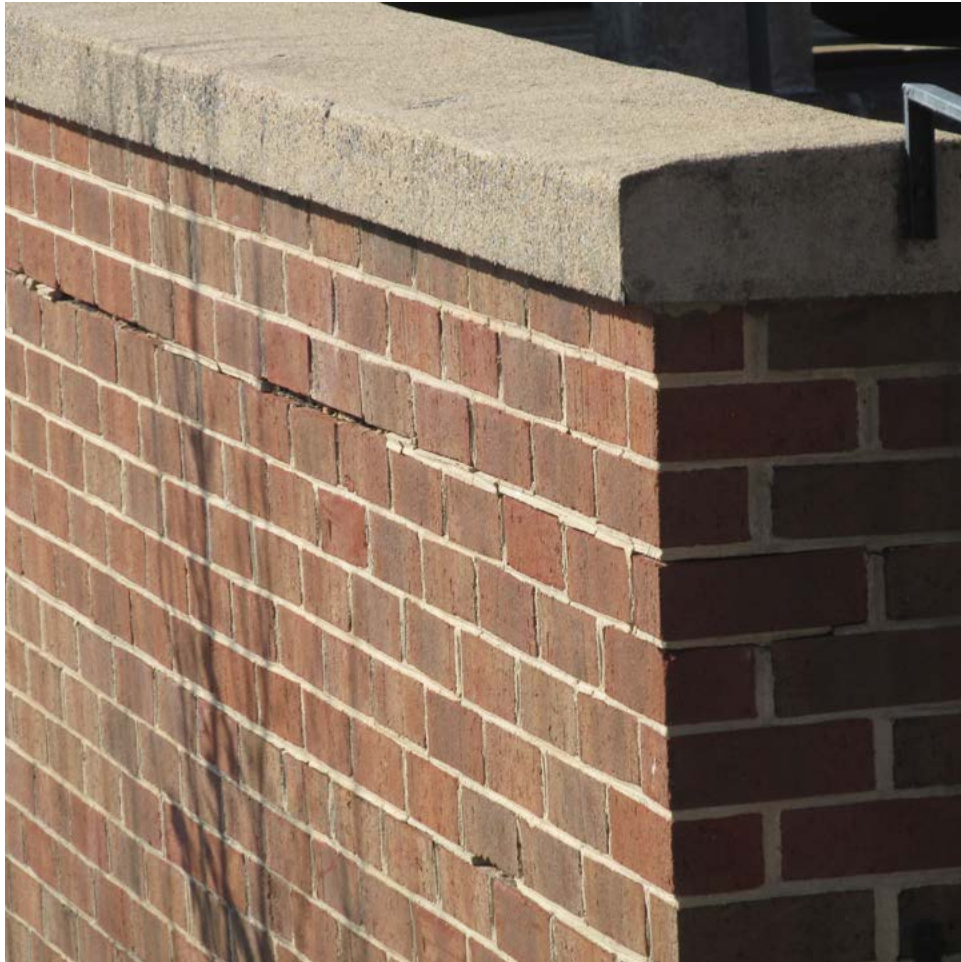
Photo 21 - View of the exterior face of the masonry wall along the east side of the parking garage. We noted cracked and loose or missing mortar in the joints in the brick veneer.

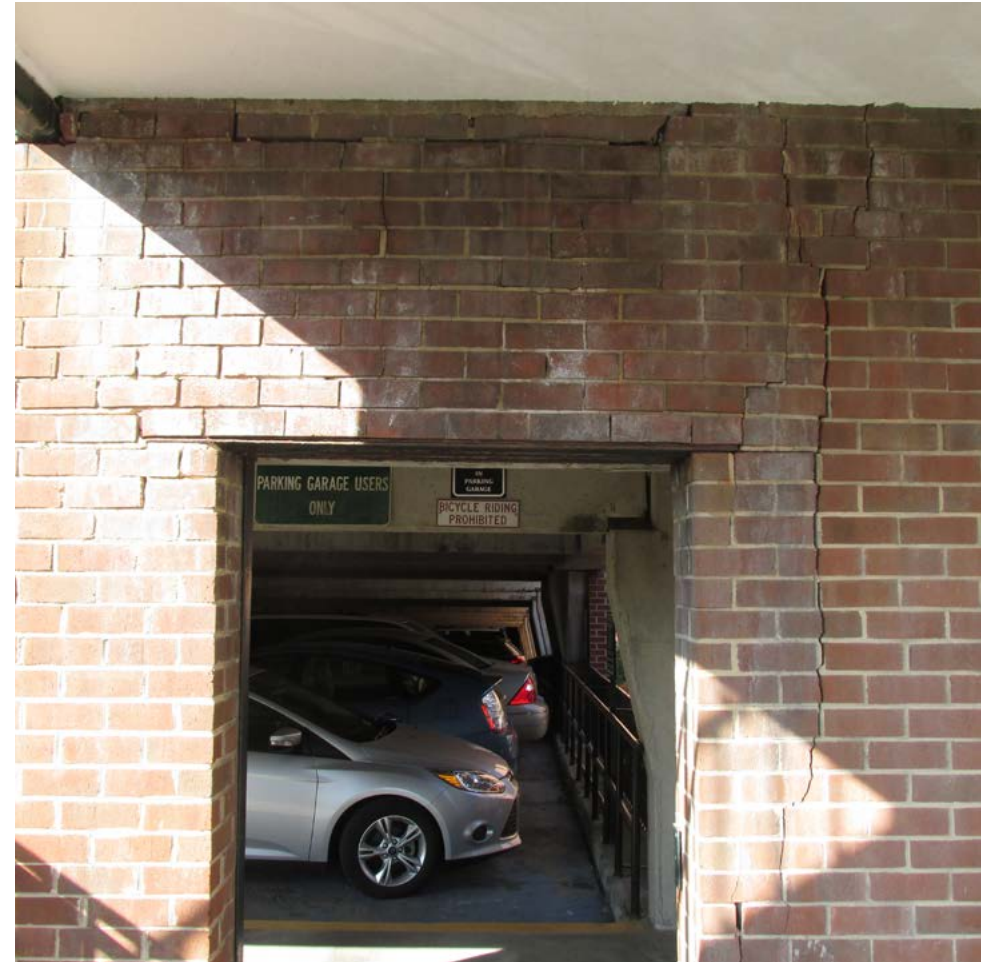
Photo 22 - View of the entrance to the 2B level of the parking garage at the northeast corner of the parking garage. We noted vertical, horizontal, and stairstep cracks in the brick and mortar joints of the masonry wall. We also noted loose and or missing mortar in the joints of the brick veneer. Additionally, we noted the steel angles forming the lintel above the opening were rusted.

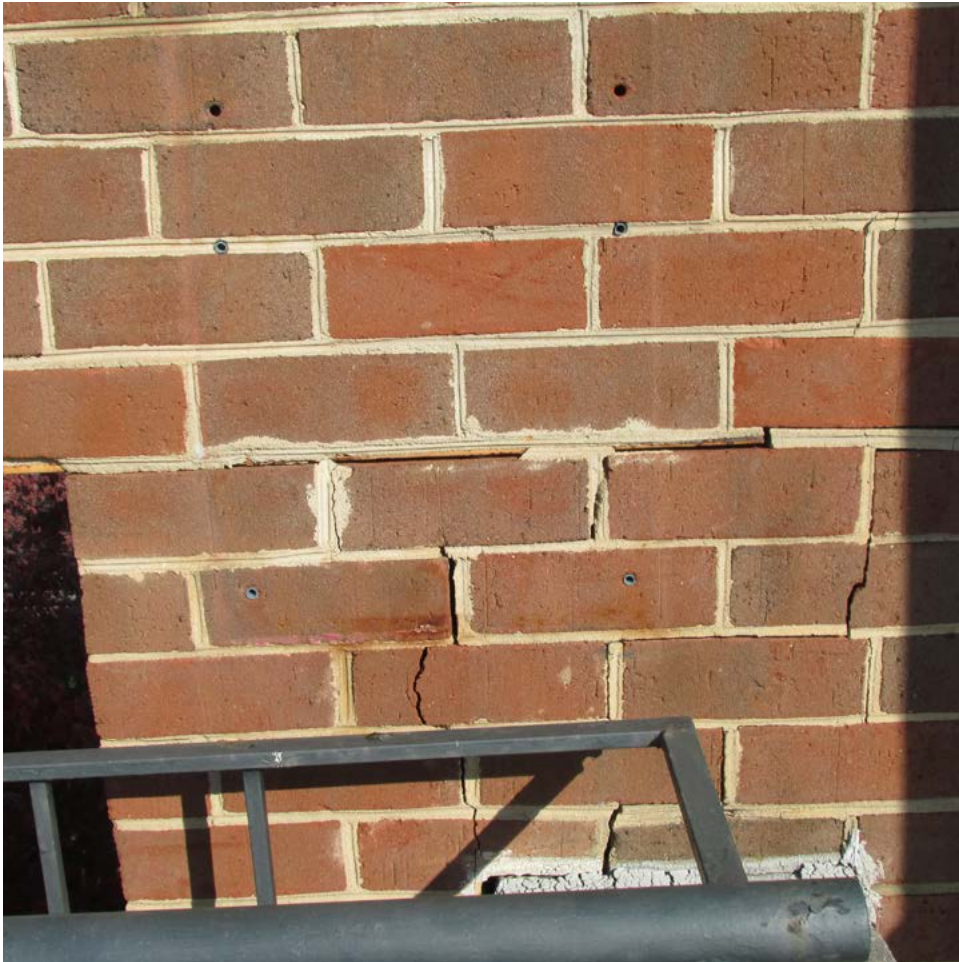
Photo 23 - Close-up view of the brick veneer at the top level of the elevator shaft. This photo was taking looking towards the north. We noted that a portion of masonry wall overhangs the lower section of the wall and is supported by a steel plate that is embedded approximately 24" into the wall. We noted horizontal and stairstep cracks in the brick and mortar joints of the brick veneer at this location.

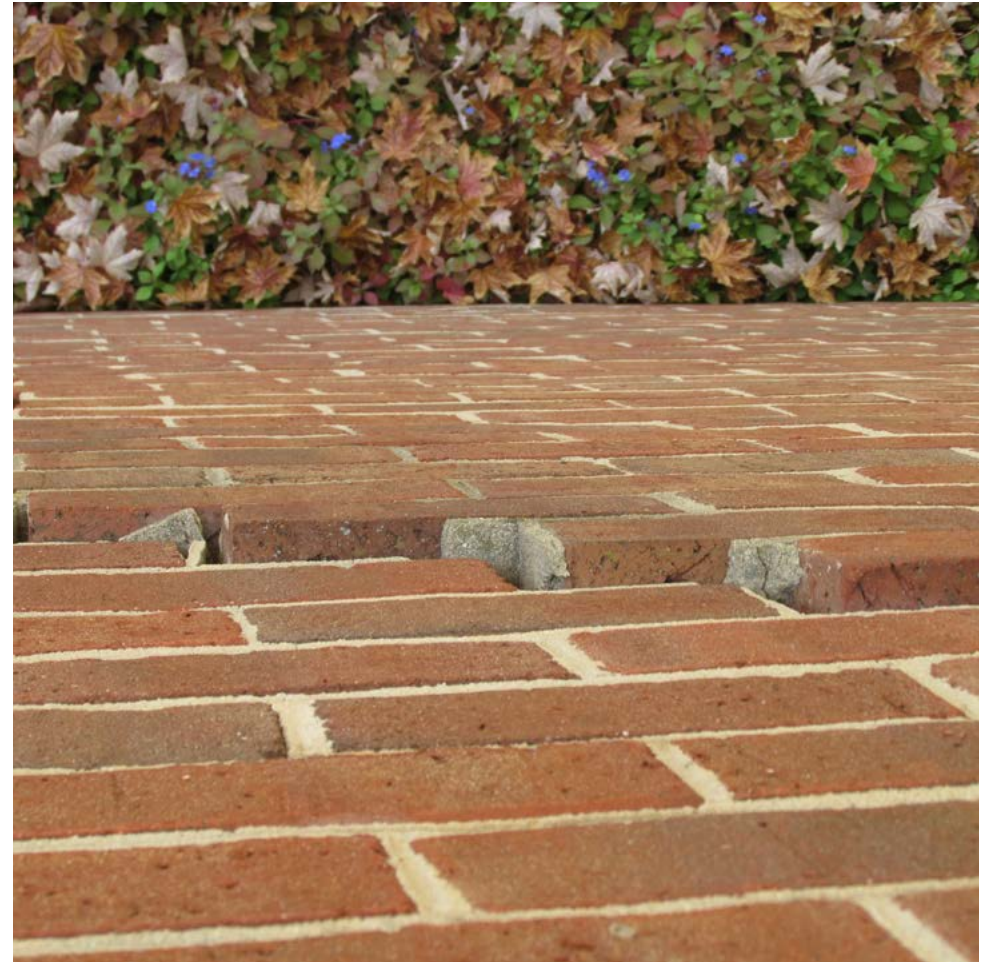
Photo 24 - View looking down the exterior face of the masonry wall located below the pedestrian ramp leading to South Lewis Street at the northwest corner of the parking garage. We noted the presence of stairstep and vertical cracks in the bricks and mortar joints of the brick veneer. Additionally, we noted that the bricks above the crack were displaced from those below the crack.

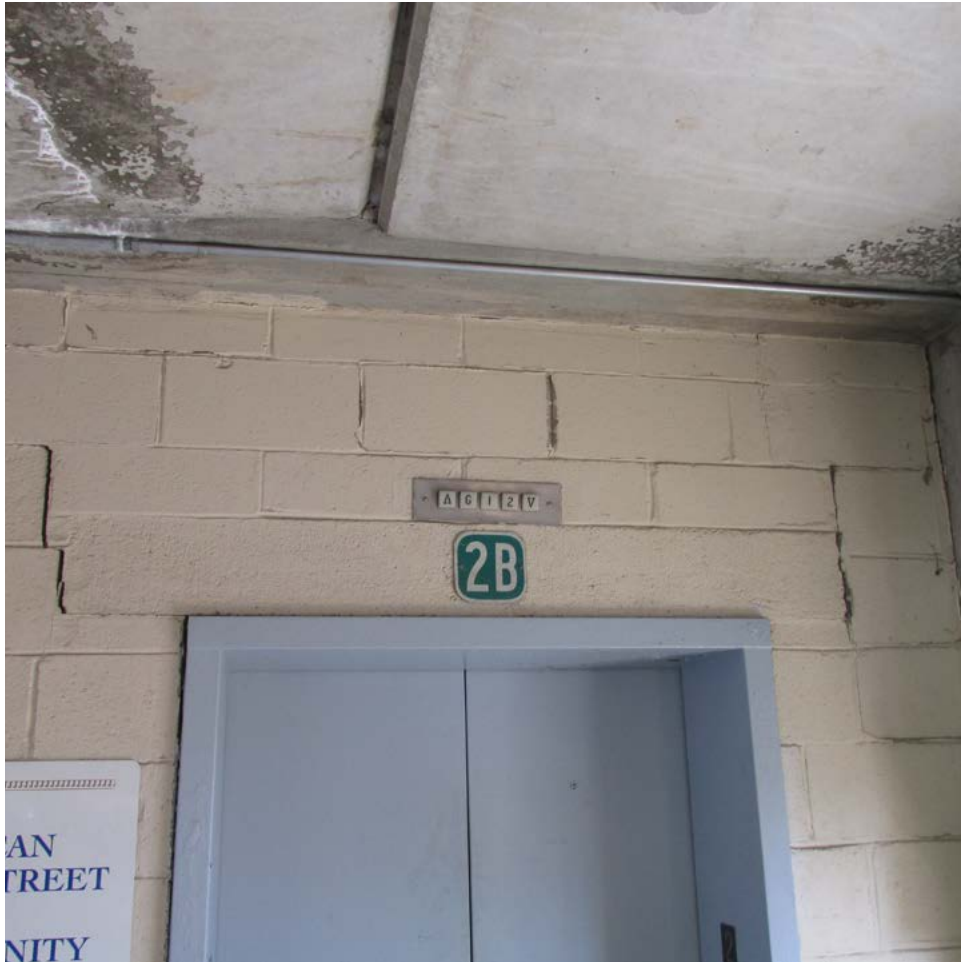
Photo 25 - View of the interior face of the masonry wall for the elevator enclosure at level 2B. The photo is taken looking towards the north. We noted stairstep and horizontal cracks in the mortar joints of the CMU wall. Additionally, the flanges of the interior and end single tee precast concrete planks were vertically offset approximately 1 inch from each other.

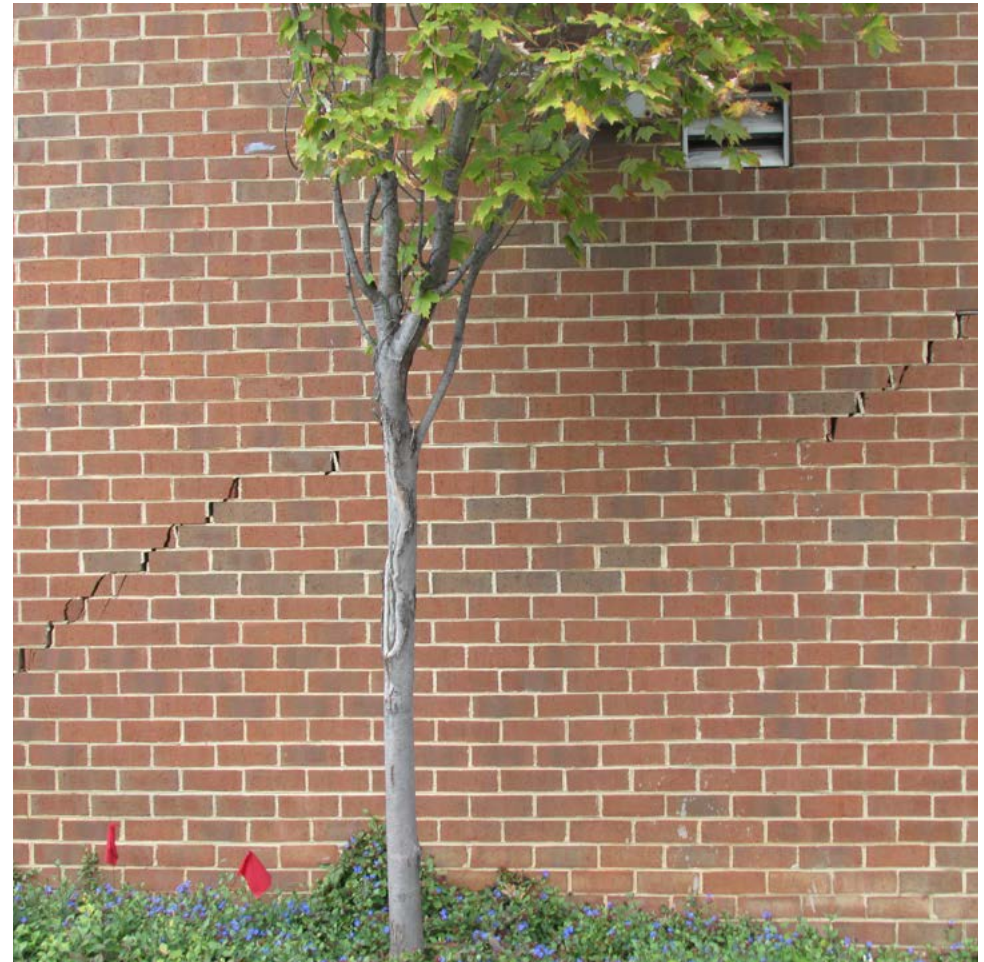
Photo 26 - View of the exterior face of the masonry wall to the west of the main entrance to the parking garage off of Johnson Street. We noted the presence of horizontal and stairstep cracks in the bricks and mortar joints of the brick veneer. The cracks were a maximum of approximately 3/4" wide at some locations.

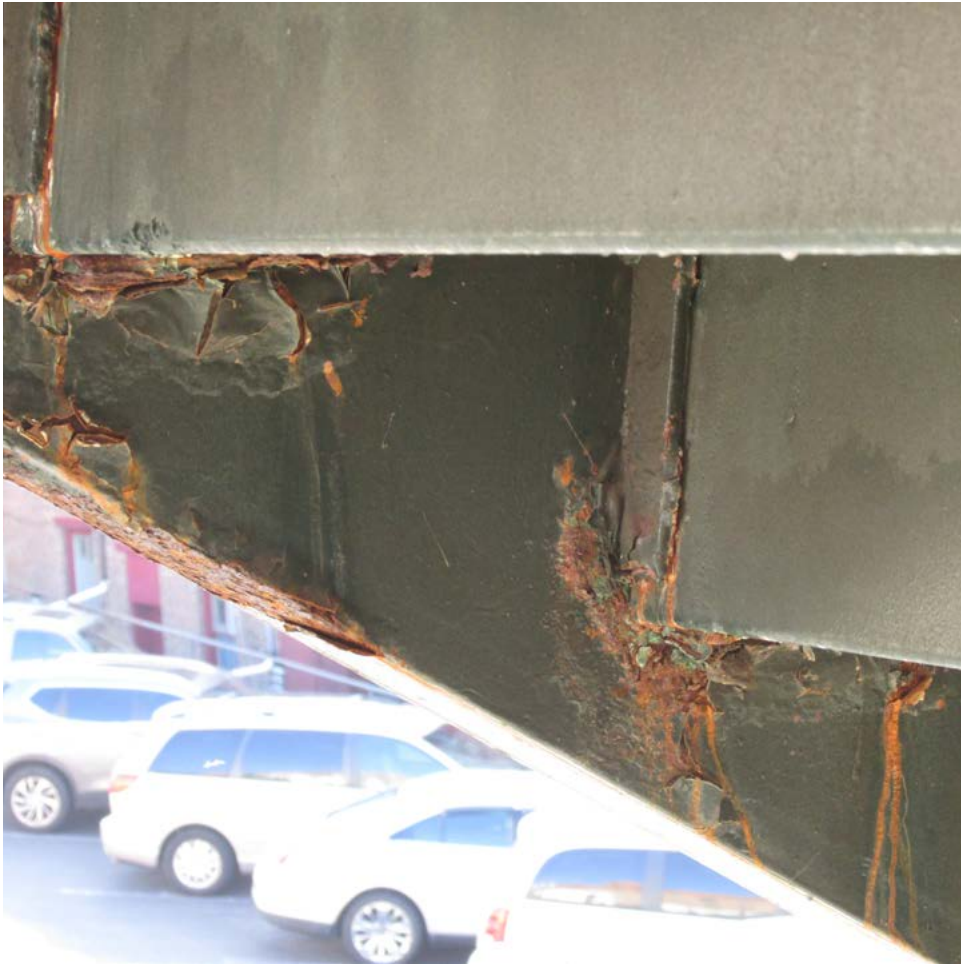
Photo 27 - Close-up of the underside of the steel stair stringers of the exterior stair along the east side of the parking garage. We noted that the metal stair pans were supported by steel bars welded to the stair stringer. Corrosion of the stringer, support bars, and metal stair pans were observed.

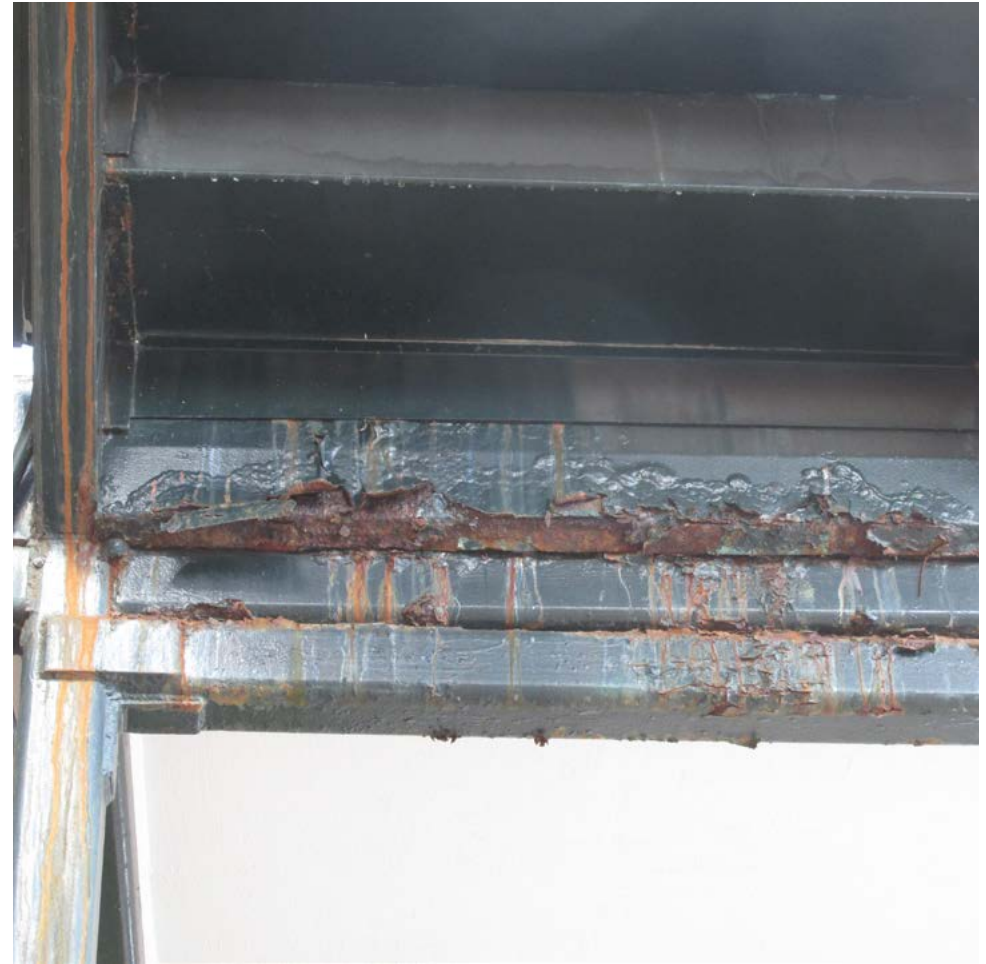
Photo 28 - View of the underside of the exterior steel stair along the east elevation of the parking garage. We noted corrosion of the metal stair pan and supporting steel framing.
