**Phase I Environmental Site Assessment  
of the  
Western State Hospital  
Staunton, Virginia**

Prepared for  
City of Staunton, Virginia

Wiley|Wilson Comm. No. 209161.00

August 31, 2009

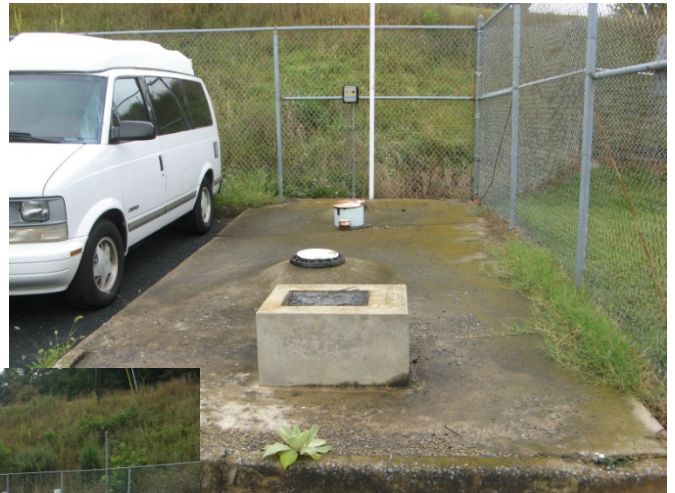
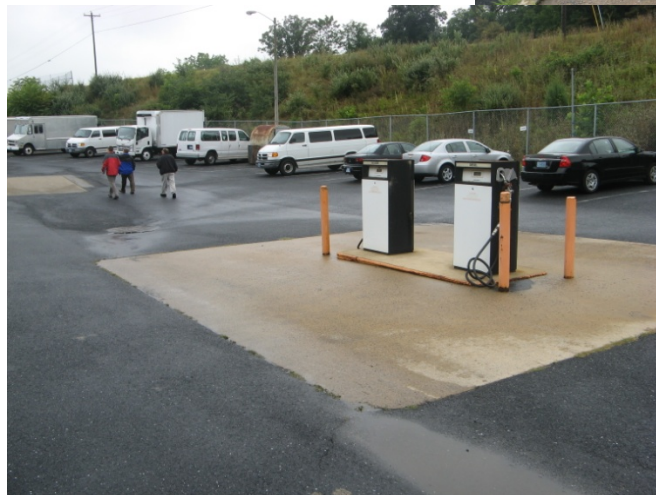
The WSH property owner provided record information regarding fuel storage tanks for the standby generators and gasoline storage and pumping site on the campus. Underground fuel storage tanks have been identified on site and associated with the structures or equipment for which they provide fuel. Identified suspect LUST have been evaluated and removed and site evaluated by the Commonwealth as closed. Copies of the UST Replacement, Removal and Closures are included in Appendix E – Historical Research Documentation. Below are photographs of the gasoline and diesel USTs and vehicle filling station located on the property behind Building 126.

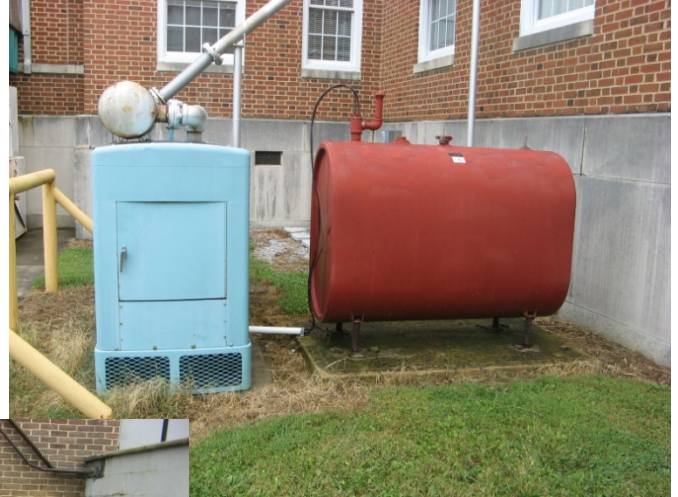
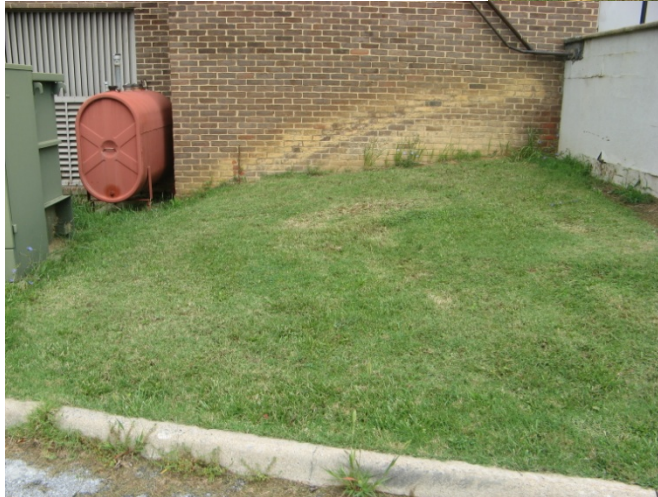
The photograph below is a typical aboveground fuel storage tank for a standby generator located behind most of the buildings on the WSH campus. The second photograph is a site where an UST was removed (area under the grass) and replaced with an AST seen on the upper left of the photo in red. Chemical drum storage on site was located in the Power Plant Building 114 and the Physical Plant Services/Materials Management/Transportation Building 126. Further description and information is located in Section 6 Site Reconnaissance.
