Re: Western State Hospital Buildings Assessment  
Wiley|Wilson Comm. No. 209161

At your request, a team from Wiley|Wilson visited the Western State Hospital (WSH) campus at the intersection of US 250 and Interstate 81 in Staunton to do an architectural and structural overview assessment of existing buildings in order to determine their overall condition and to look for any major defects that could hinder their possible redevelopment. Currently, no specific plans are in place for future use, so we understand this assessment to be general in nature pertaining to whether the buildings may be reused by any potential commercial or industrial prospects interested in the WSH property. On-site, Thursday, August 6, were Dave Roberts to assess structural integrity and Arthur Wilson to assess basic architectural components. Tim Wagner was also on-site on August 6, 2009 to perform a Phase I Environmental Site Assessment. Note that there are 22 structures on the WSH property, so the building assessment is only an overview as to what could be explored in one day.

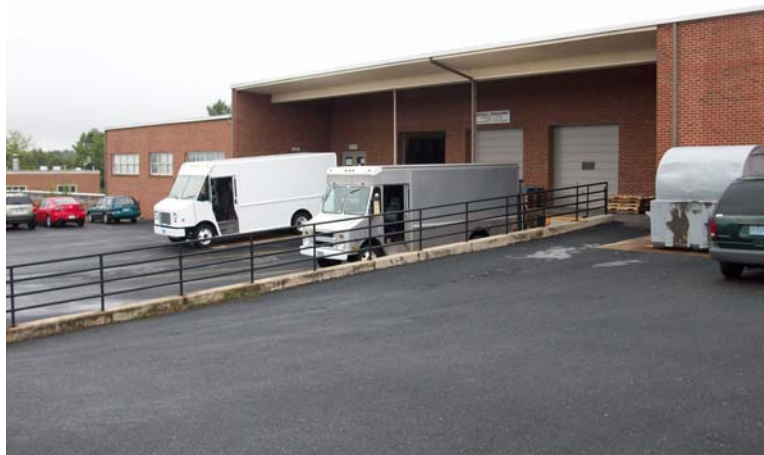
Building 126 – Physical Plant Services/Materials Management - Building was CMU, Steel, and Bar Joist Construction with metal deck. No structural issues were noted.

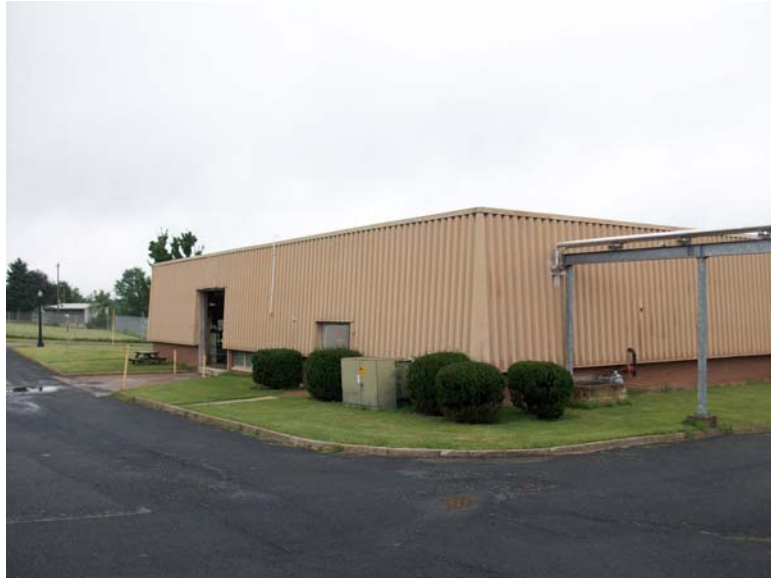
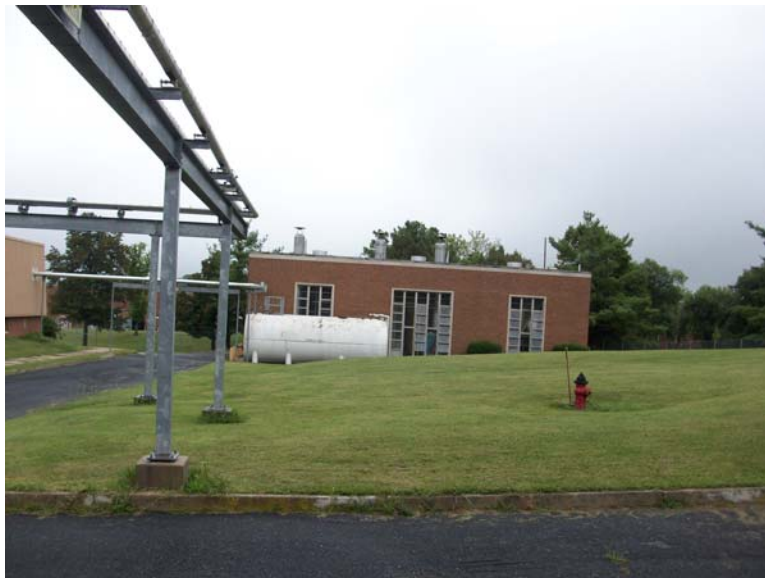
Building 125 – Laundry - Building was CMU, Steel, and Bar Joist Construction. Owner representative noted building had been damaged by a fire recently, but all areas appeared to be repaired and in good condition.

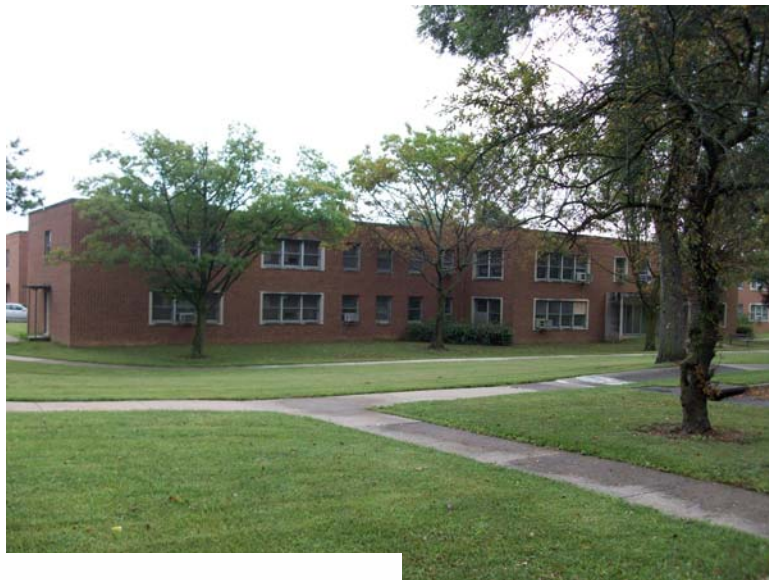
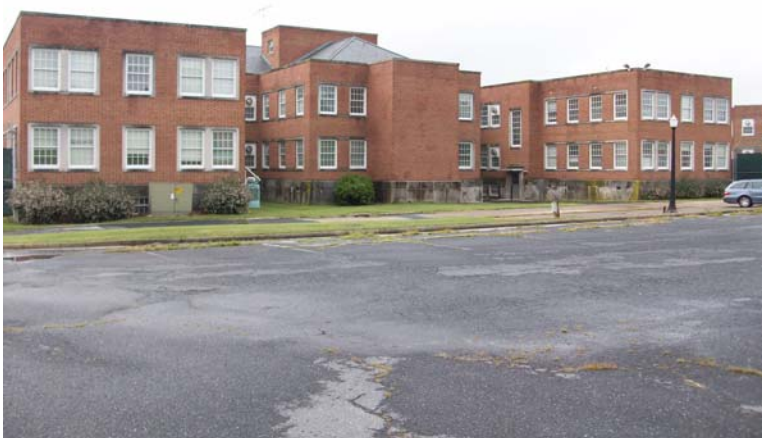
Buildings 112, 113, 116, 117, 118 – Buildings appeared to be concrete frame and slab construction. No structural issues noted. Several awnings at entrances at ends of buildings appear to have had support posts removed, although concrete awnings are still in place and appear to be in good condition.

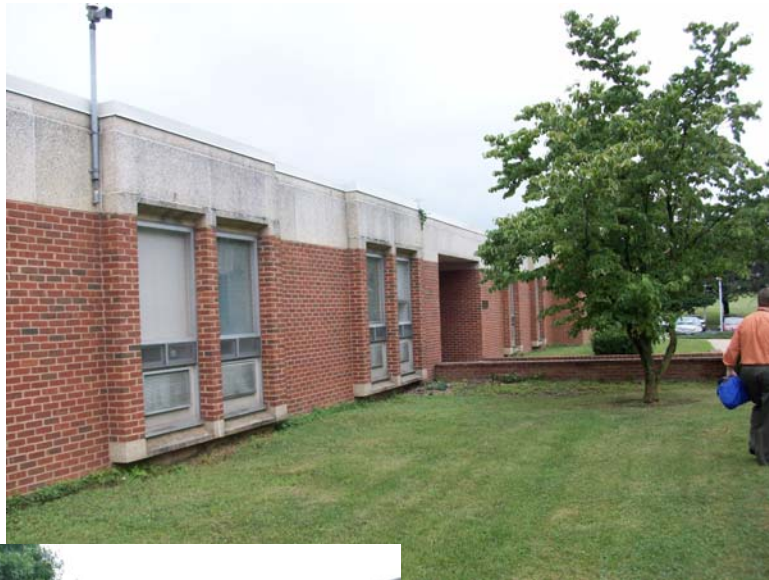
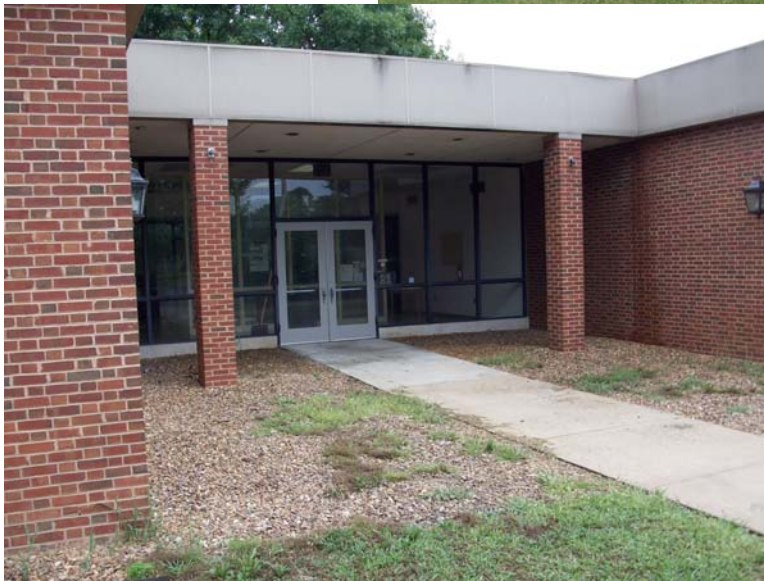
Building 124 – Administrative – not in service – Roof failure noted which has resulted in some interior finish damage due to water intrusion. Several structural cracks noted in masonry walls indicating differential settlement. These do not appear to be severe or indicate major structural problems at this time.

Overall, the buildings are in good condition considering their age. Failure to repair the roofs in buildings 100 and 124 could lead to continued damage to the buildings if not repaired. Nearly all of the buildings contain some amount of asbestos, though most of the friable asbestos is reported to have been abated. Only enclosed asbestos and non-friable asbestos remain. The buildings should be able to be reused without extensive structural or architectural repairs being needed.

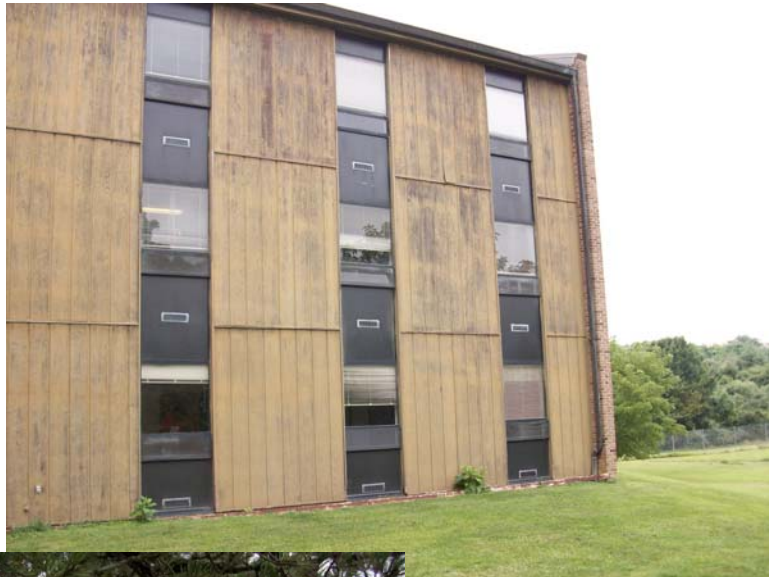
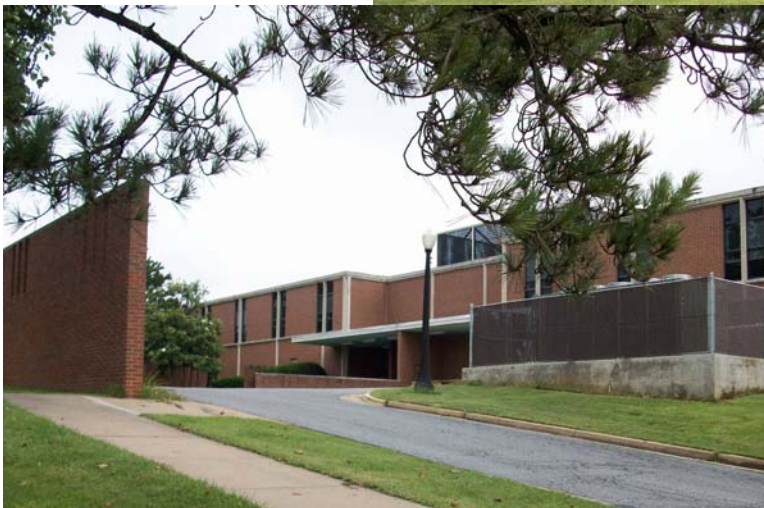
Building 127 – The construction type is hard to determine. Interior condition appeared to be good. Exterior siding is failing in numerous places. No significant structural deficiencies noted.

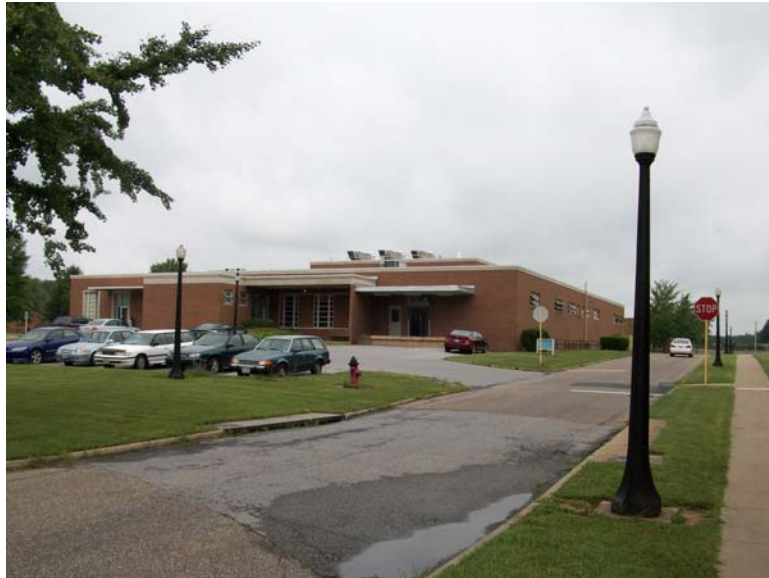
Building 119 – Kitchen. No structural deficiencies noted.

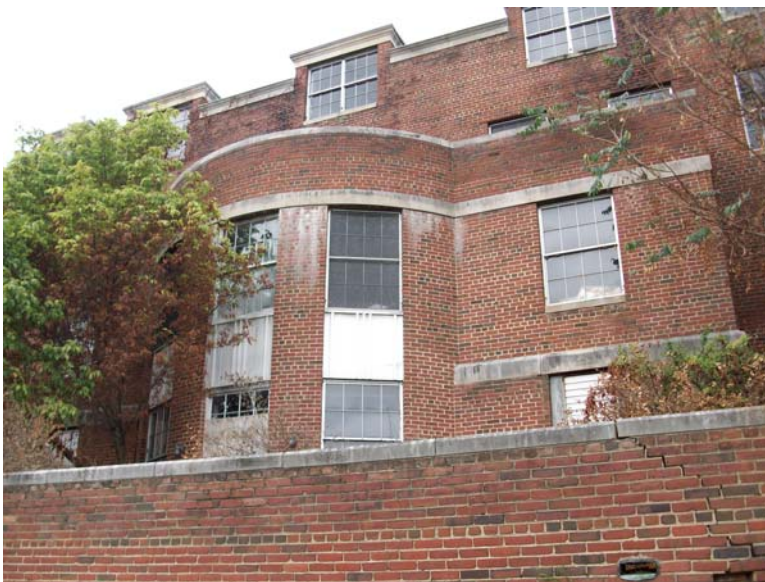
Building 100 – Chirp Building - Currently abandoned; used only for storage. Visible roof failure of slate shingles. Water intrusion is apparent on main floor at column location. No significant structural damage noted at this time on interior of building. Some structural damage and ongoing failure at rear patio retaining walls is apparent.
