MEMORANDUM

SUBJECT: June 23, 2026 HISTORIC PRESERVATION COMMISSION MEETING

**Project**  
Facade & Interior Alterations  
113 West Beverley St.  
Staunton, VA 24401

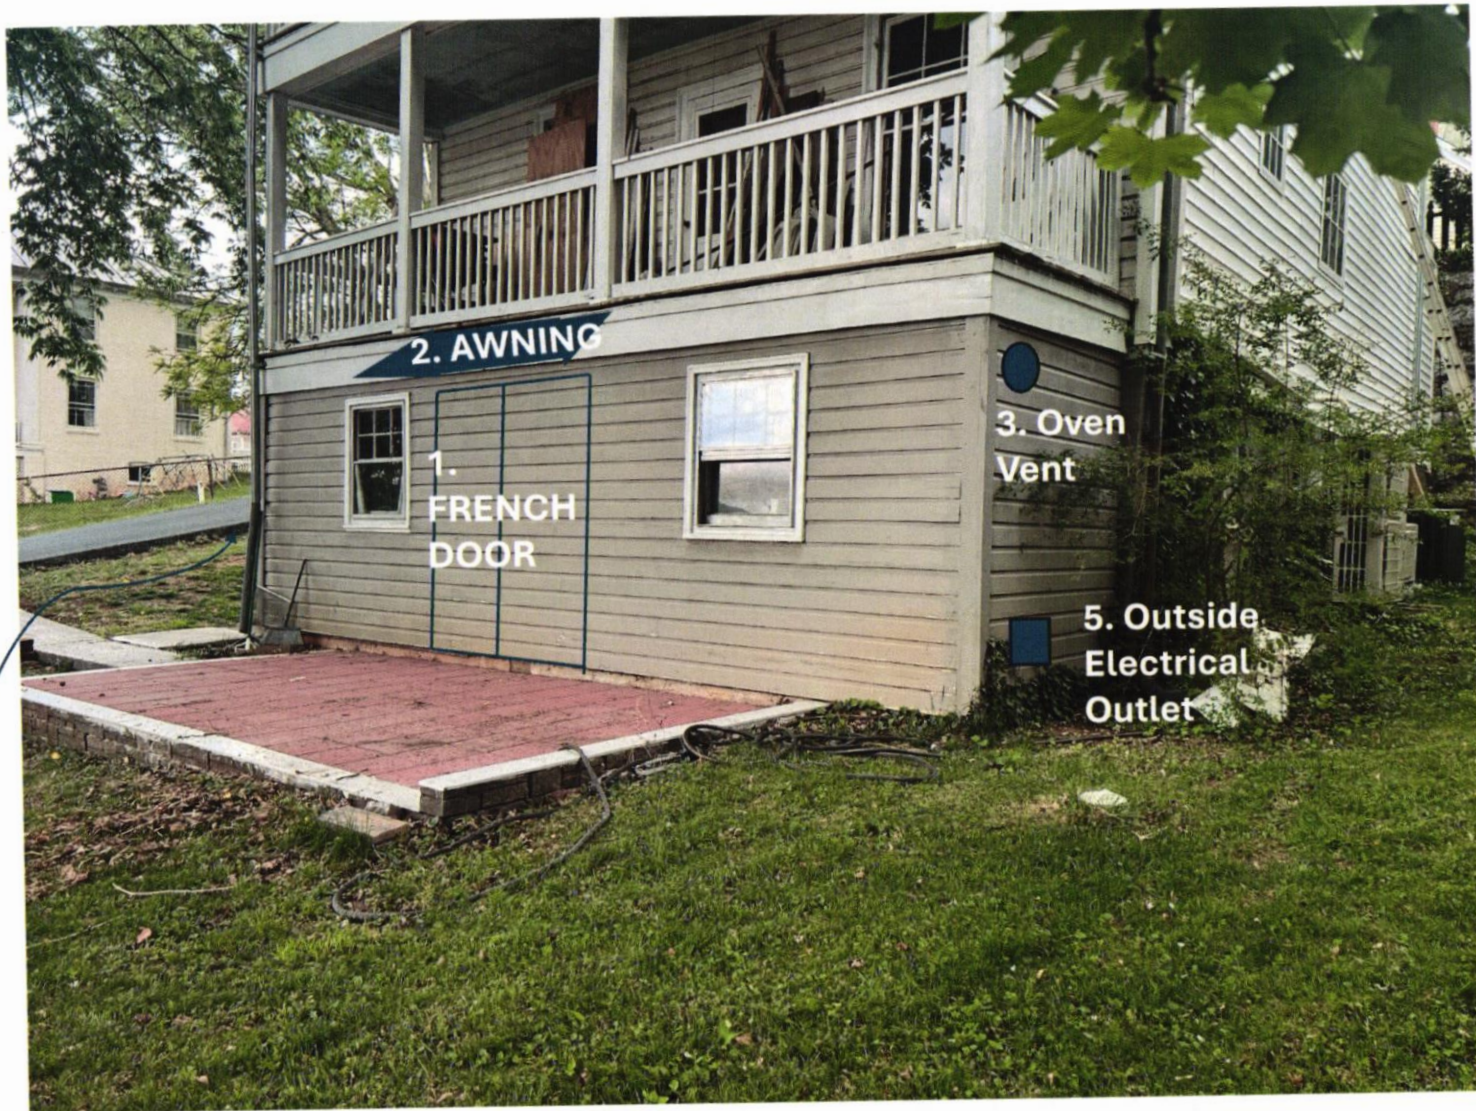
201 N  
Madison

**Proposed  
Changes (1-  
4 Previously  
Approved)**

1. French Door
2. Awning
3. Oven Vent
4. Old Side Door Filled In
5. Exterior Outlet

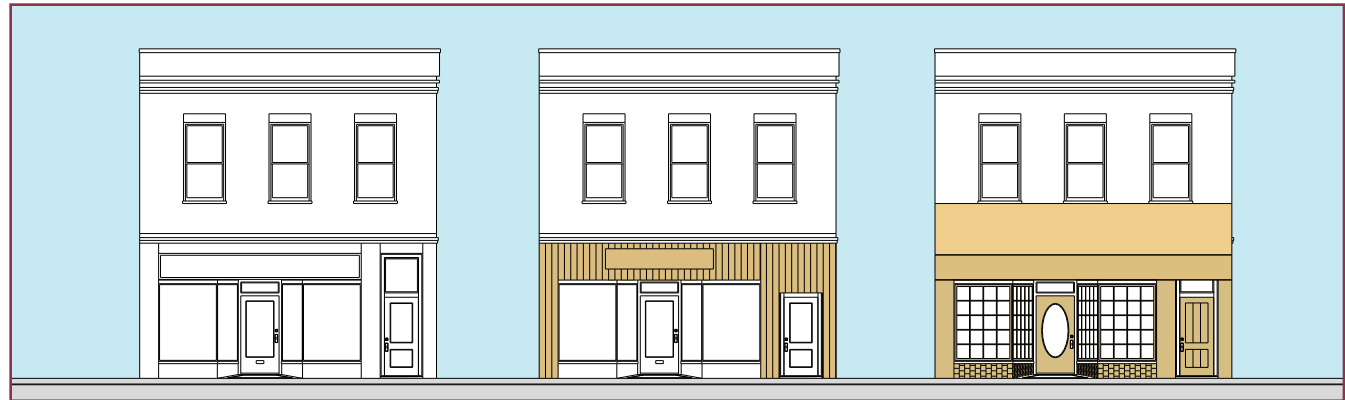
This original storefront may have been remodeled into a new design that does not respect its historic character (see images on right).

Here the original storefront surround has been covered with a new material & the upstairs door & transom has been remodeled.

Here, the new material extends to the 2nd floor windows. The storefront windows & the doors also were replaced.

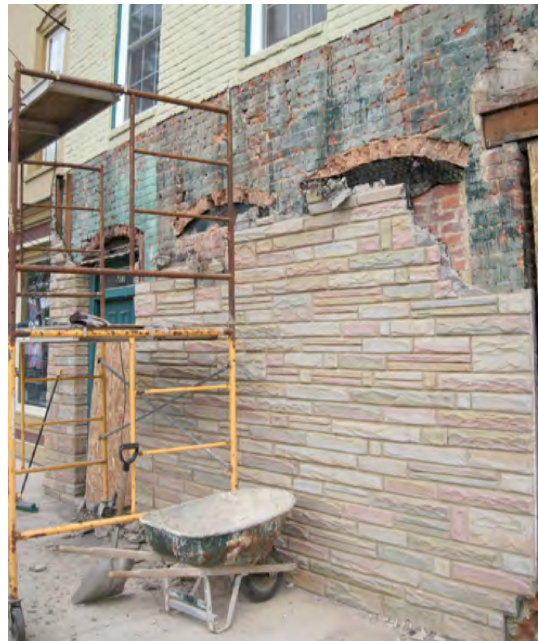
This storefront originally had two surviving historic openings that were bricked in. The storefront was inappropriately covered with perma stone that damaged the historic surfaces.

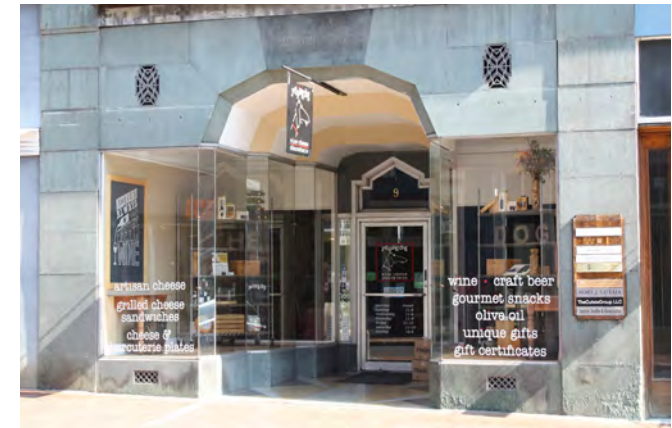
This art deco storefront is a remodeling of an earlier one. Due to its age and design, it now is a contributing historic element and should be preserved. It is constructed of Lynchburg greenstone. Note the butted glass panels.

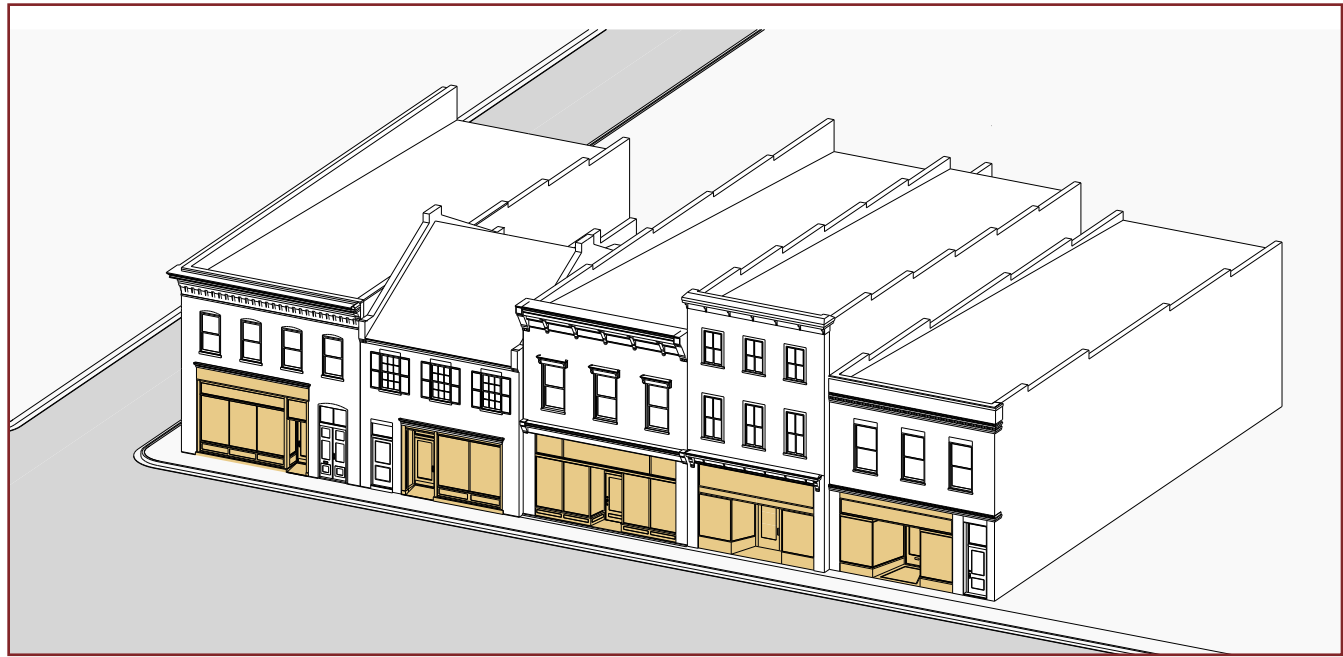
Blocks of downtown storefronts historically created a continuous shopping experience with display windows & welcoming entrances that angled out, creating more display area.
