## MEMORANDUM

SUBJECT: April 6, 2026 HISTORIC PRESERVATION COMMISSION SPECIAL MEETING

### HSF Recommendation

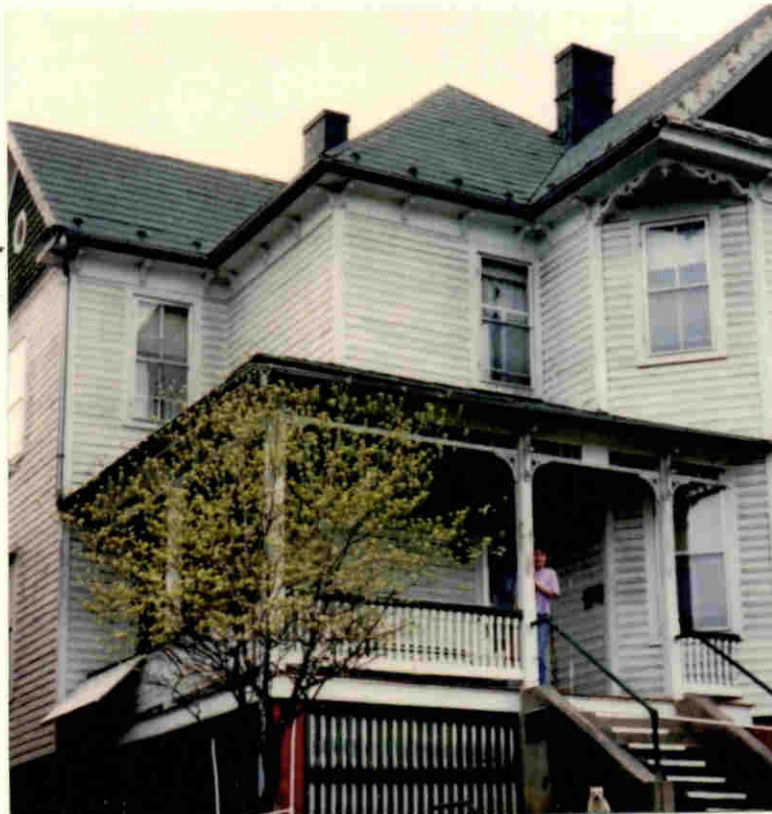
PRESENT WOODEN SHAKE AREAS

1 of 2 eyebrows →  
below left gable

← Watertable below  
front gable

HOUSE WHEN WE PURCHASED IN 1987

- *Replace metal shingle roof with standing seam metal roof.*
- *Replace 5-inch half round metal gutter with same.*
- *Replace wooden shakes with metal standing seam on front water table and left side eyebrows to at Gable bases.*
- *We have contracted with Baber Enterprises for new roof- gutters.*
- *Upper metal shingle roof will be replaced with standing seam metal.*
- *Lower front and side standing seam metal roof will be replaced with same. Wooden shake areas will be replaced with metal standing seam.*
- *Roof metal panels will be Englert 24 gauge, 17 inches between seams. 1 staggered row of Berger RT 300 snow guards will match roof color. Any vent installation will be on rear.*

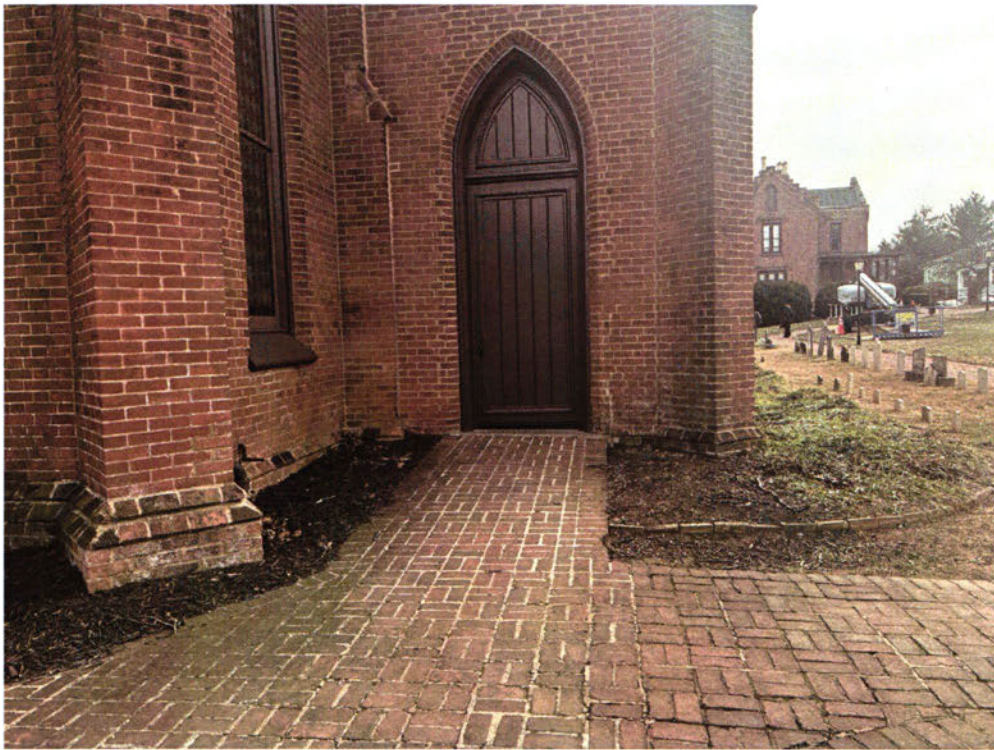
Trinity Church's only handicapped accessible doorway.

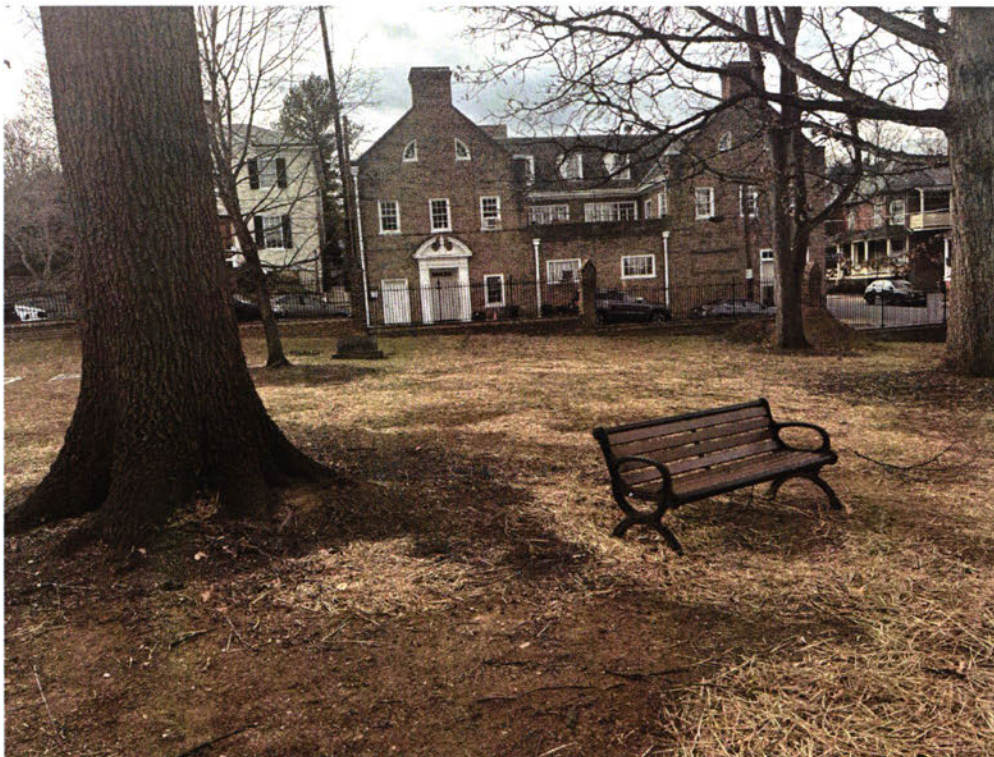
View from front walk of churchyard looking west to area of proposed ADA ramp.

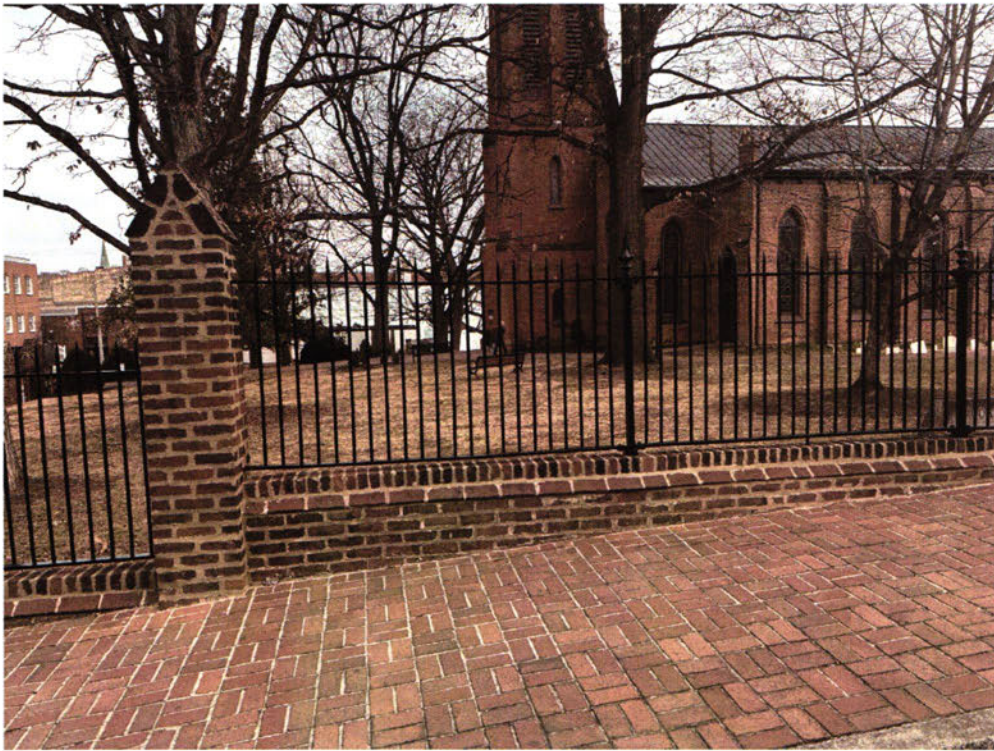
Section of Church Street brick wall base and metal fence that would be modified to receive the new entry for the proposed ADA ramp.

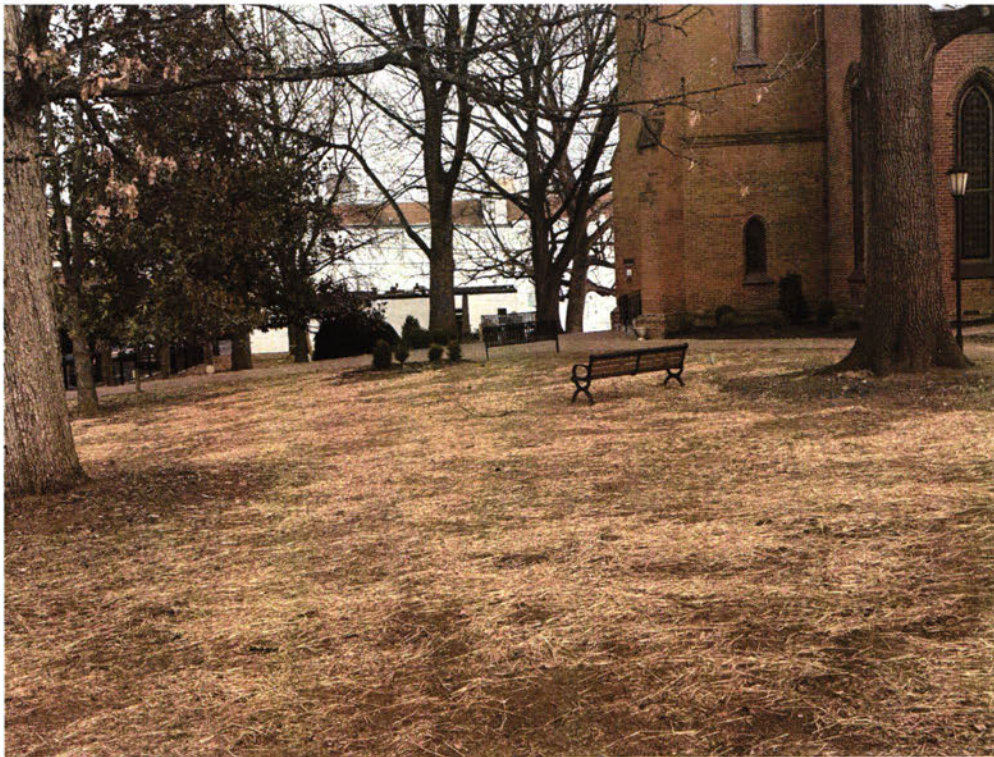
View looking east from Church Street to area of proposed ADA ramp.

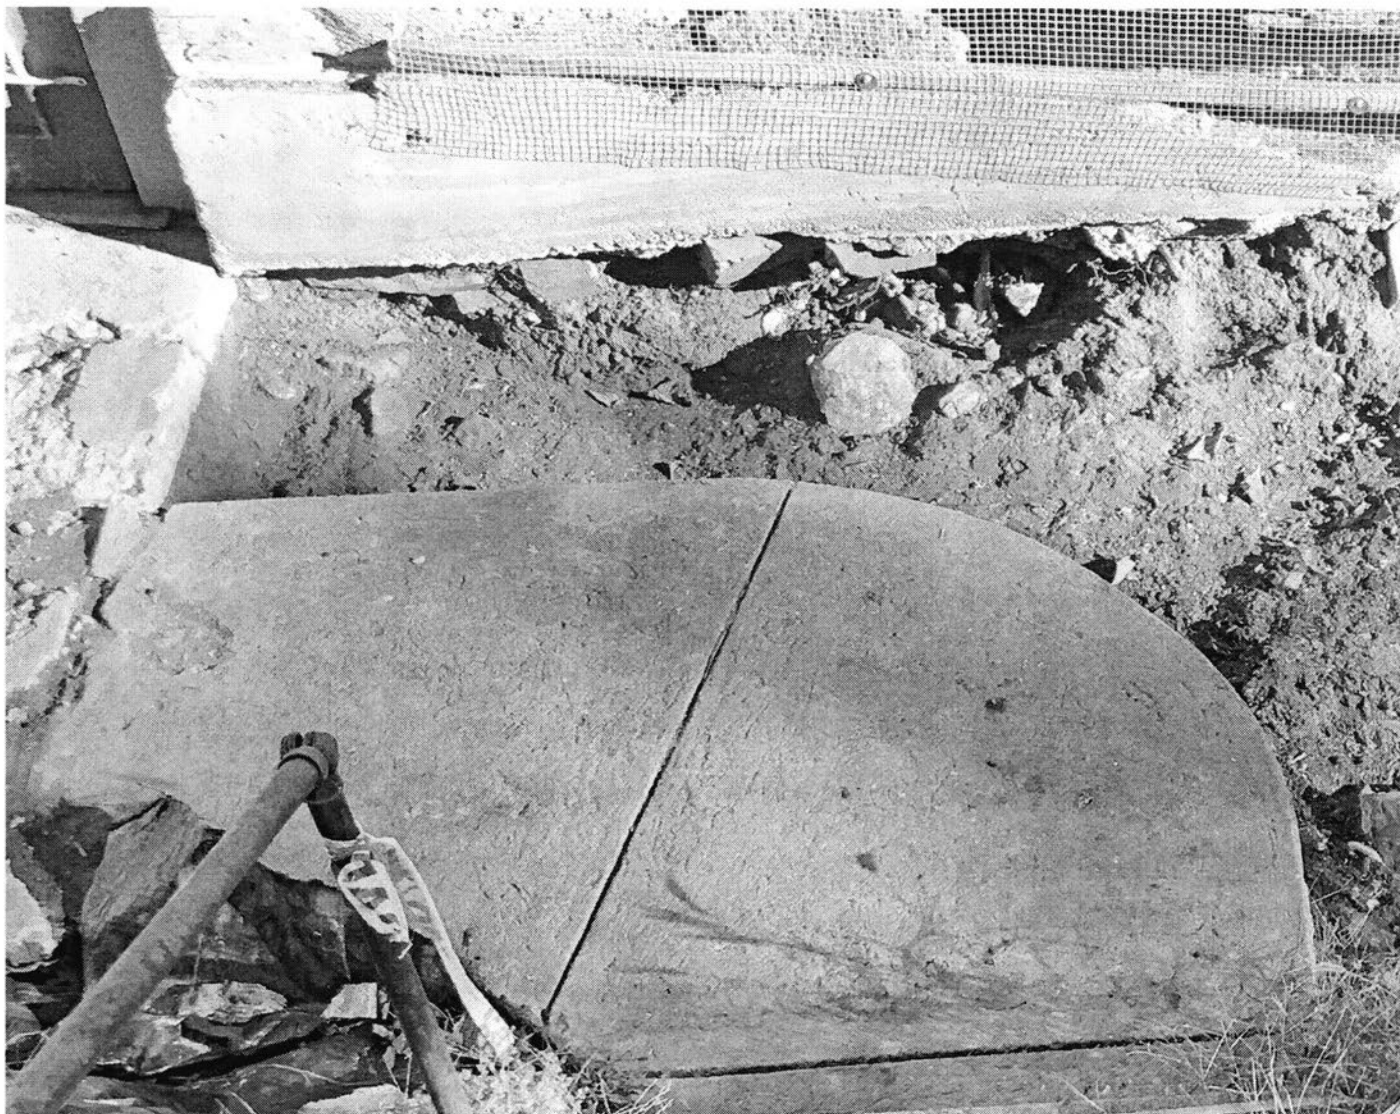
Concrete walk at landing from steps

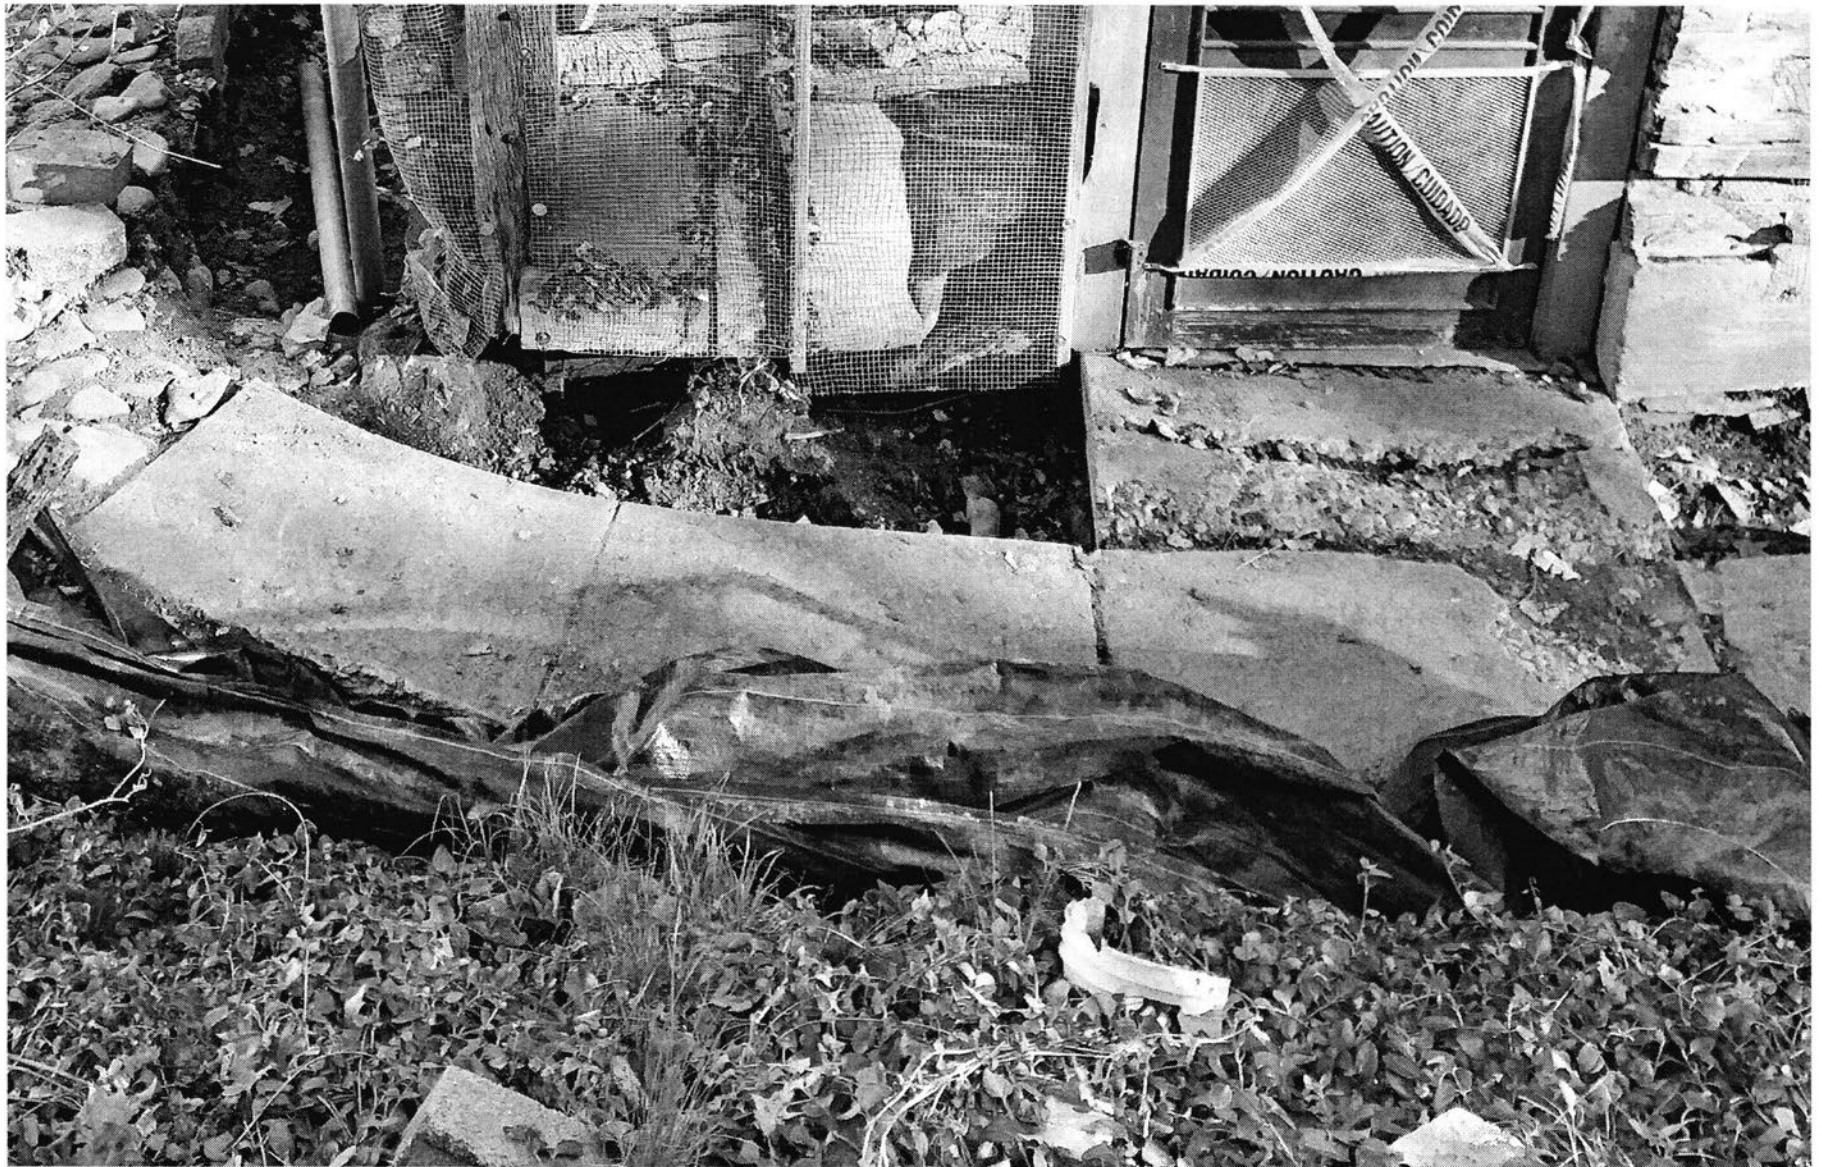
Entry Walk - view from East Beverley Street. Eroded/broken surface at door. Walk extends from concrete steps. Made of modern, gray concrete with no discernible fine aggregate. #57 stone aggregate under surface layer. Estimated date of construction is post 1987.
