MEMORANDUM

SUBJECT: June 23, 2026 HISTORIC PRESERVATION COMMISSION MEETING

**Project**  
Facade & Interior Alterations  
113 West Beverley St.  
Staunton, VA 24401

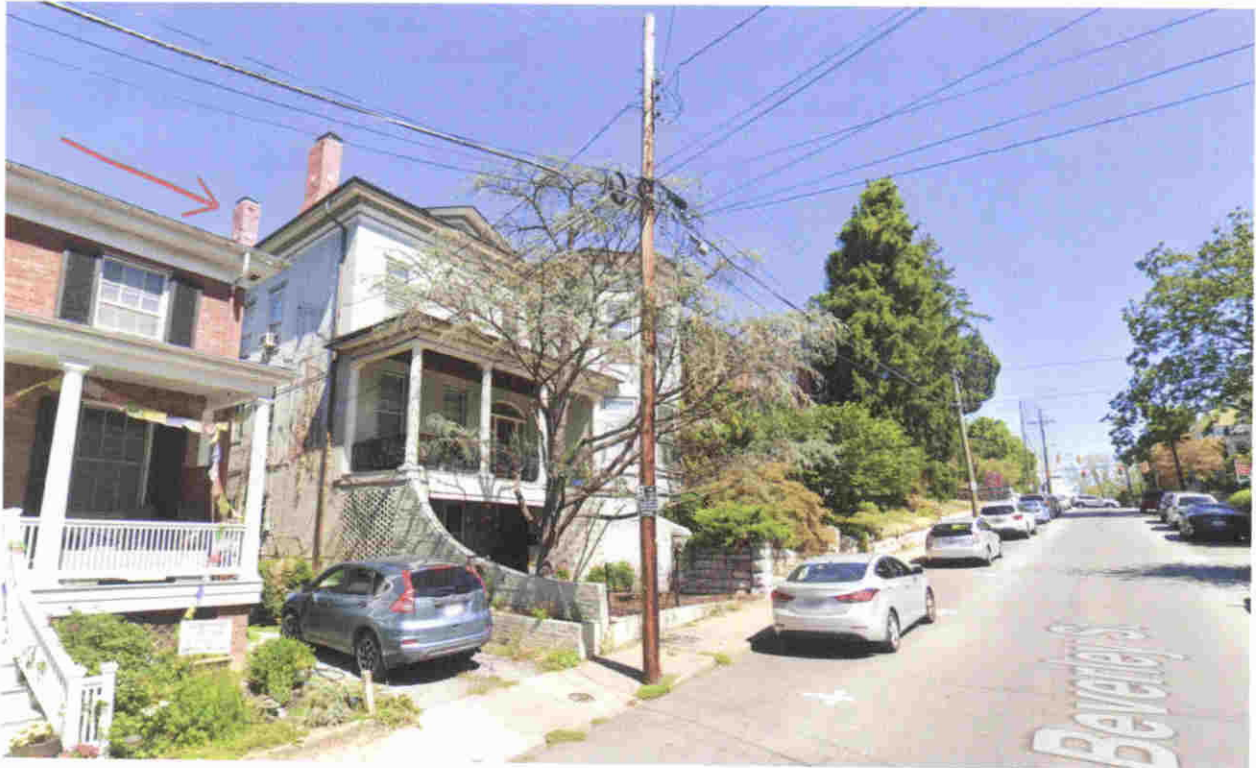
View of 221 E Beverley from Coalter looking west

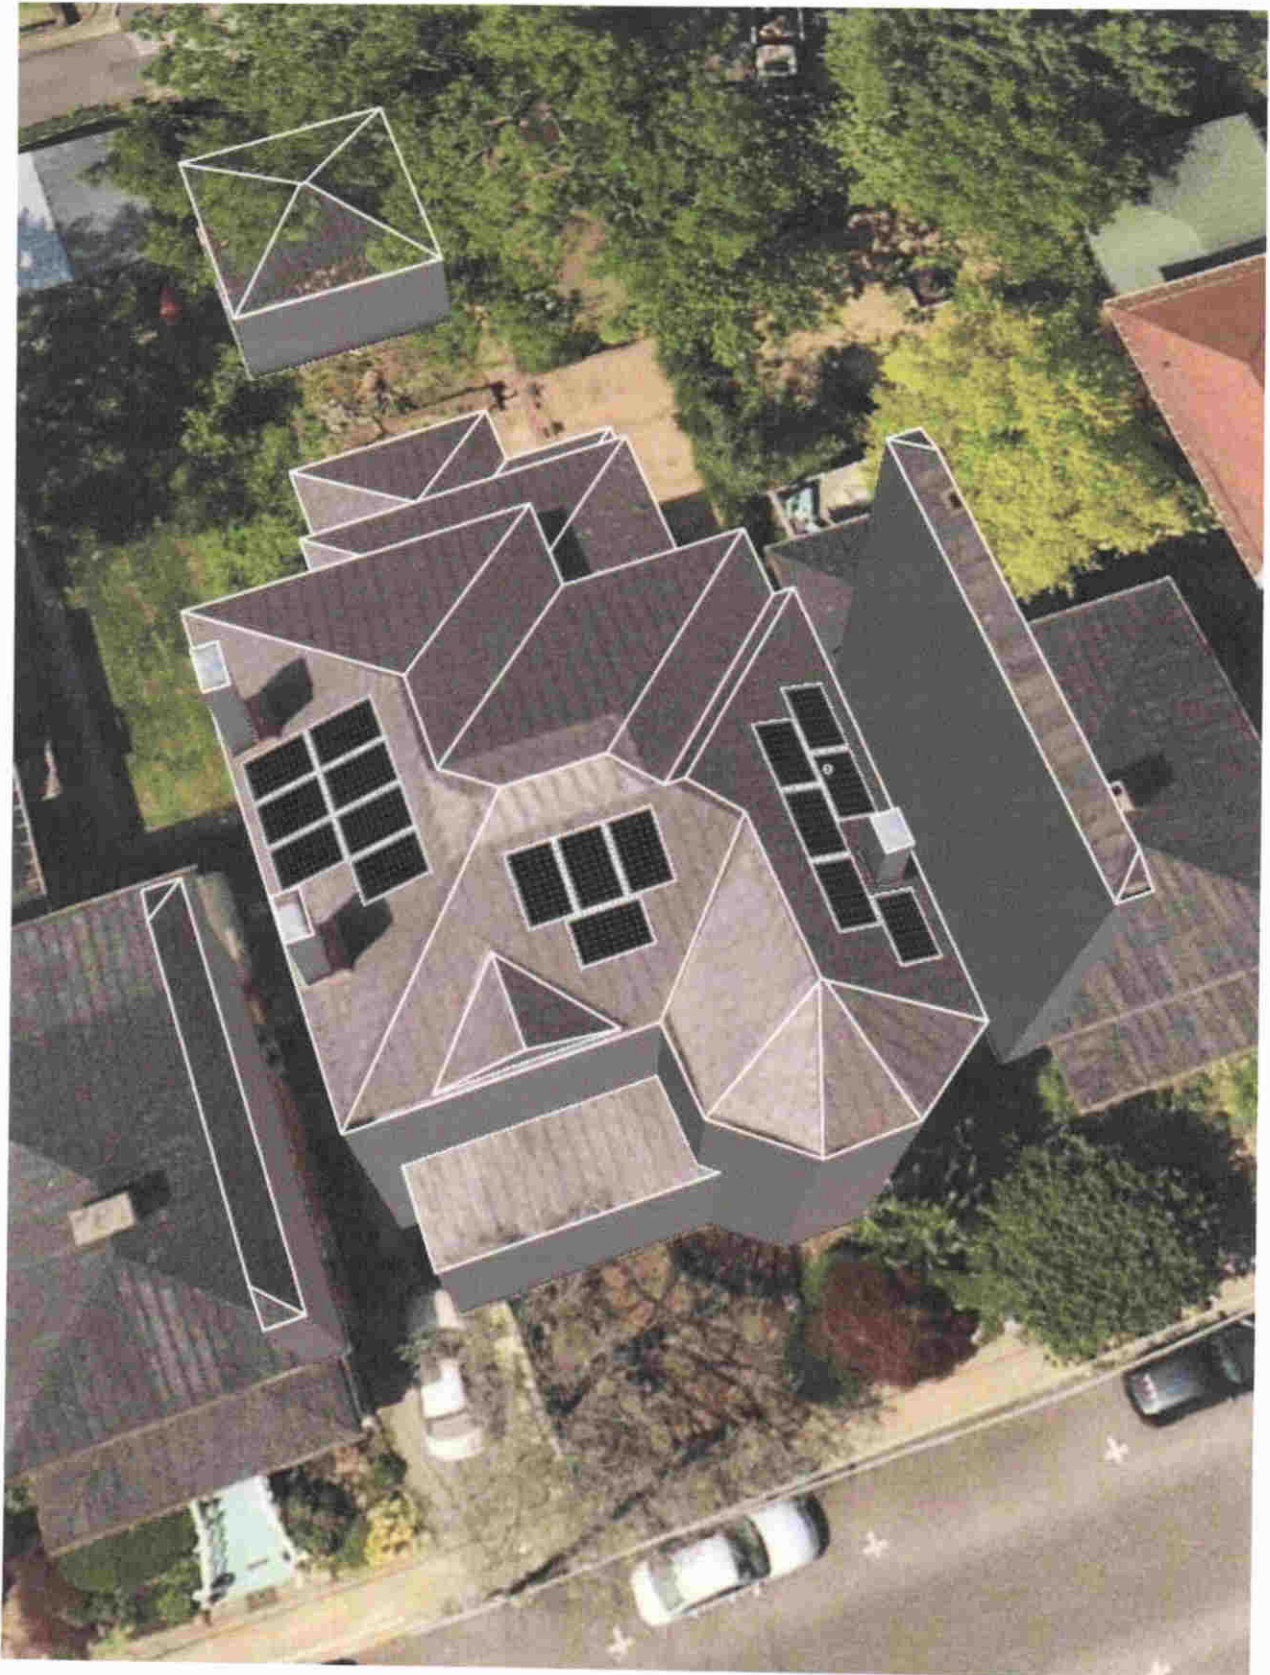
Tiger Solar proposed layout of solar panels

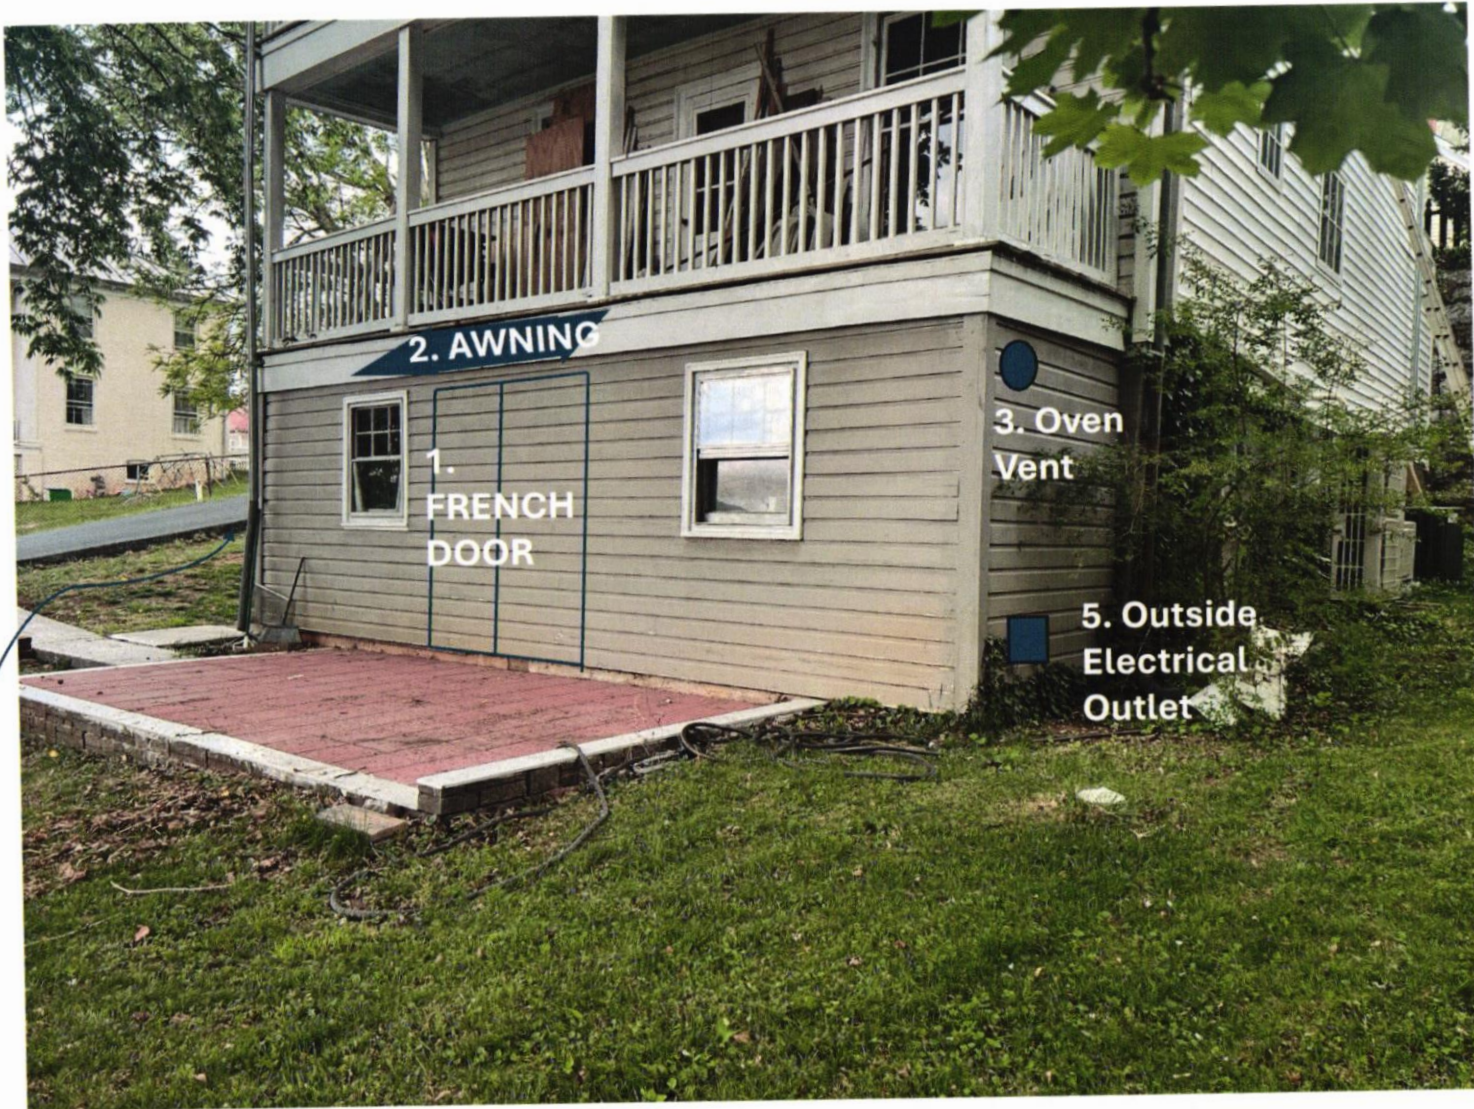
**Proposed  
Changes (1-  
4 Previously  
Approved)**

1. French Door
2. Awning
3. Oven Vent
4. Old Side Door Filled In
5. Exterior Outlet

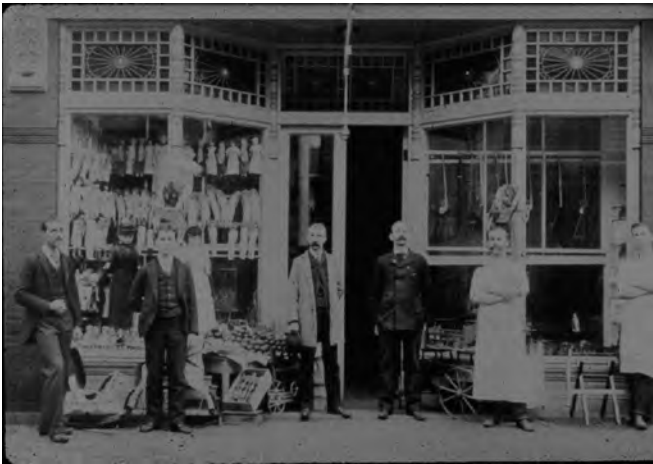
Historic photos often can aid in planning reconstruction of missing storefront elements.

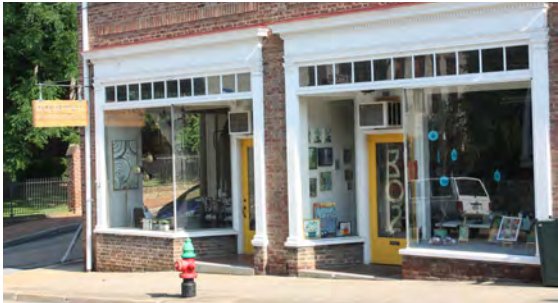
This pair of Colonial Revival styled storefronts retain their original design with the entablatures supported by pilasters. Note the original transom.

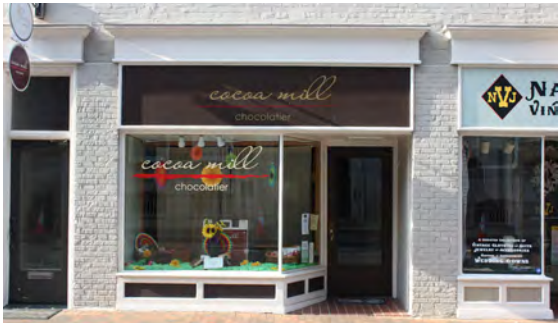
Likely, the interior of these storefronts has a lowered ceiling and therefore the transom became an appropriate location for signage.

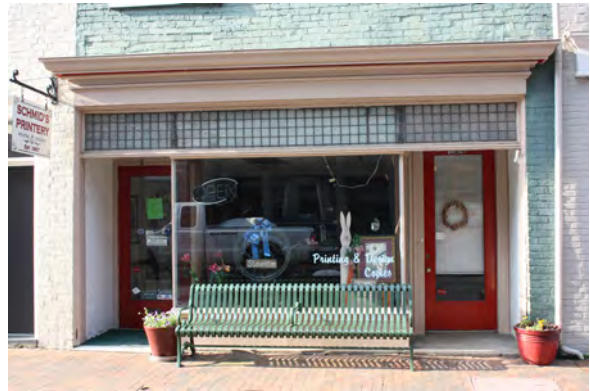
This storefront retains its prism glass tile transom, a rarely surviving feature. Note the door to the upstairs space.

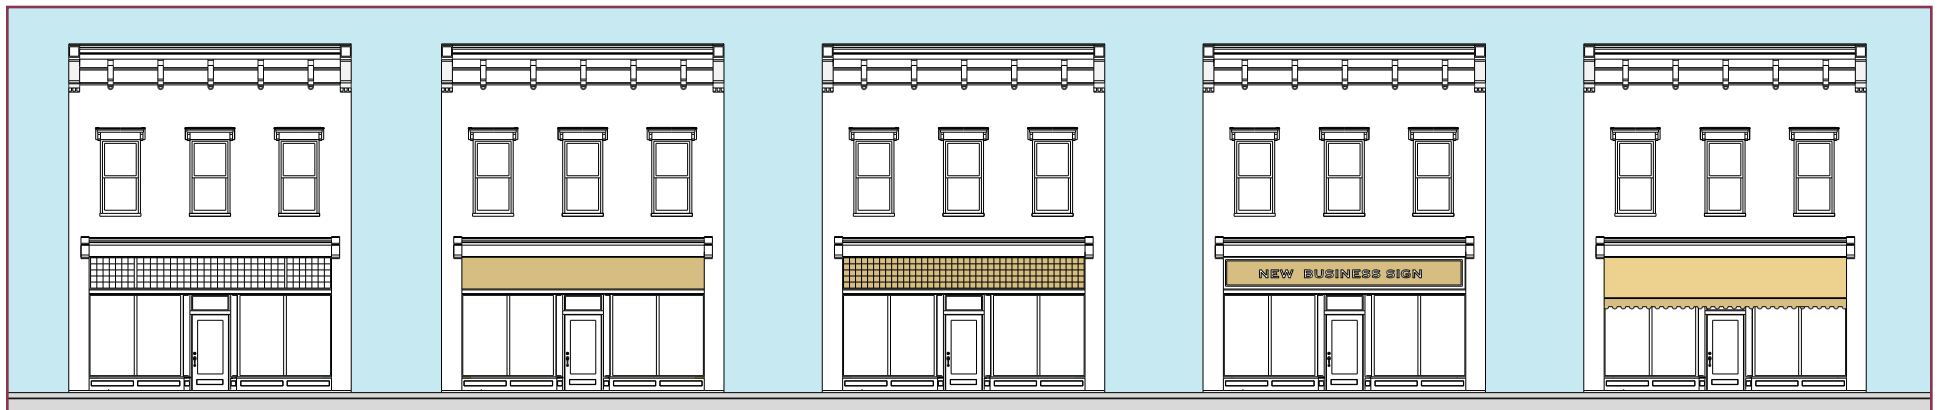
The original storefront with its historic prism glass transom.

Missing prism transom has been replaced with a wooden panel insert.

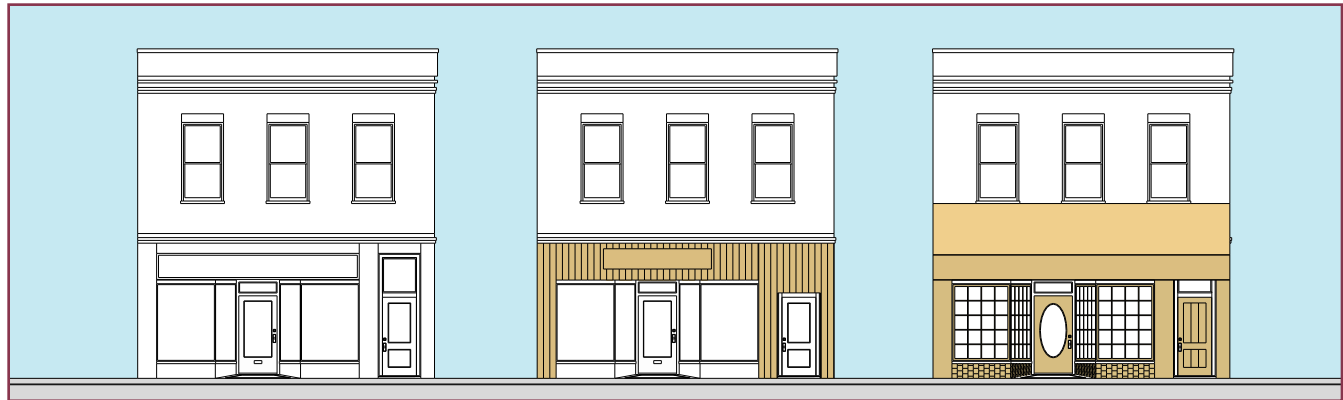
This original storefront may have been remodeled into a new design that does not respect its historic character (see images on right).

Here the original storefront surround has been covered with a new material & the upstairs door & transom has been remodeled.

Here, the new material extends to the 2nd floor windows. The storefront windows & the doors also were replaced.

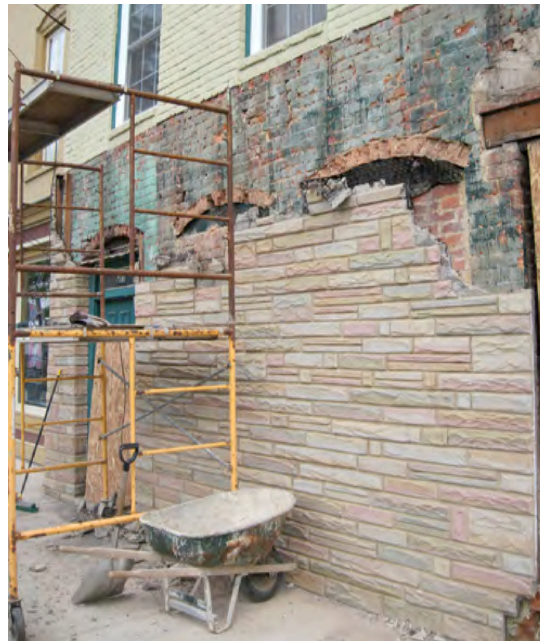
This storefront originally had two surviving historic openings that were bricked in. The storefront was inappropriately covered with permastone that damaged the historic surfaces.

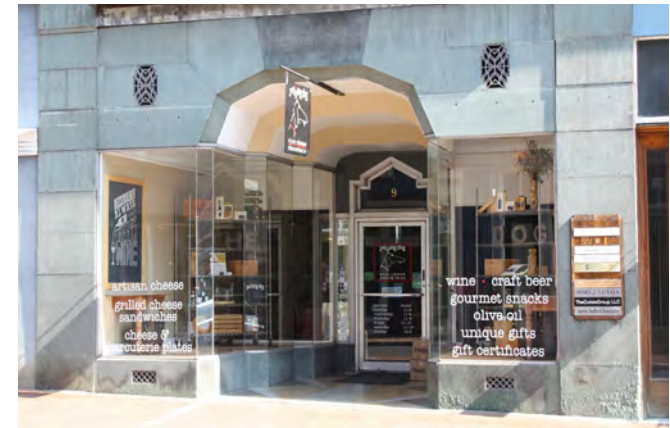
This art deco storefront is a remodeling of an earlier one. Due to its age and design, it now is a contributing historic element and should be preserved. It is constructed of Lynchburg greenstone. Note the butted glass panels.

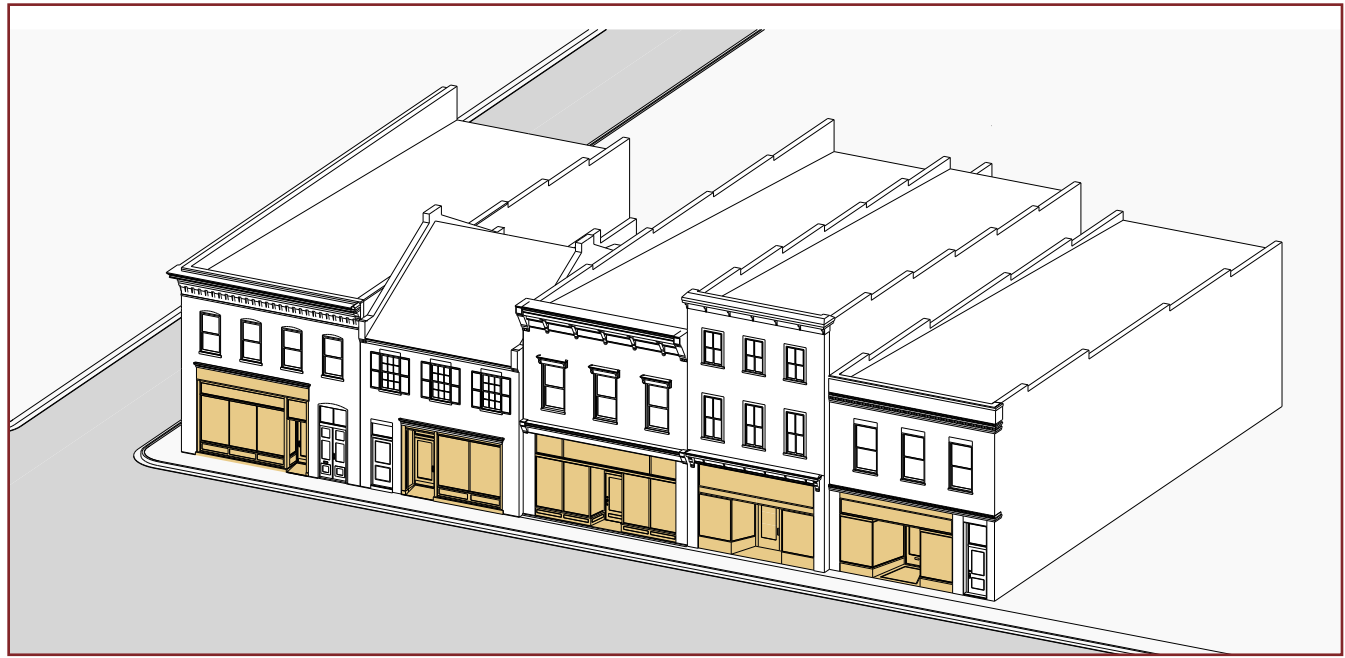
Blocks of downtown storefronts historically created a continuous shopping experience with display windows & welcoming entrances that angled out, creating more display area.

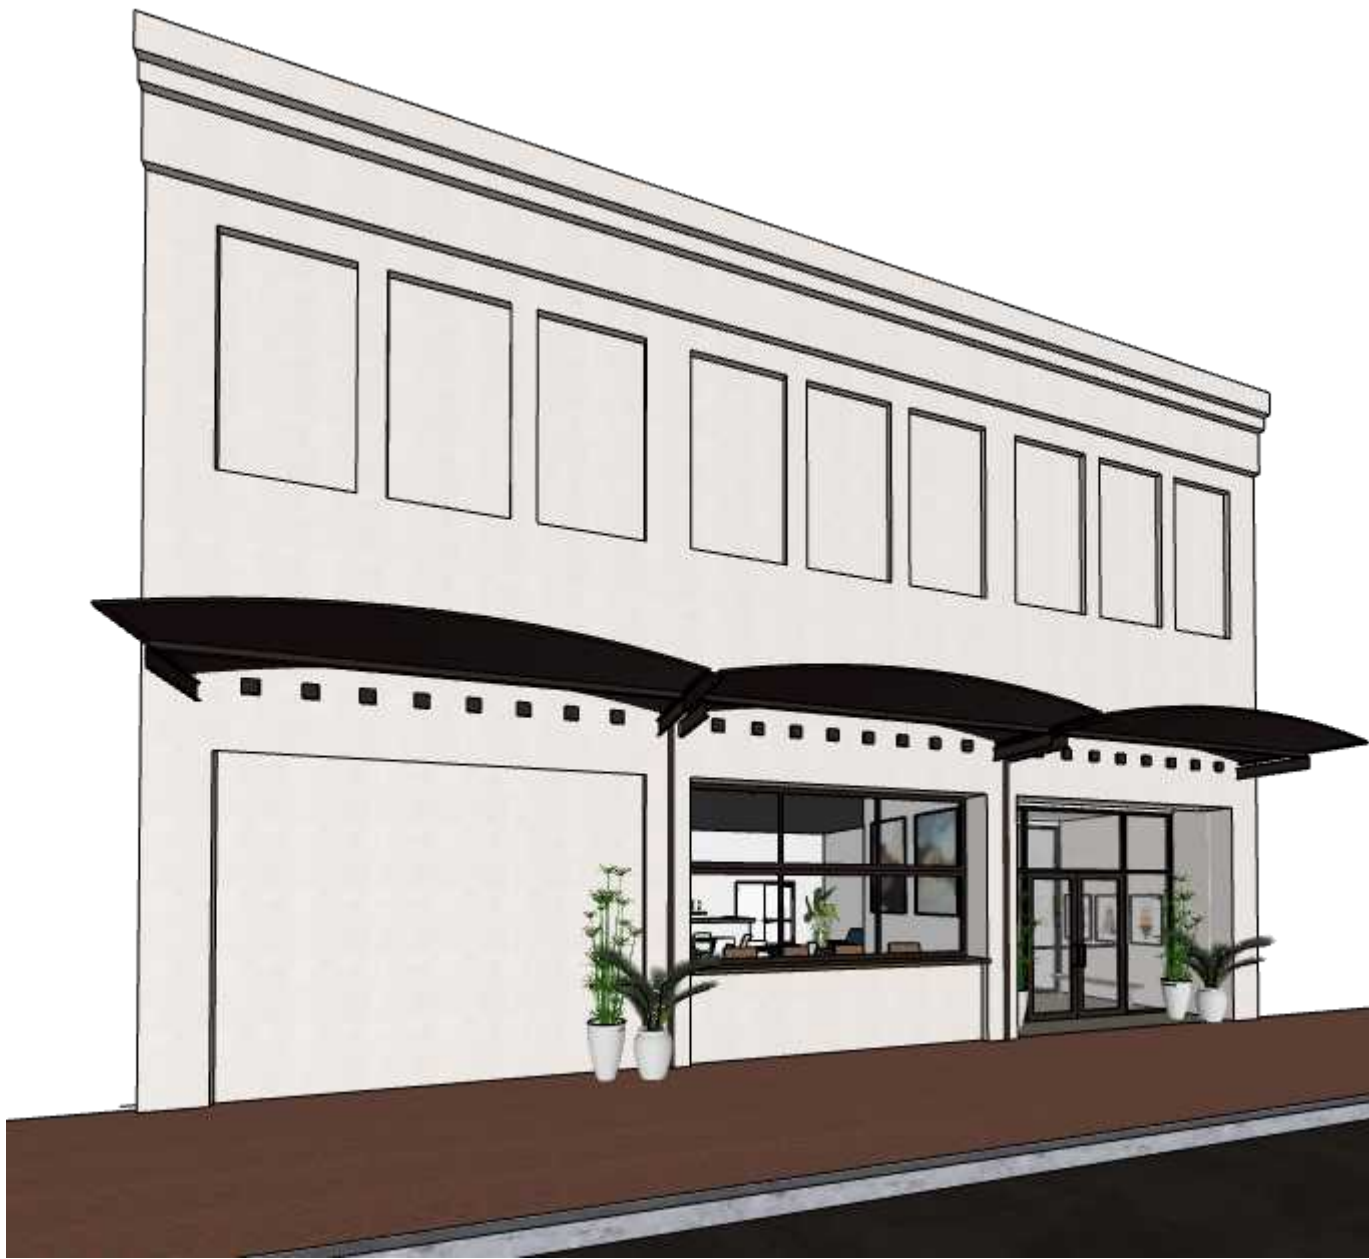
**3 Front Perspective, Proposed Storefront Closed**  
A1.0

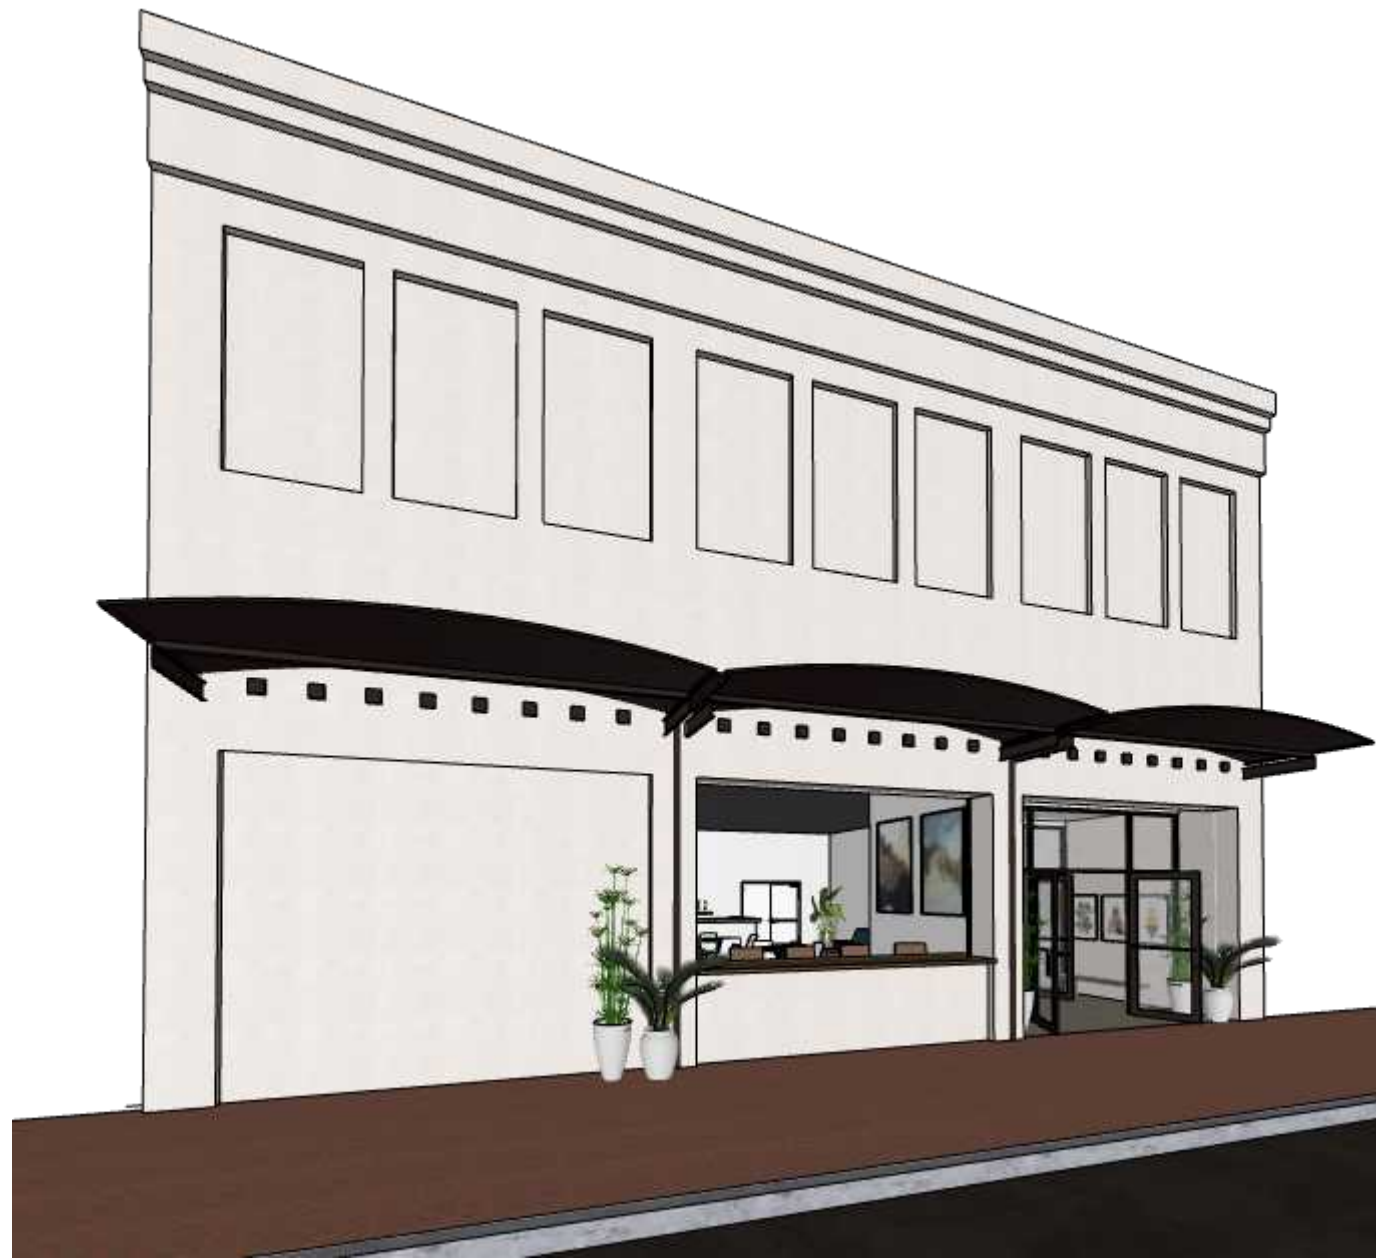
**4 Front Perspective, Proposed Storefront Open**  
A1.0

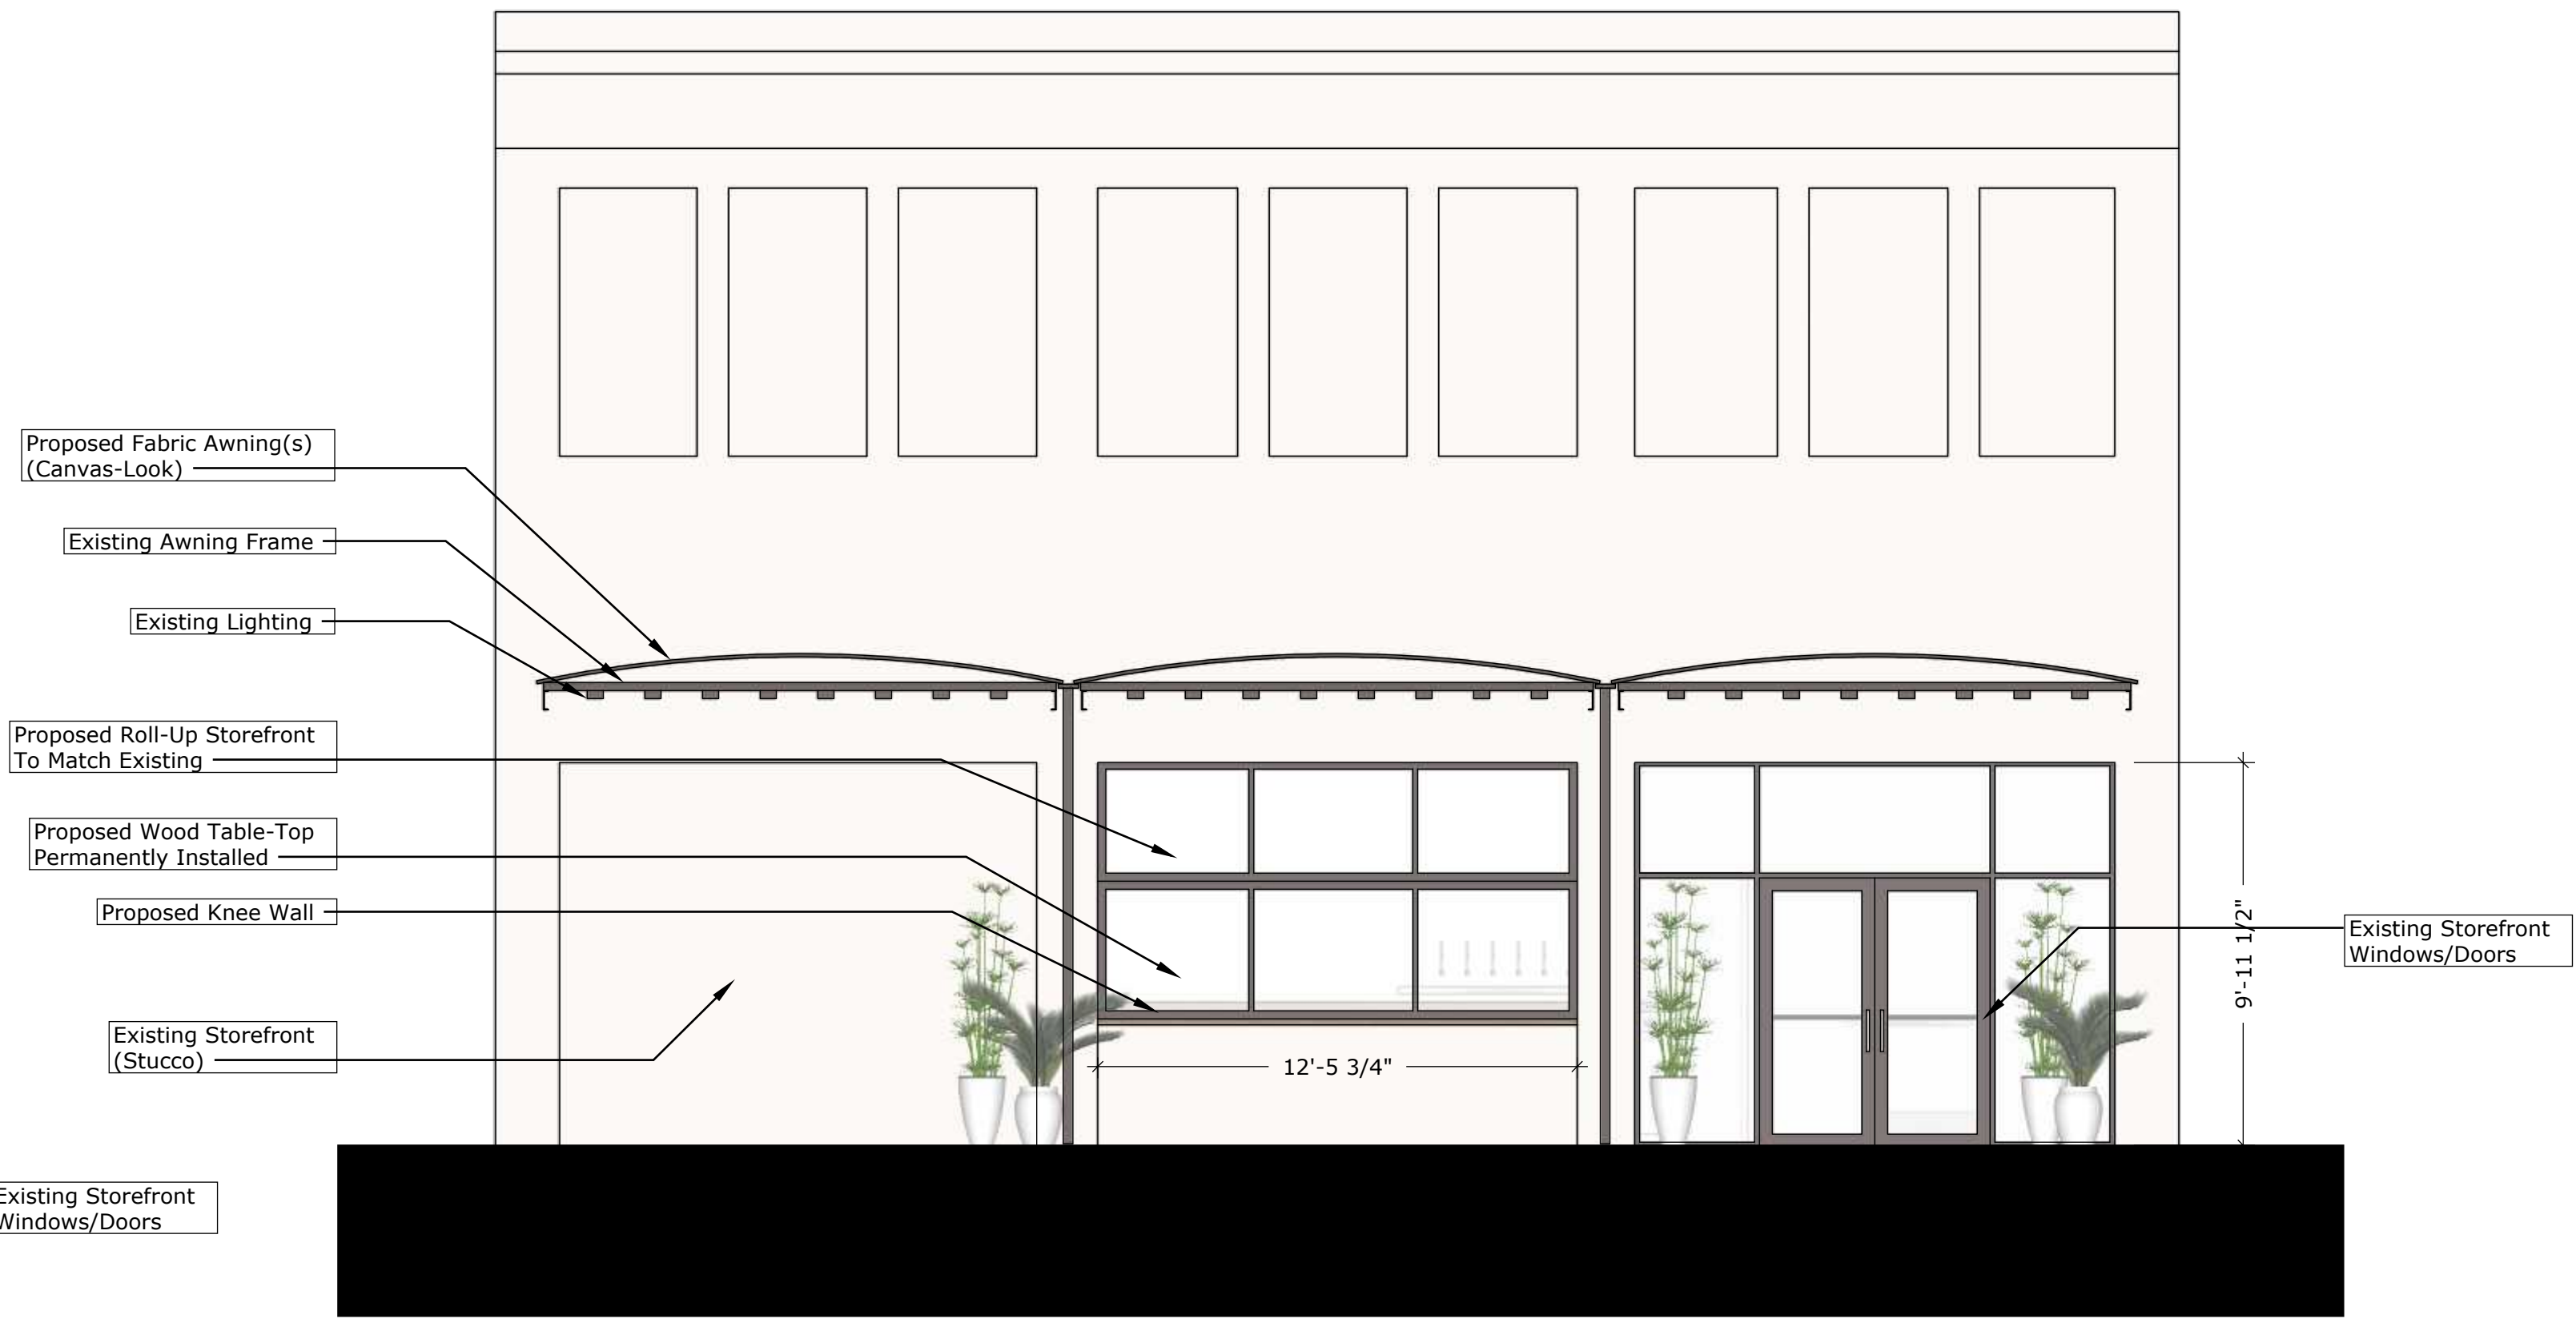
**2 Front Elevation**  
A1.0 Scale: 1/4" = 1' 0"

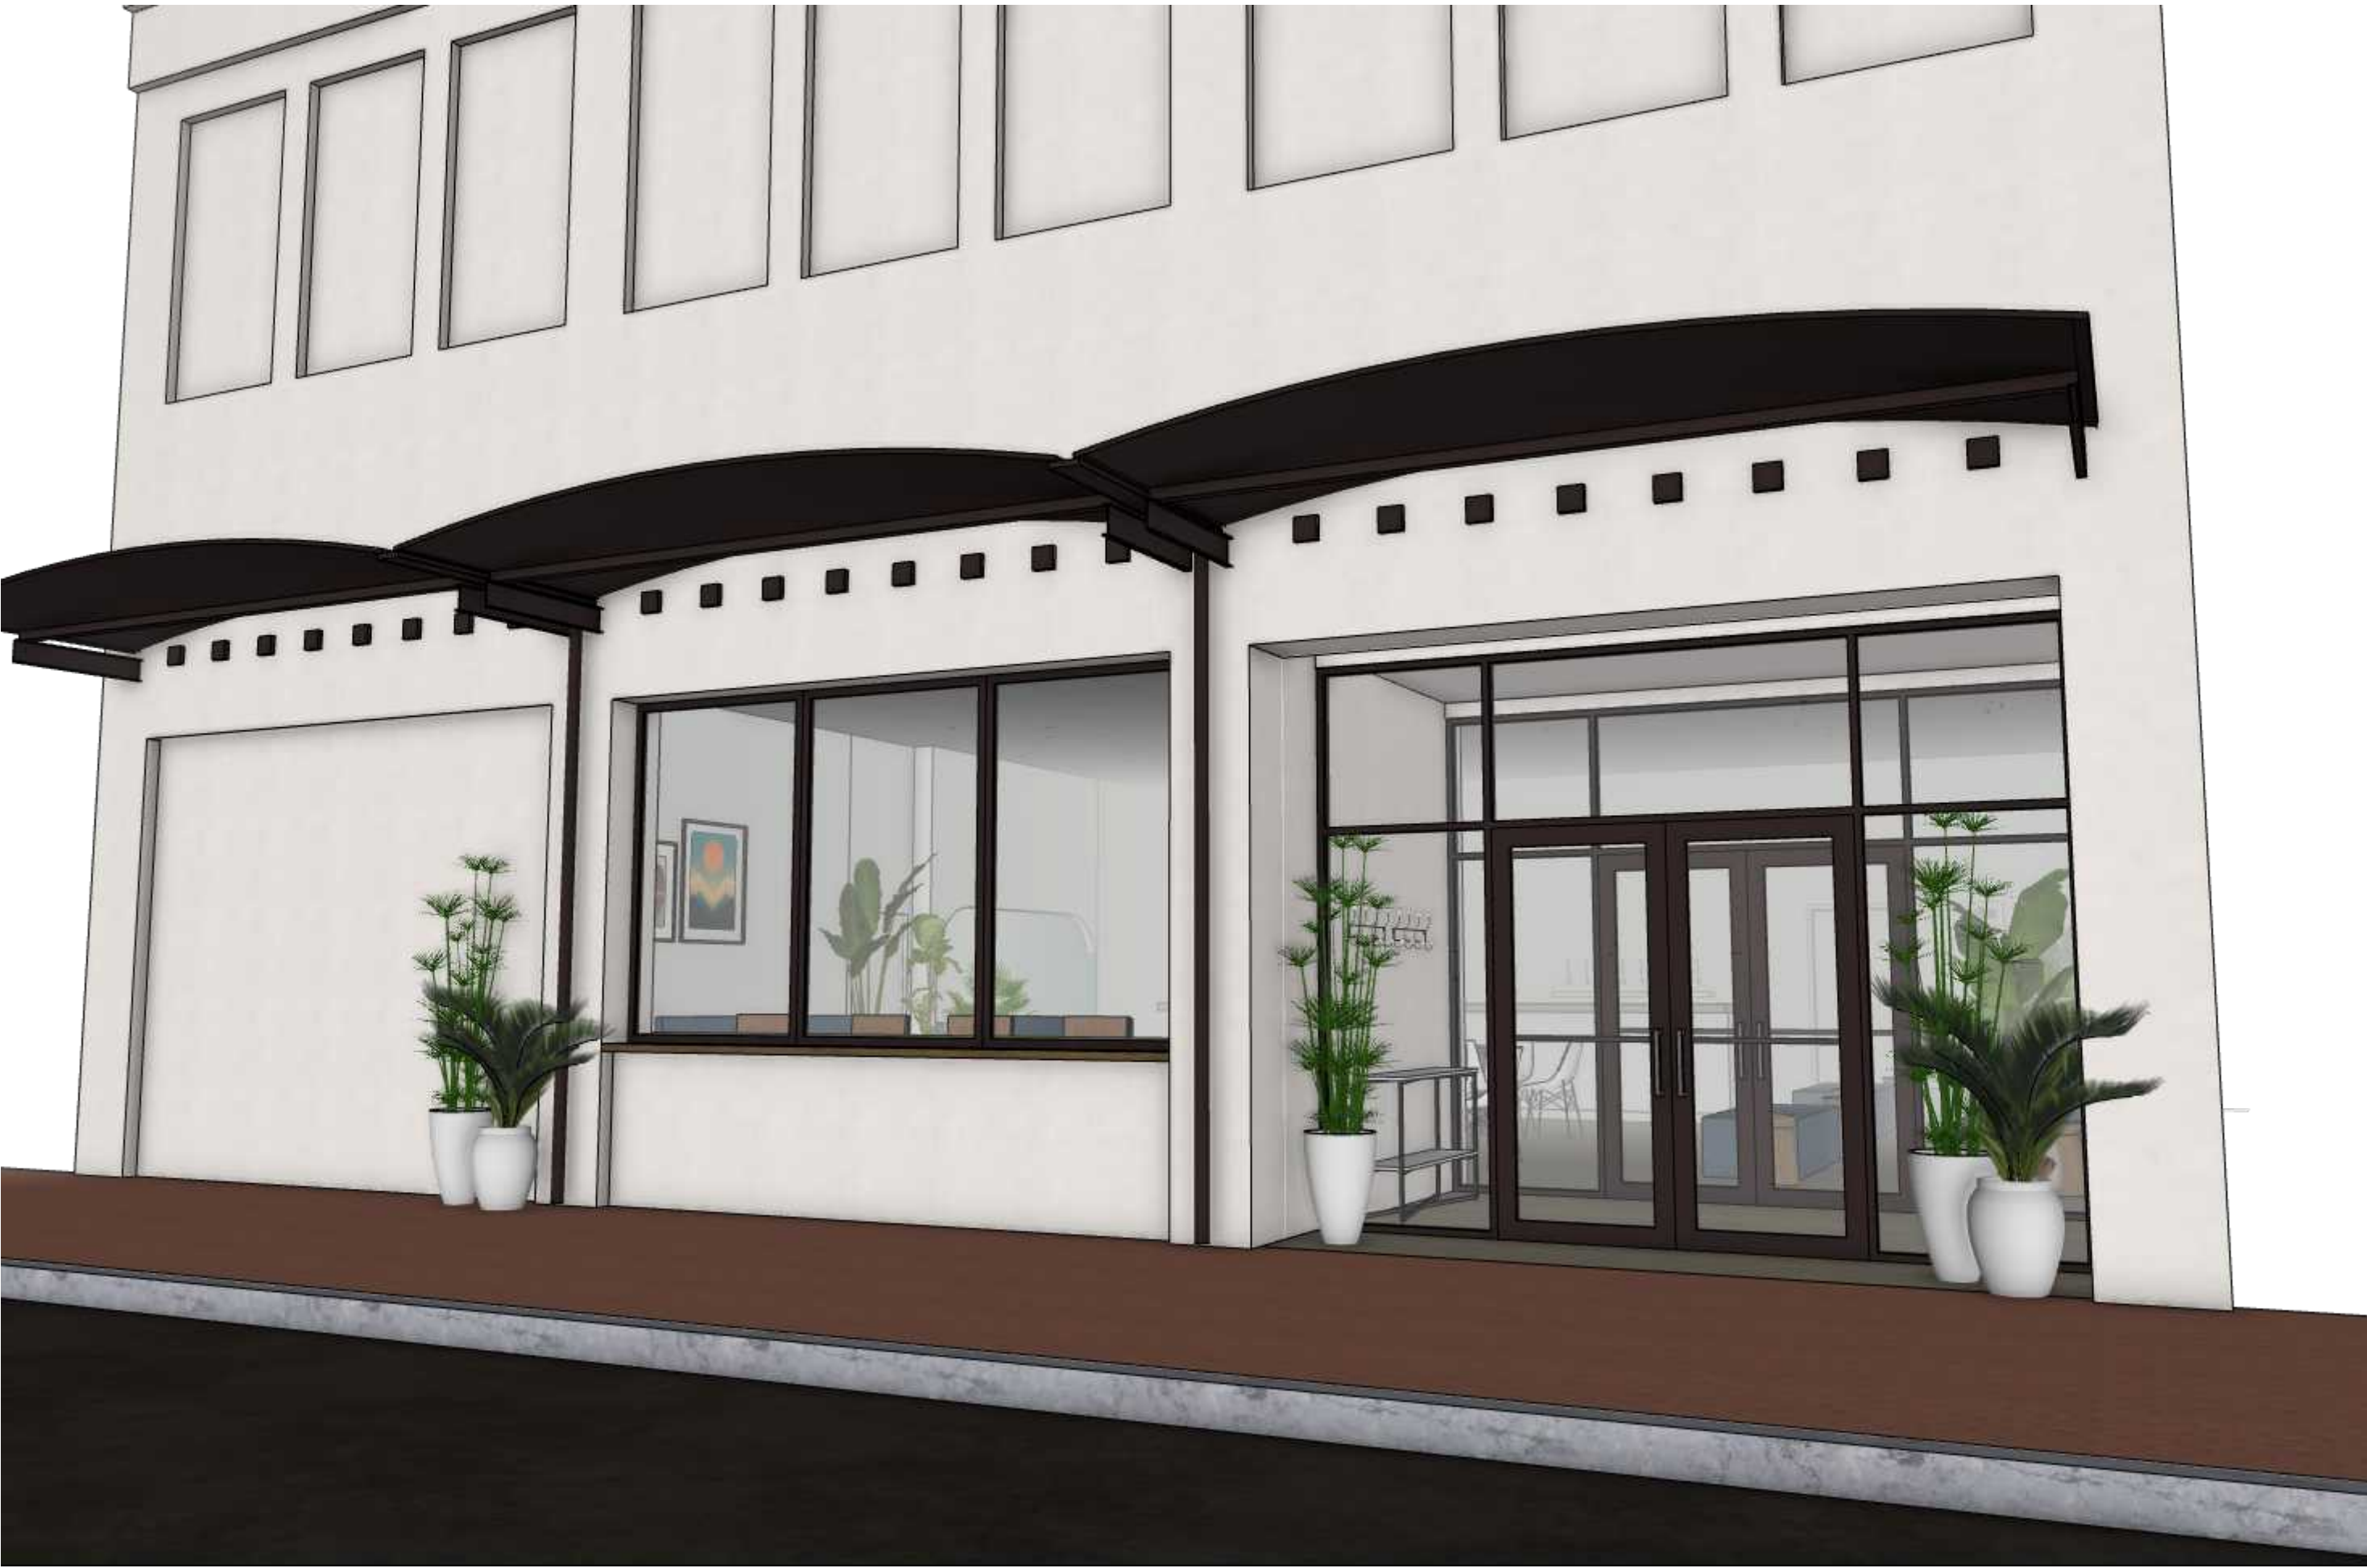
1 Front Perspective, Proposed Storefront Closed - BIFOLD DOORS  
A1.1

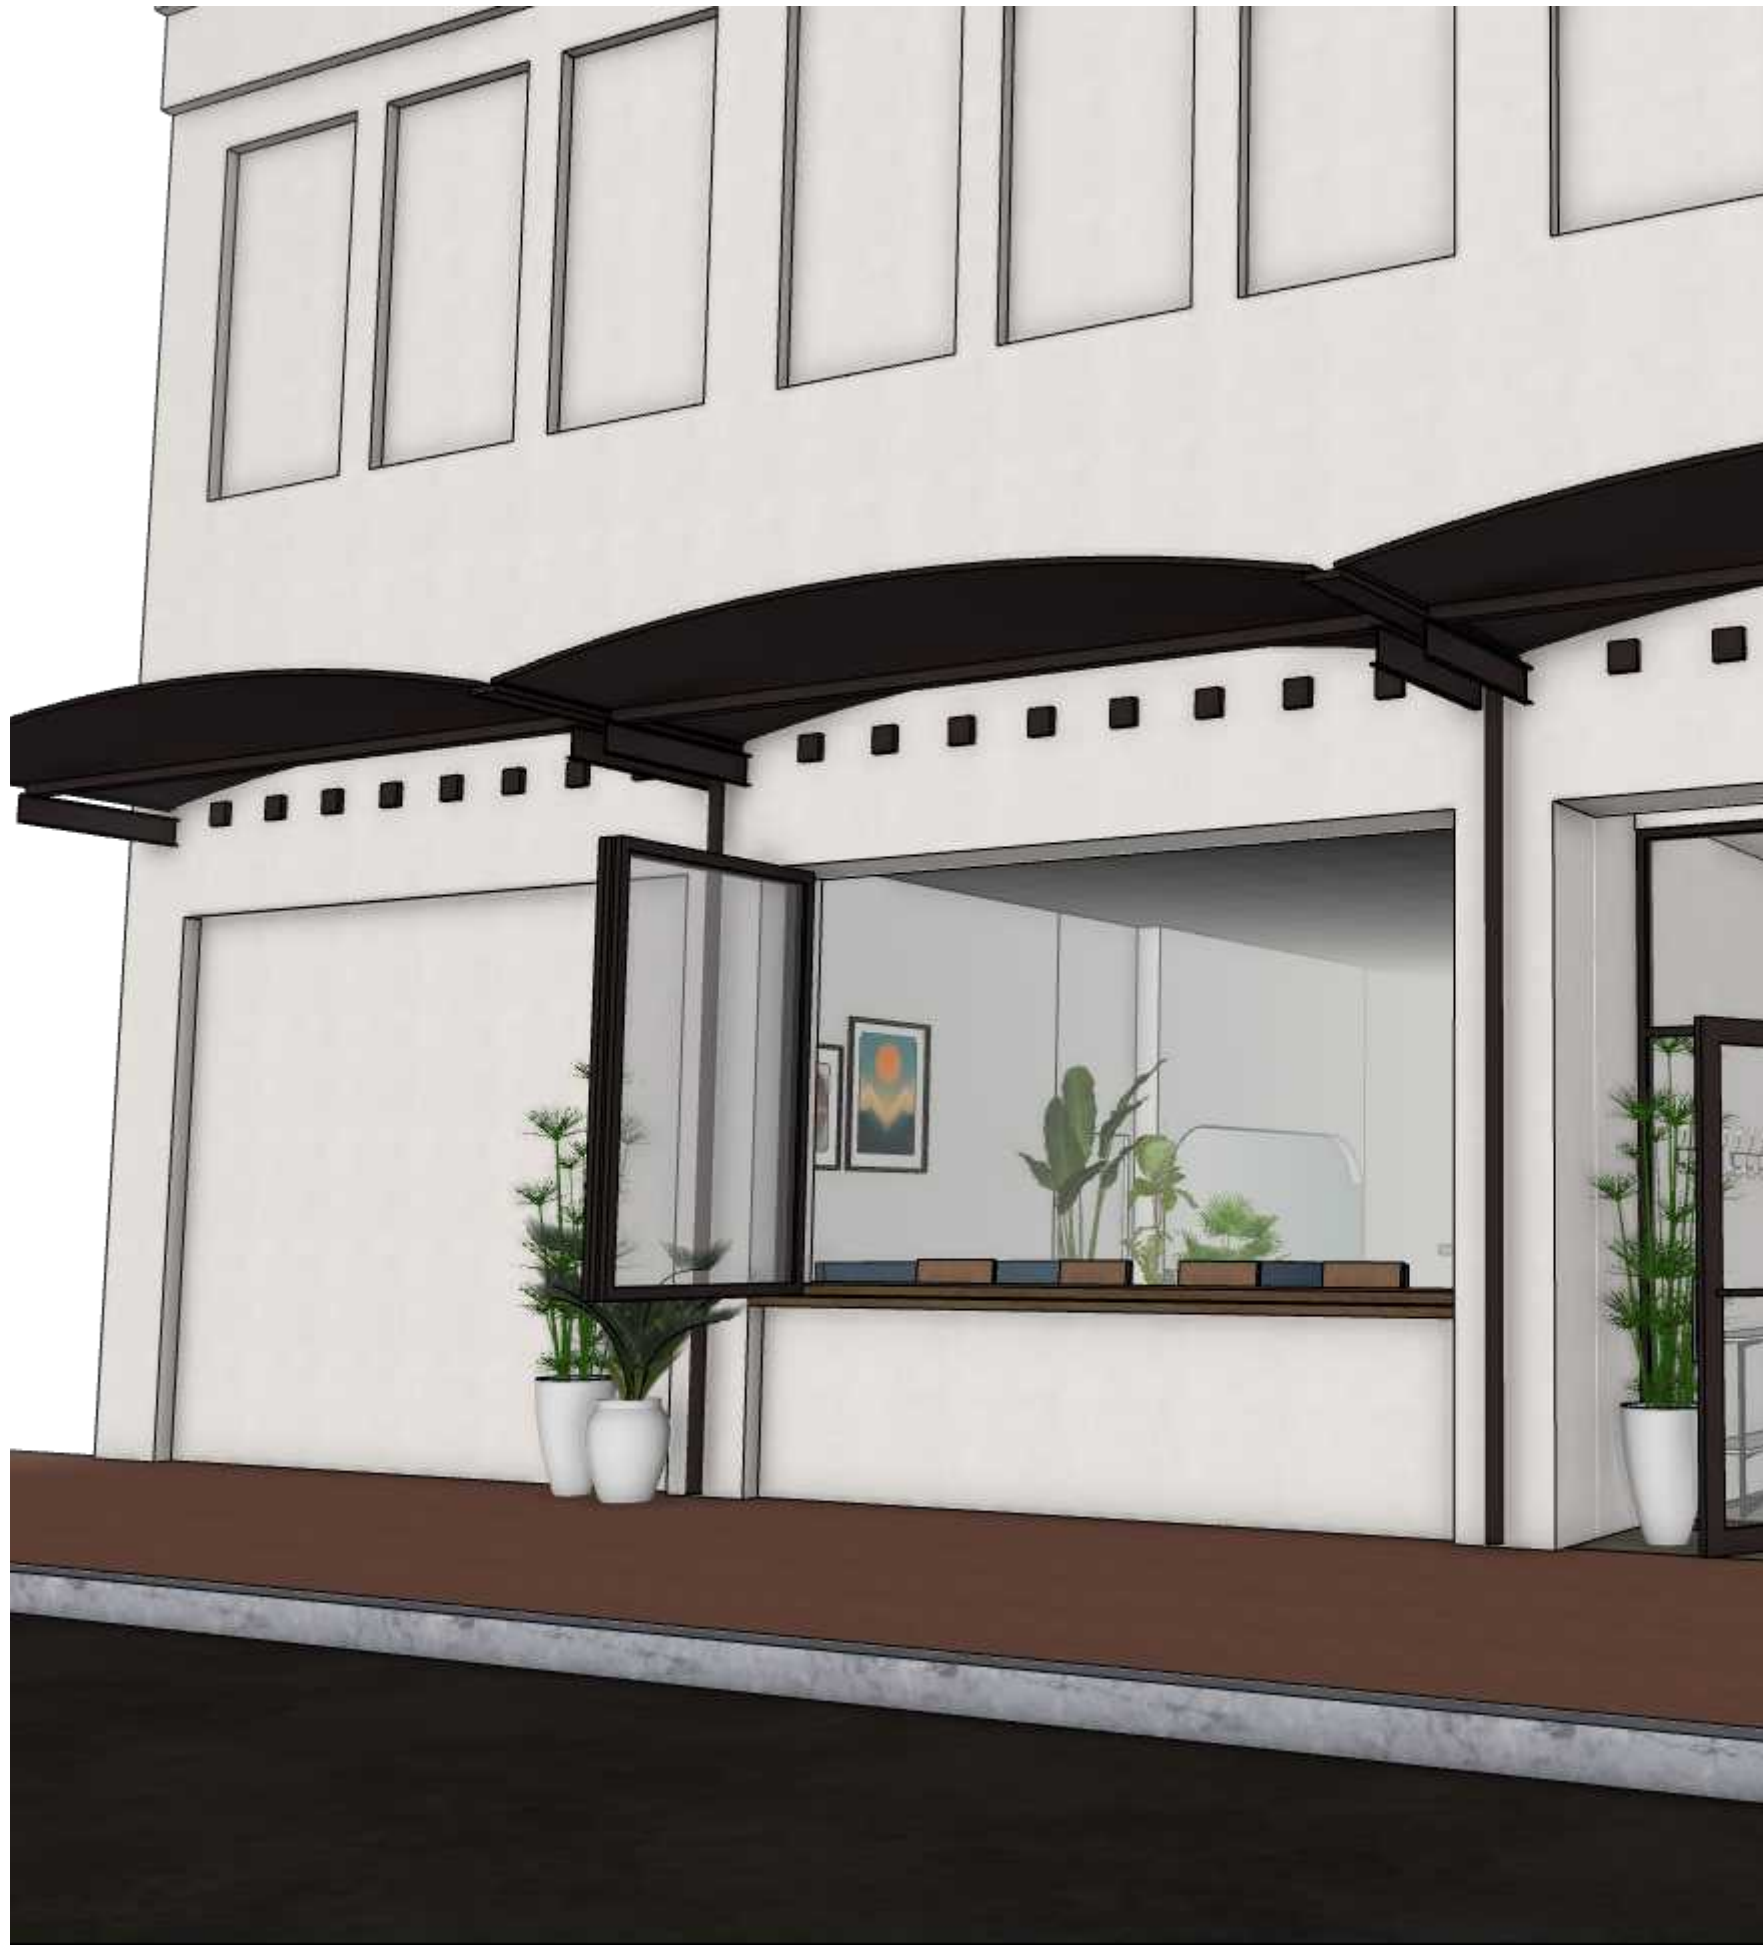
2 Front Perspective, Proposed Storefront Open - BIFOLD DOORS  
A1.1
