MEMORANDUM

SUBJECT: June 23, 2026 HISTORIC PRESERVATION COMMISSION MEETING

**Project**  
Facade & Interior Alterations  
113 West Beverley St.  
Staunton, VA 24401

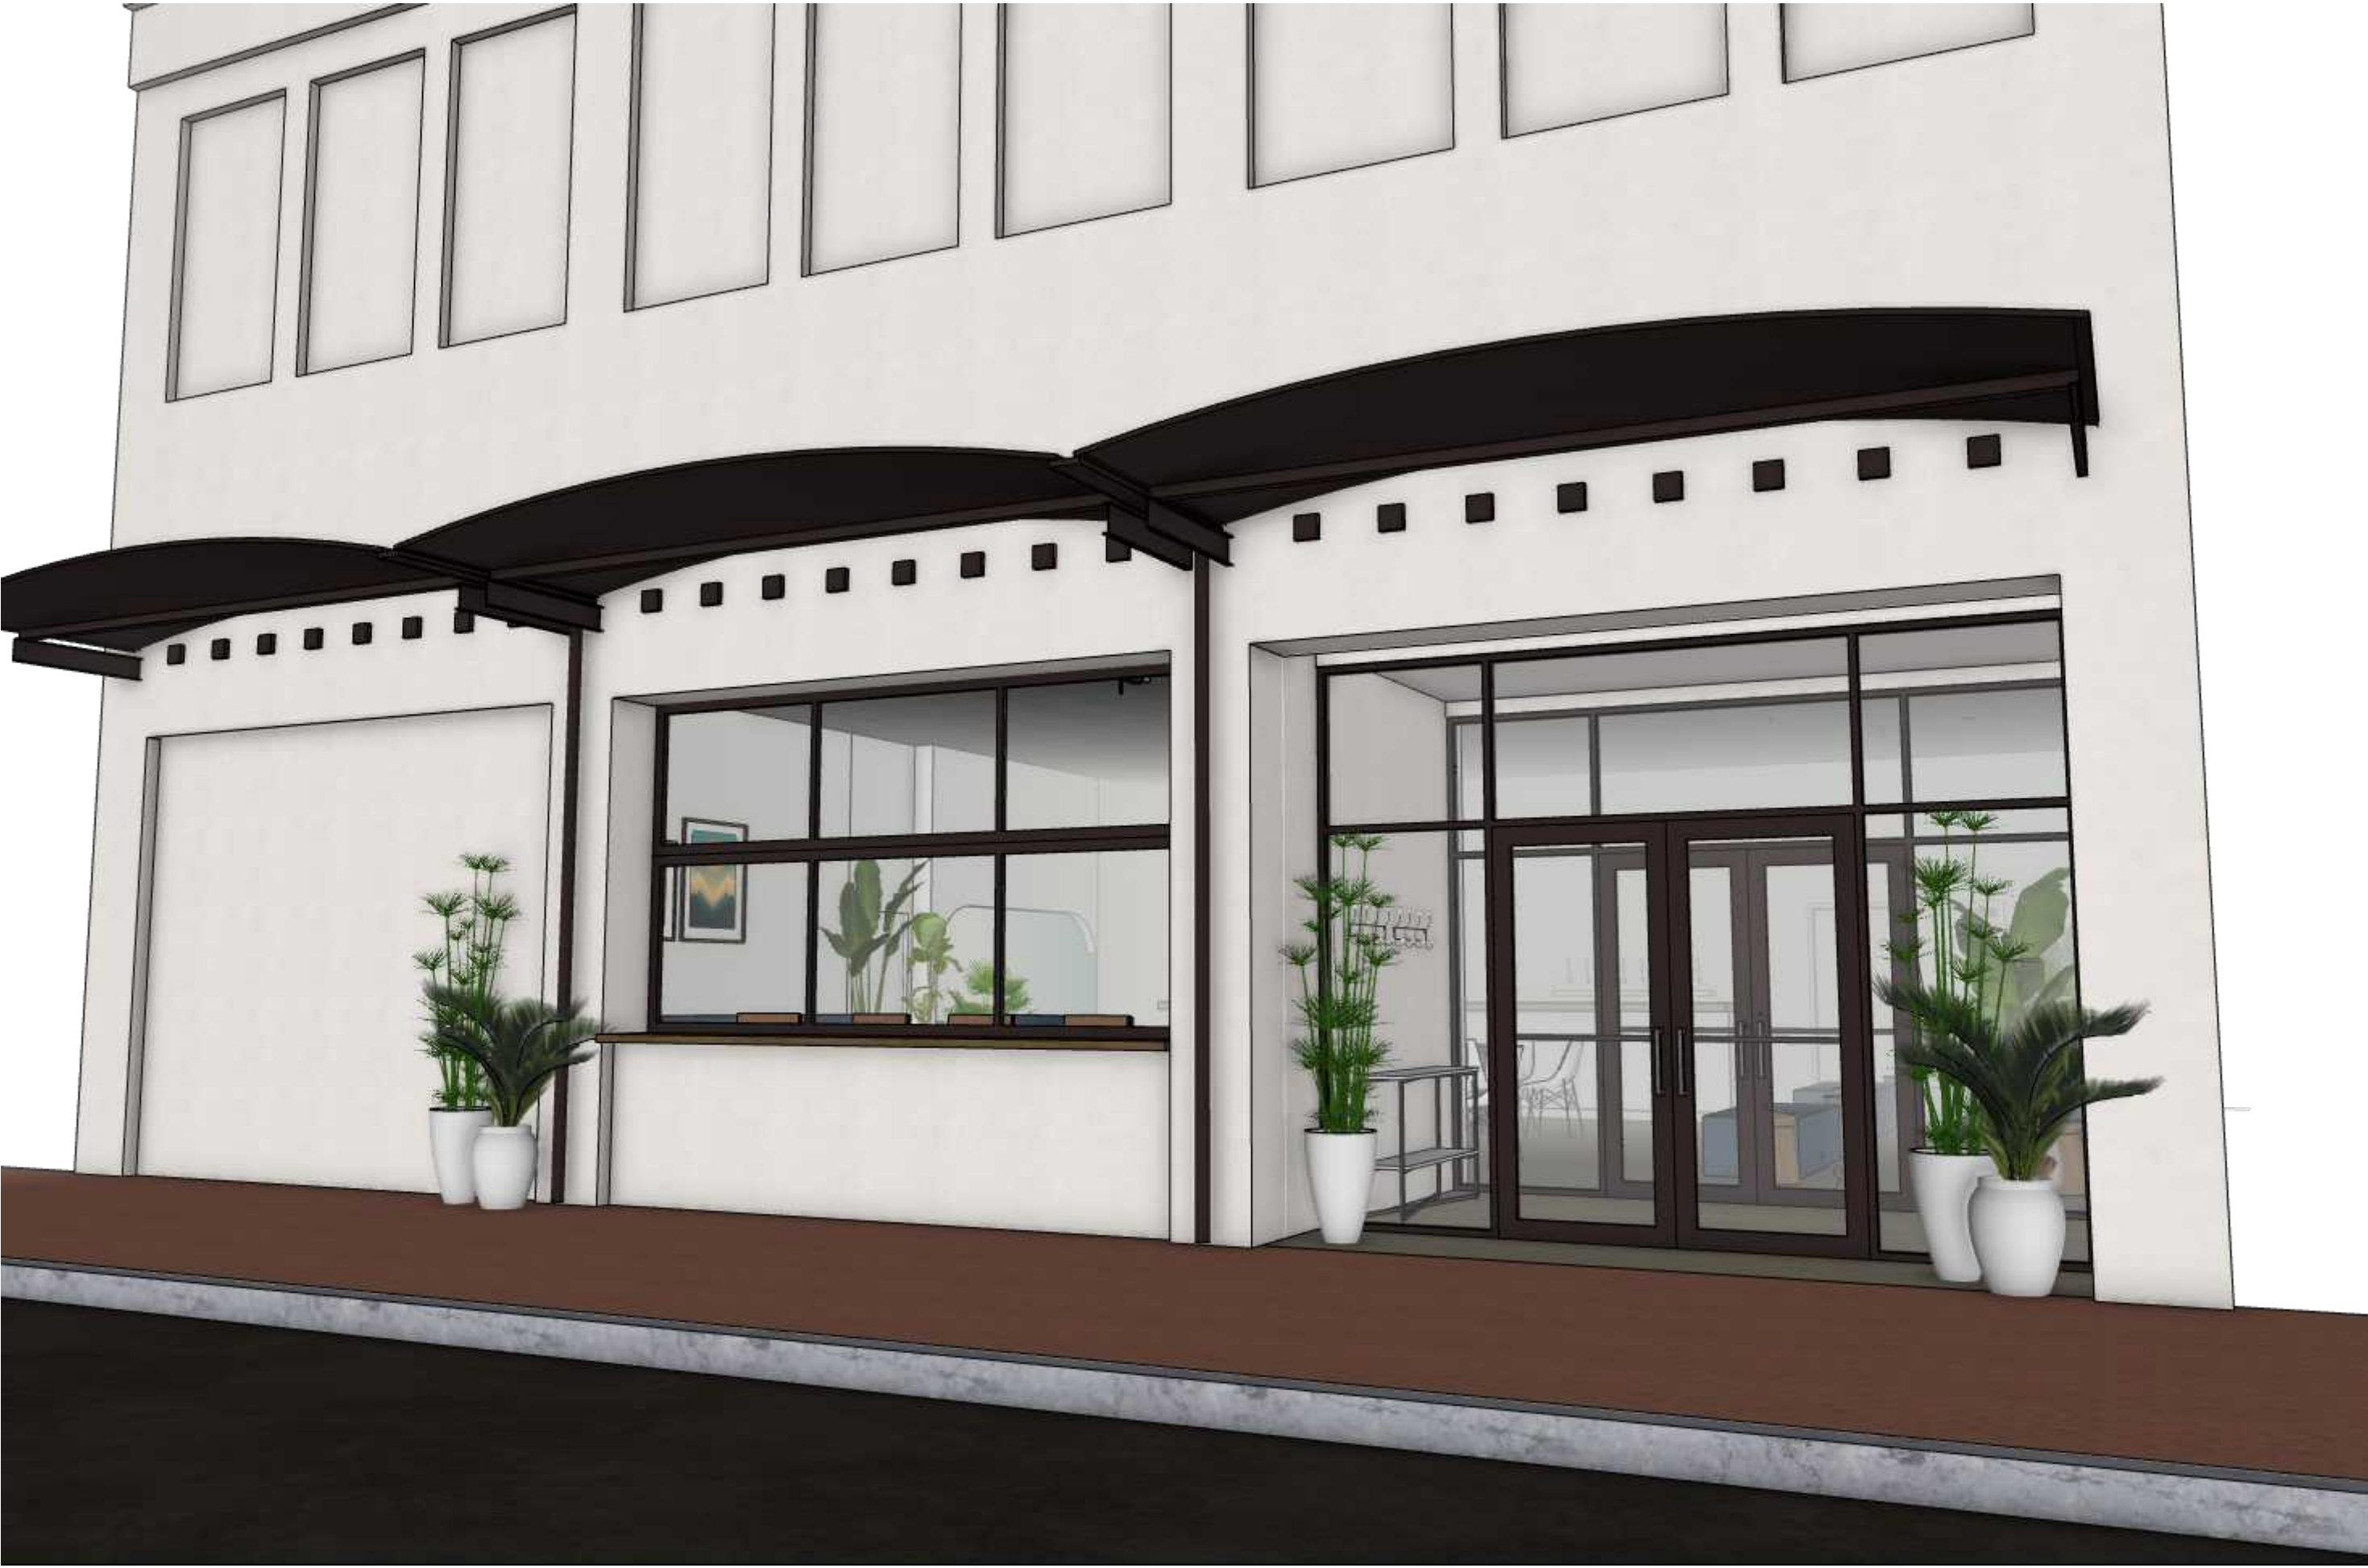
3 Front Perspective, Proposed Storefront Closed - HANGER STYLE DOOR  
A1.1

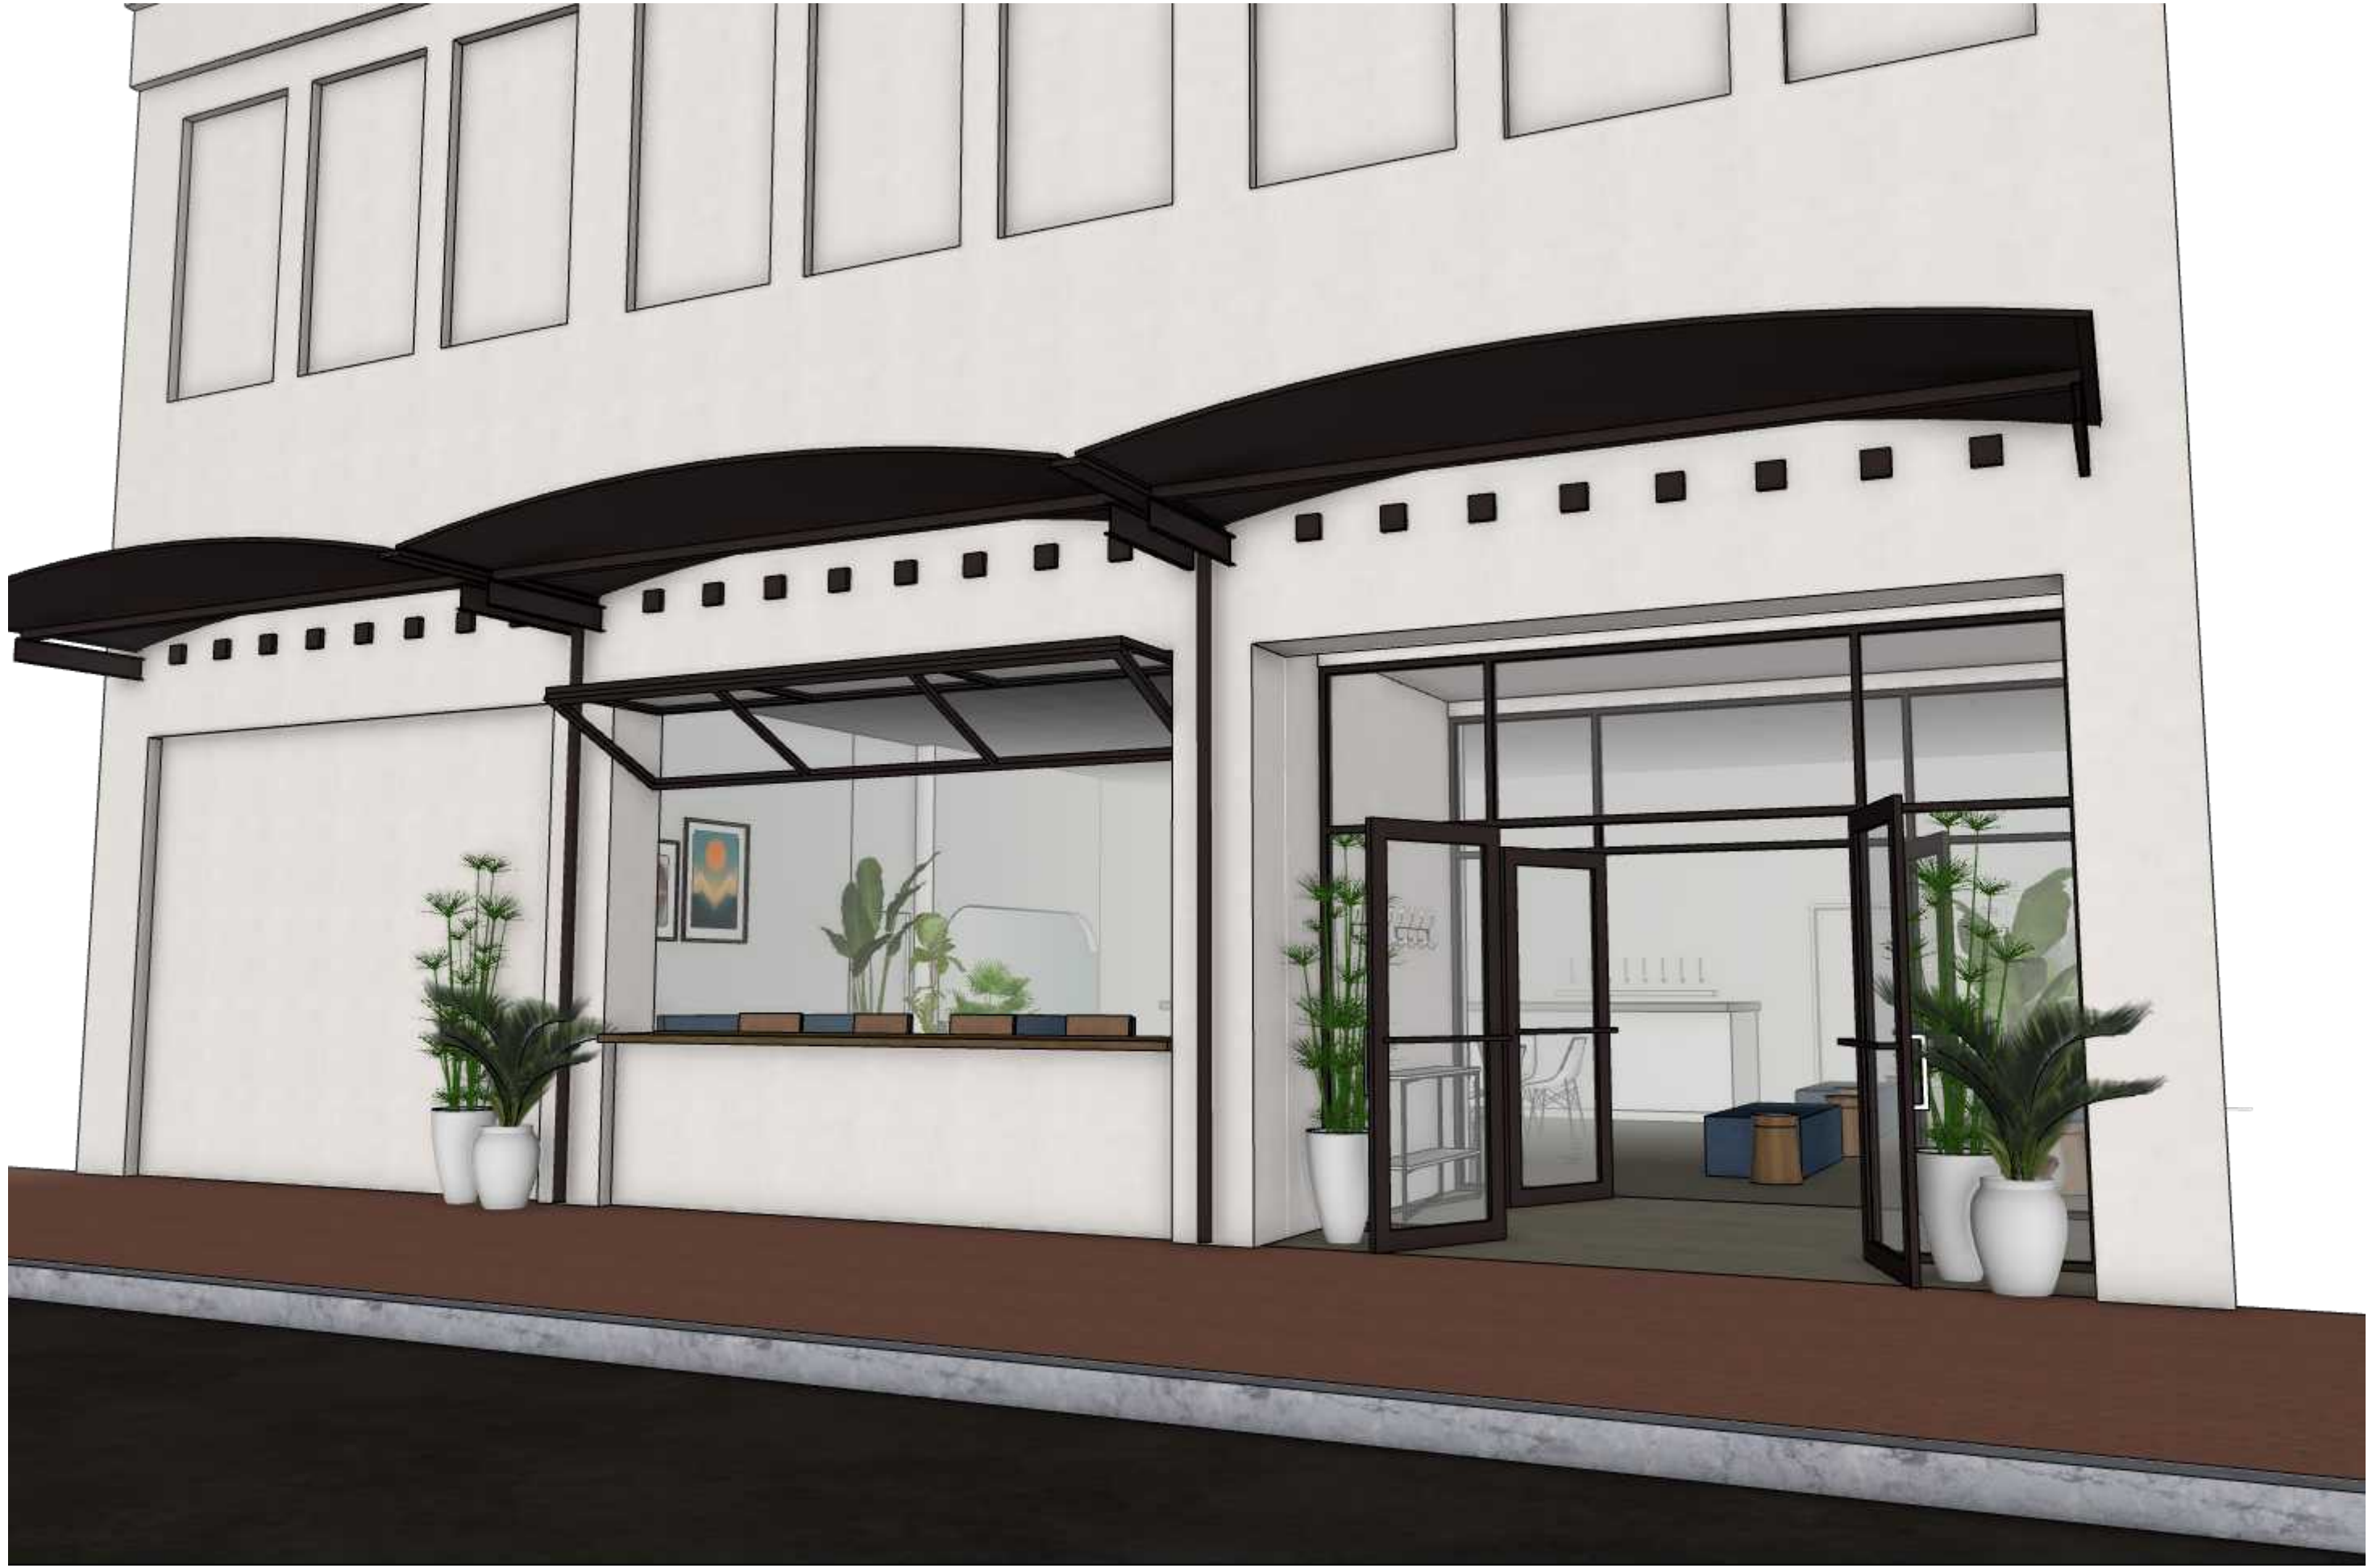
4 Front Perspective, Proposed Storefront Open - HANGER STYLE DOOR  
A1.1
