## MEMORANDUM

SUBJECT: May 26, 2026 HISTORIC PRESERVATION COMMISSION MEETING

# RENOVATIONS FOR HVAC INSTALLATION

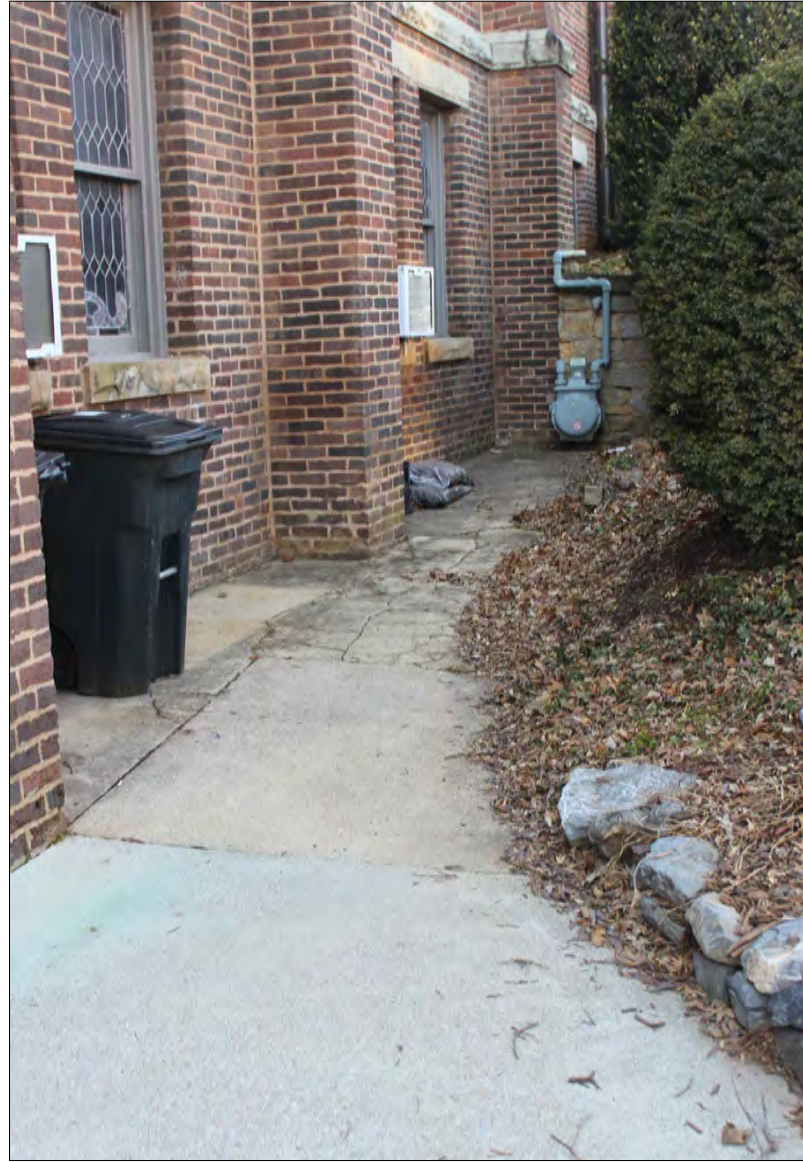
PHOTO: Existing Slab and Gas meter at work area

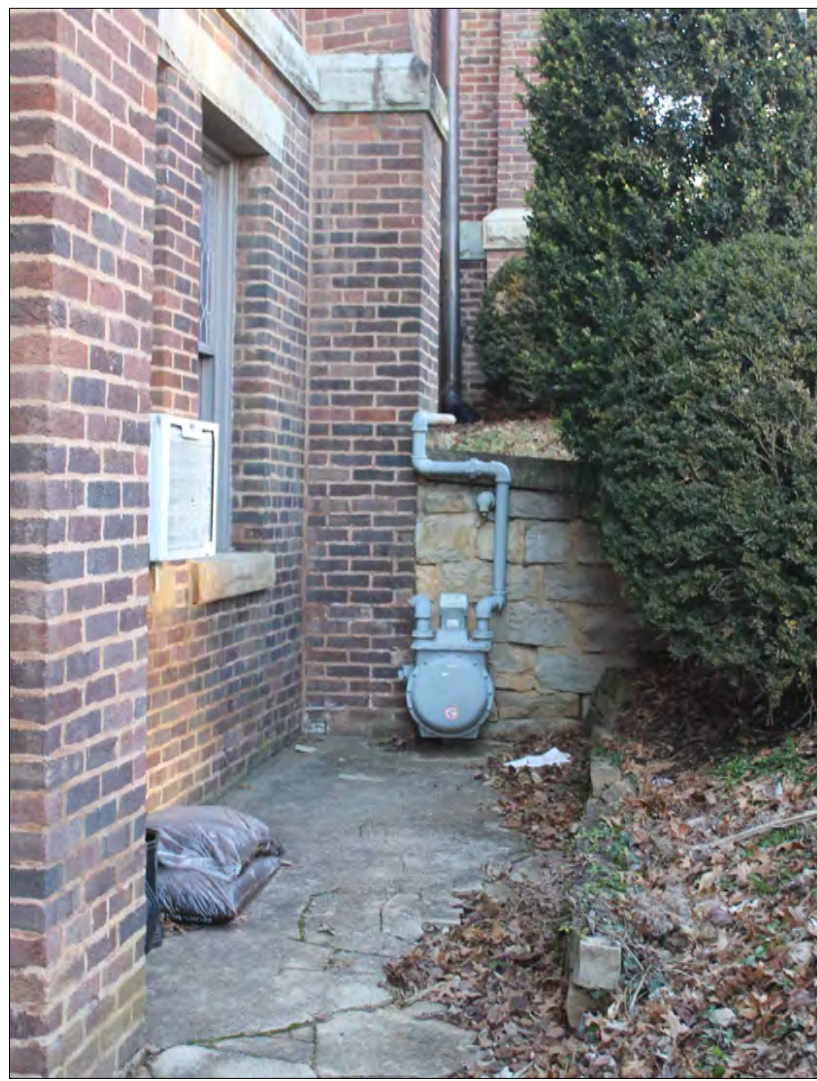
PHOTO: Retaining wall and Gas meter at work area

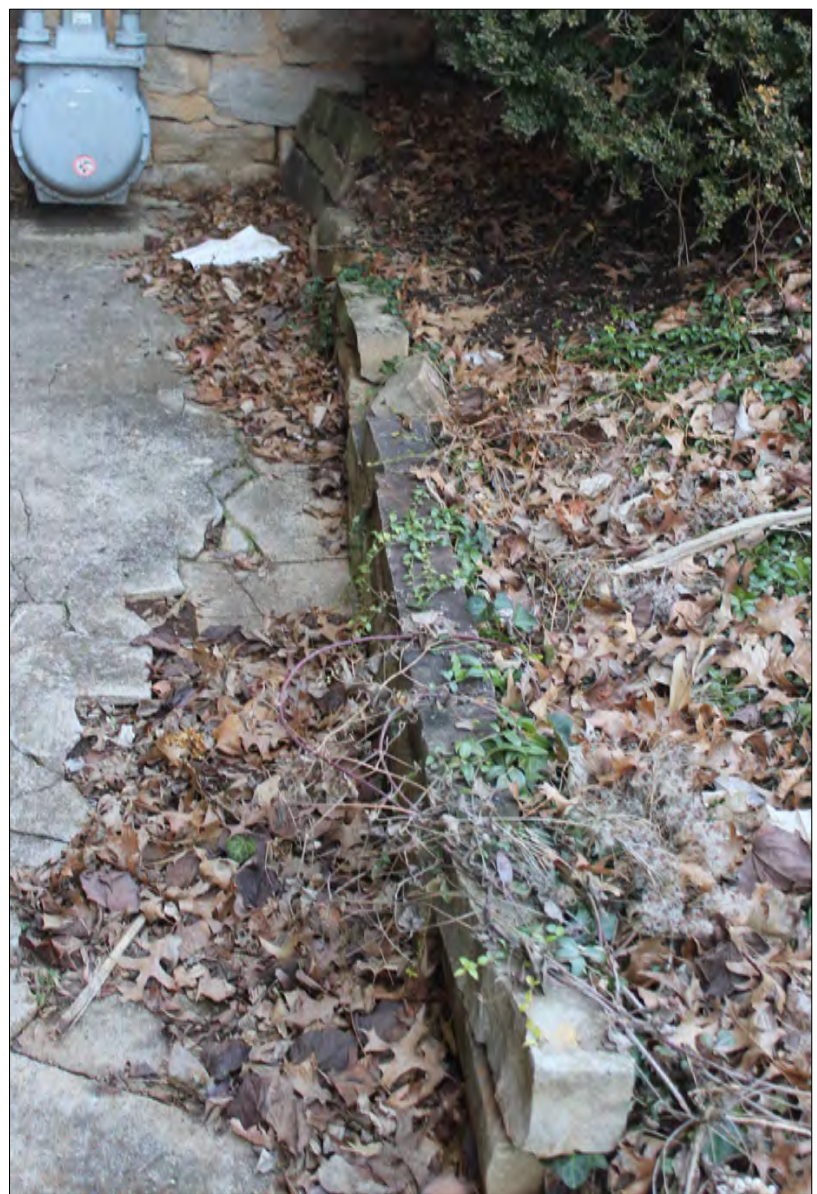
PHOTO: Existing slab/soil edge at work area

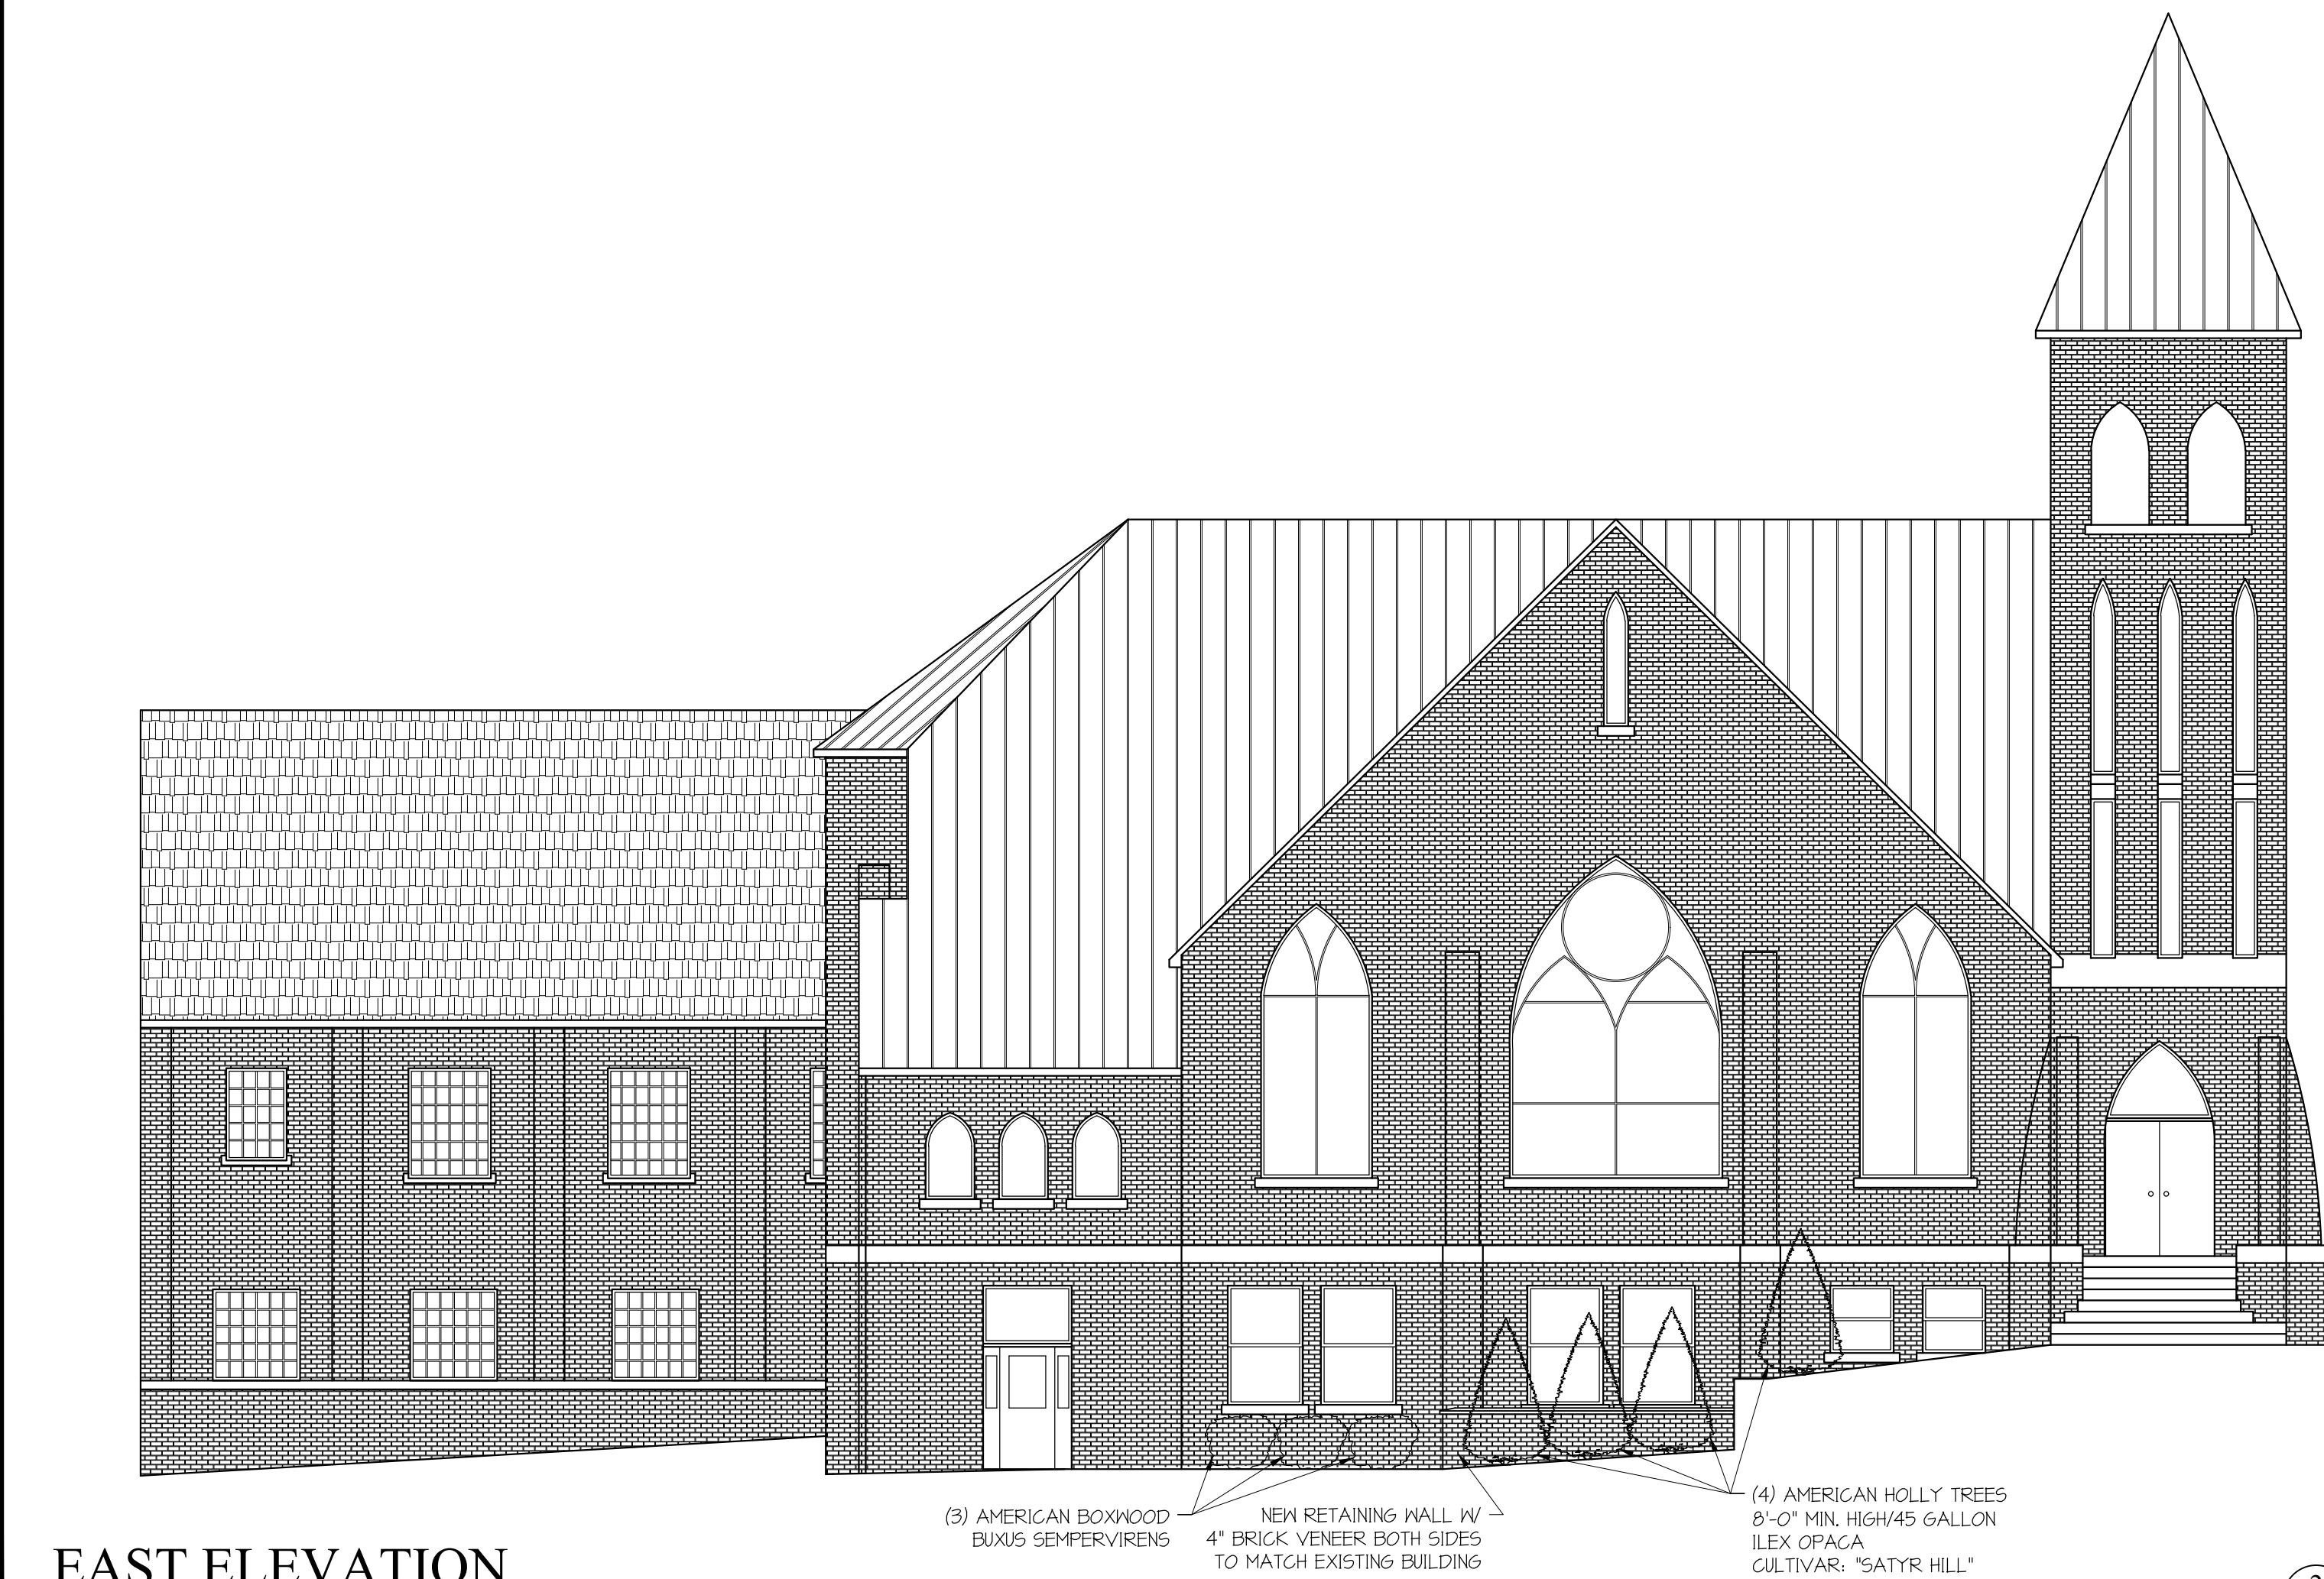
EAST ELEVATION

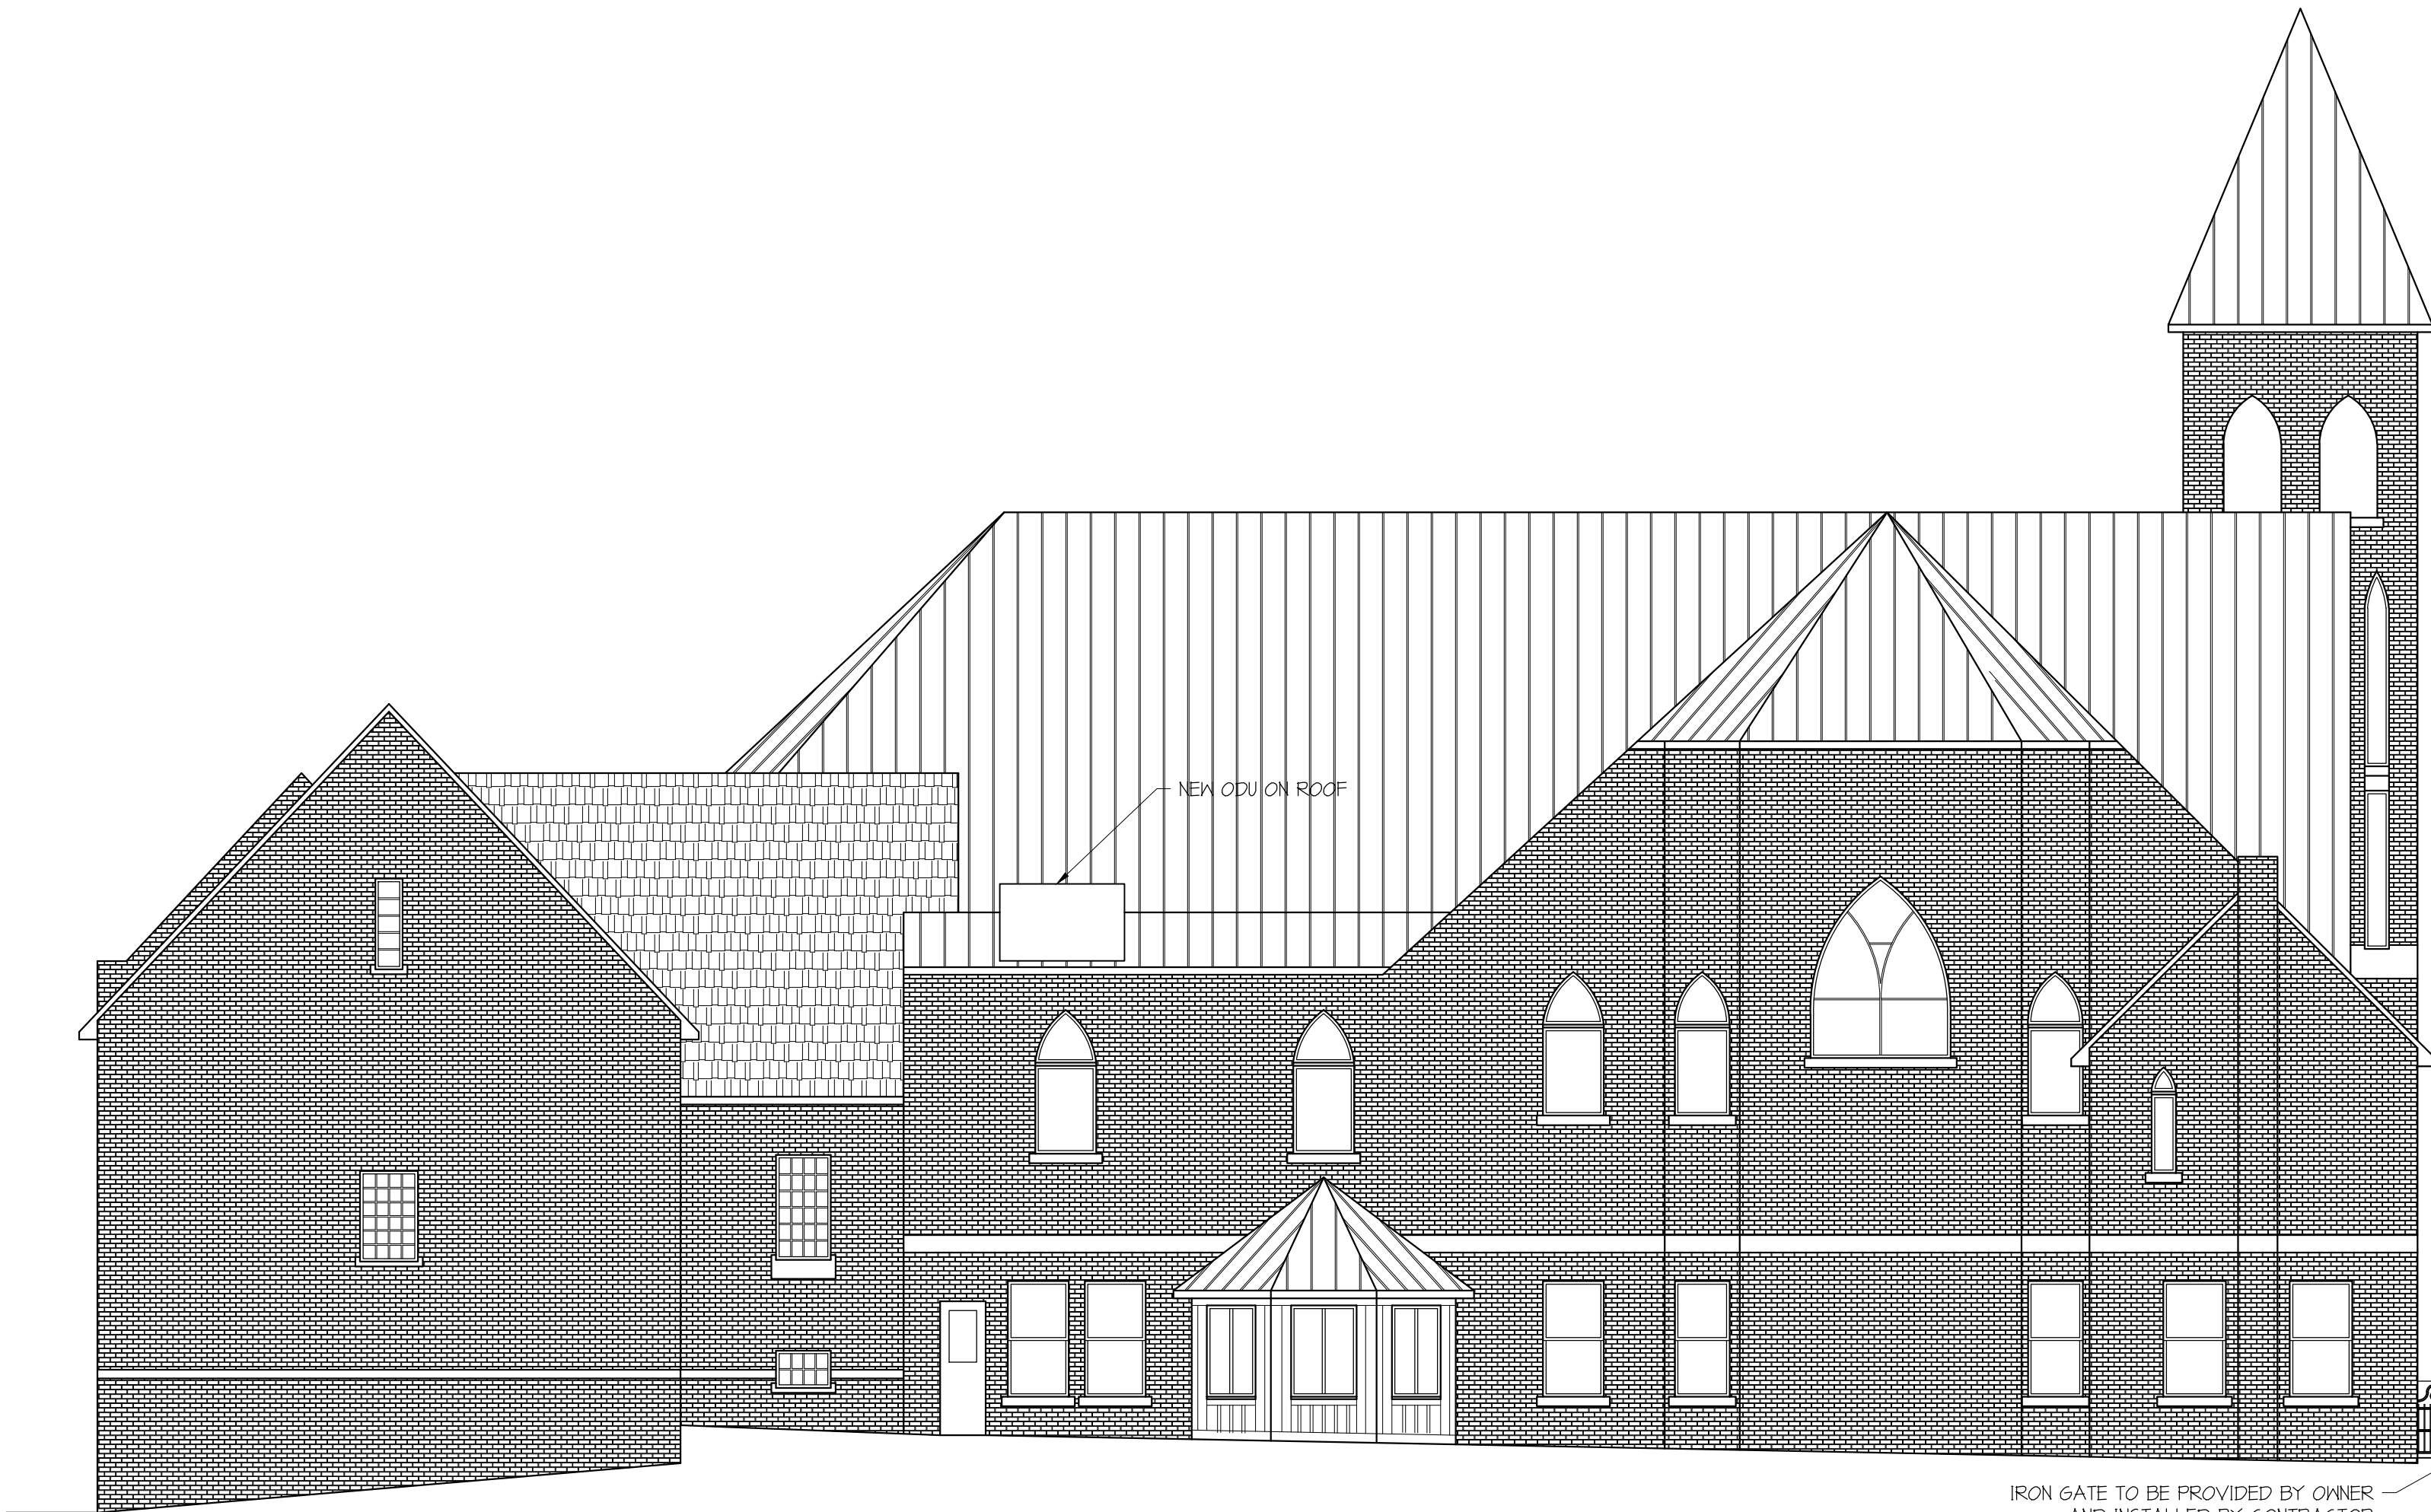
SOUTH ELEVATION

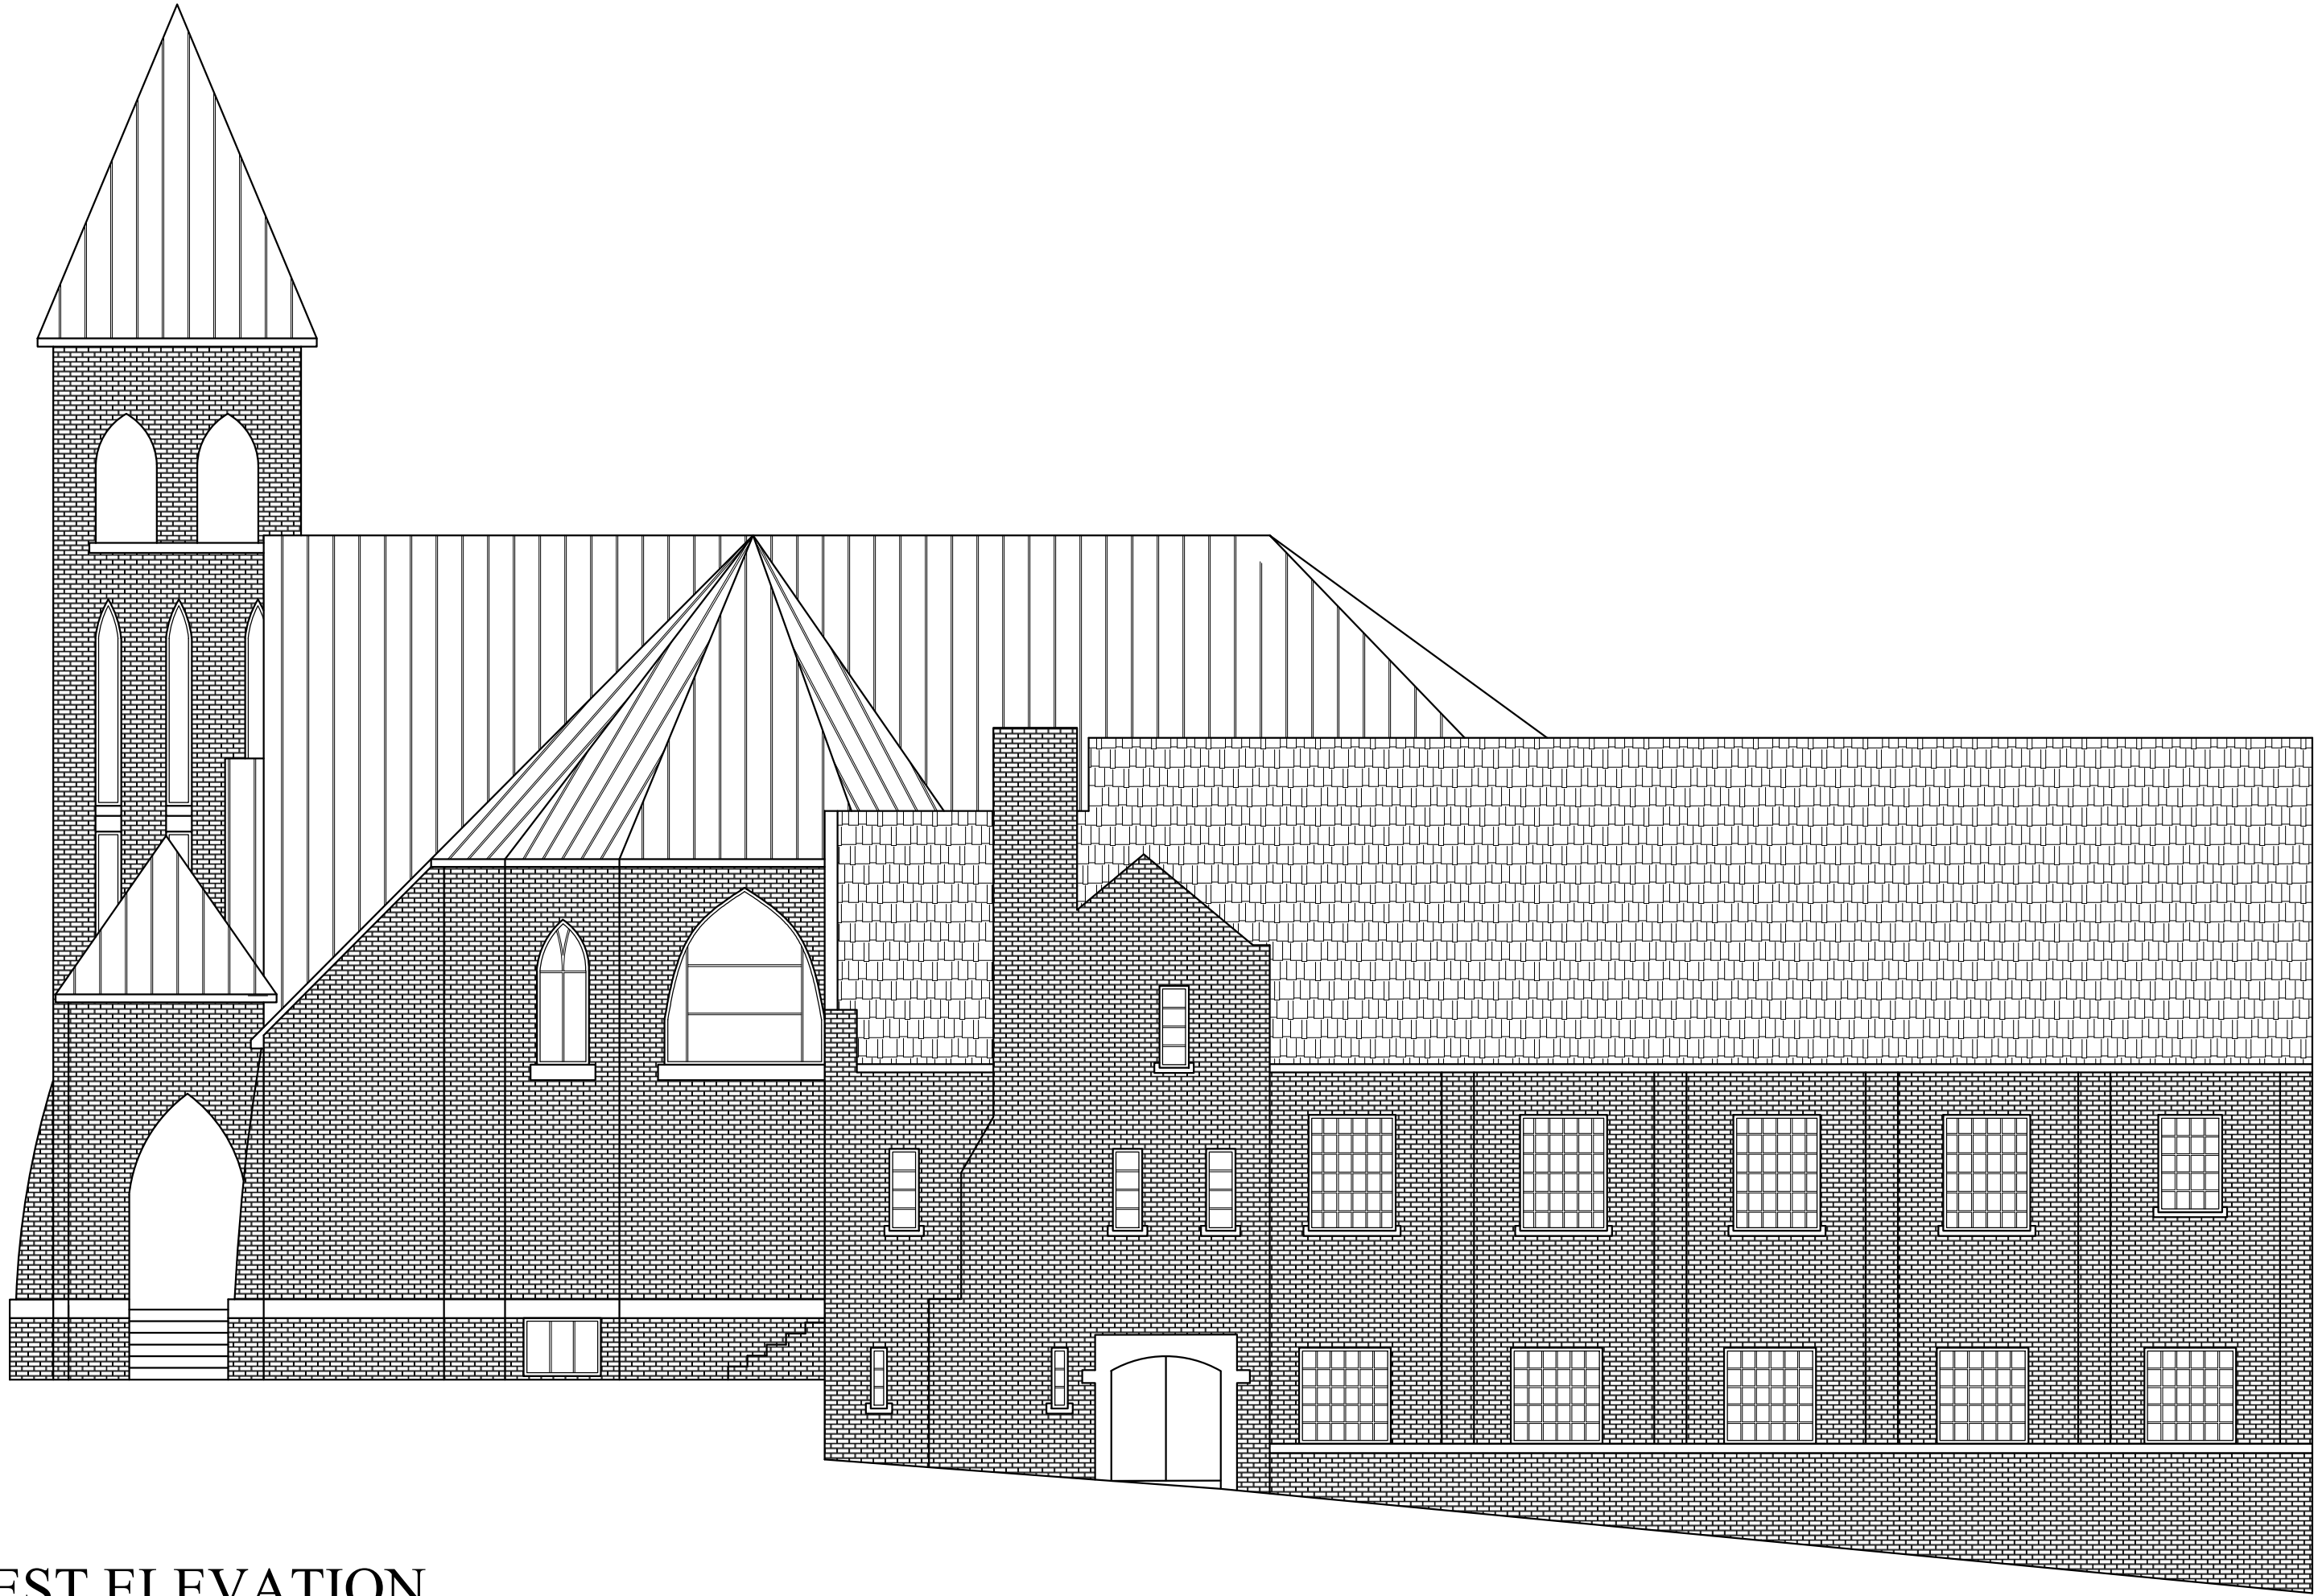
WEST ELEVATION
