**STAUNTON HISTORIC PRESERVATION COMMISSION****May 26, 2026****5:30 p.m.****Council Chambers**

**NEW BUSINESS****a.       **CERTIFICATE OF APPROPRIATENESS****

# RENOVATIONS FOR SANCTUARY HVAC INSTALLATION

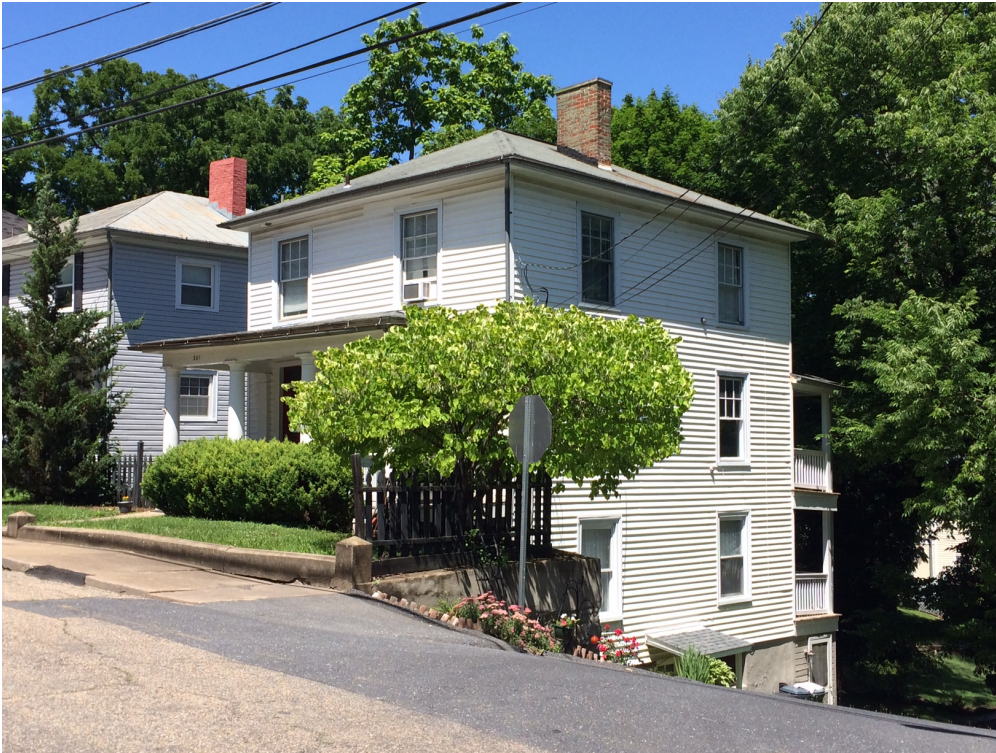
6-16-2021

Existing Condition: Constructed between 1904 and 1909 this is a two bay, two-story frame residence.

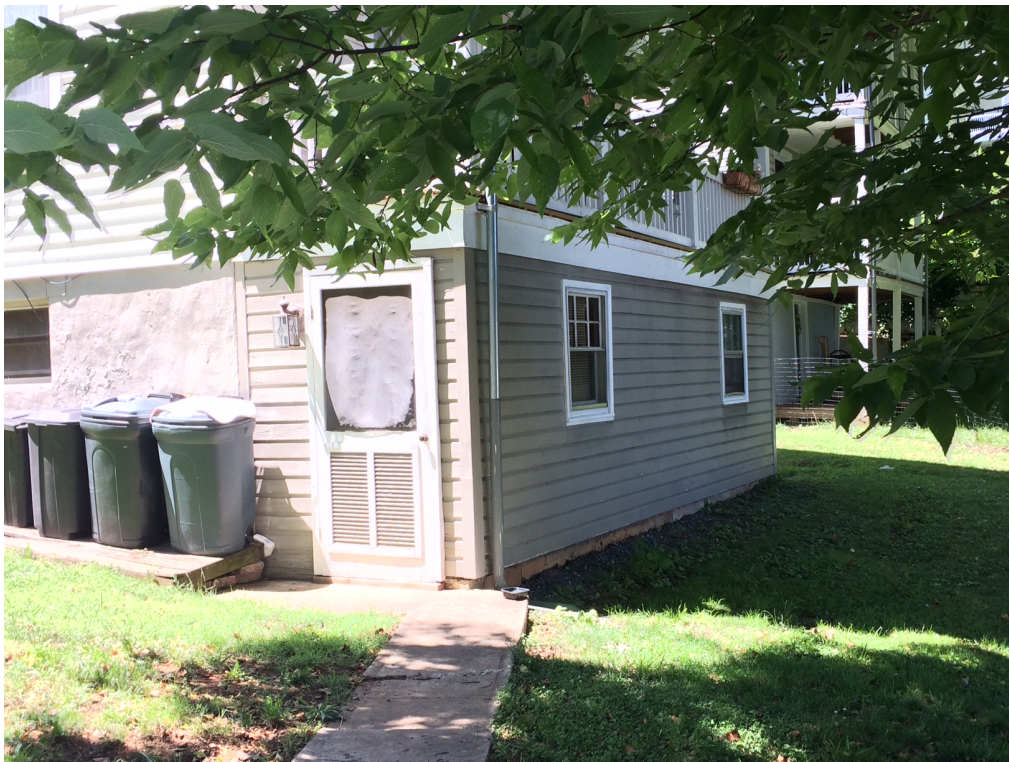
Asphalt shingles cover the hip roof with a brick masonry chimney. Vinyl siding and wrap cover the exterior walls and trim while the historic wood German siding can be viewed under the porch roof. Windows are six over one light; double hung wood sash except for replacement one over one light vinyl sash windows on the lower floor. A single story front porch with hip roof includes Tuscan columns and balustrade with molded rail and square pickets.

A three-story wood frame porch is on the rear of the building including hip roof, square columns and balustrade with molded rail and square pickets. The lower level is enclosed with German wood siding. A wood screen side door is on the south end and two square windows are on the east, rear side.

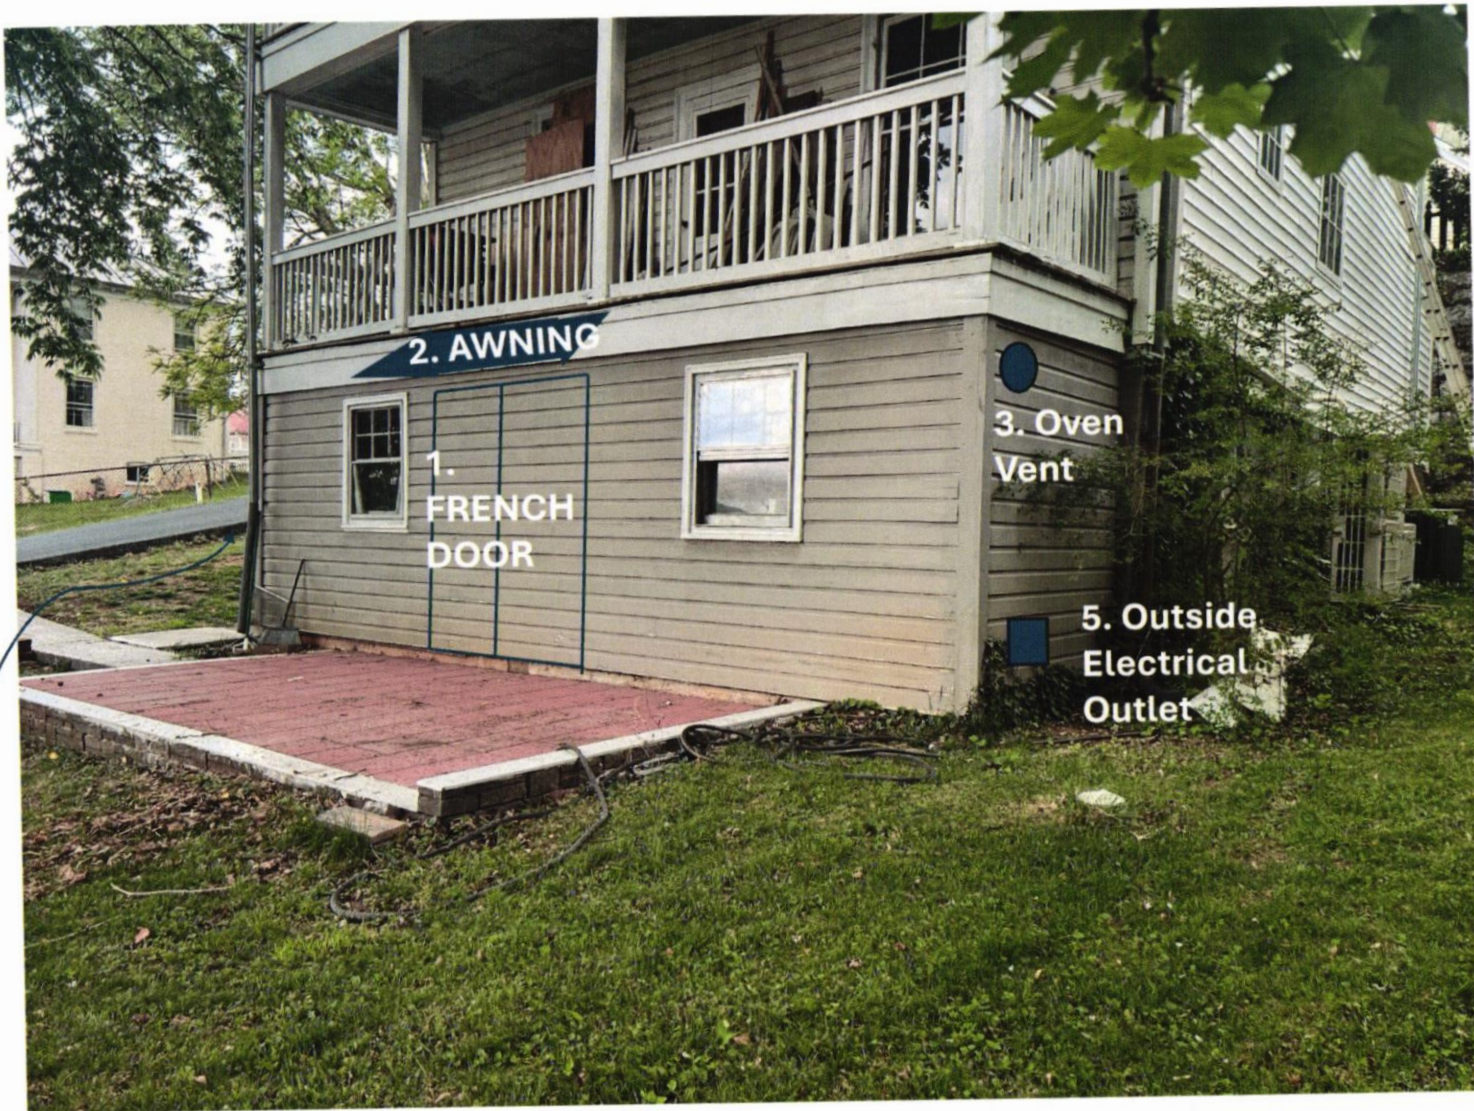
201 N  
Madison

**Proposed  
Changes (1-  
4 Previously  
Approved)**

1. French Door
2. Awning
3. Oven Vent
4. Old Side Door Filled In
5. Exterior Outlet
