## GAS DISTRIBUTION SYSTEM

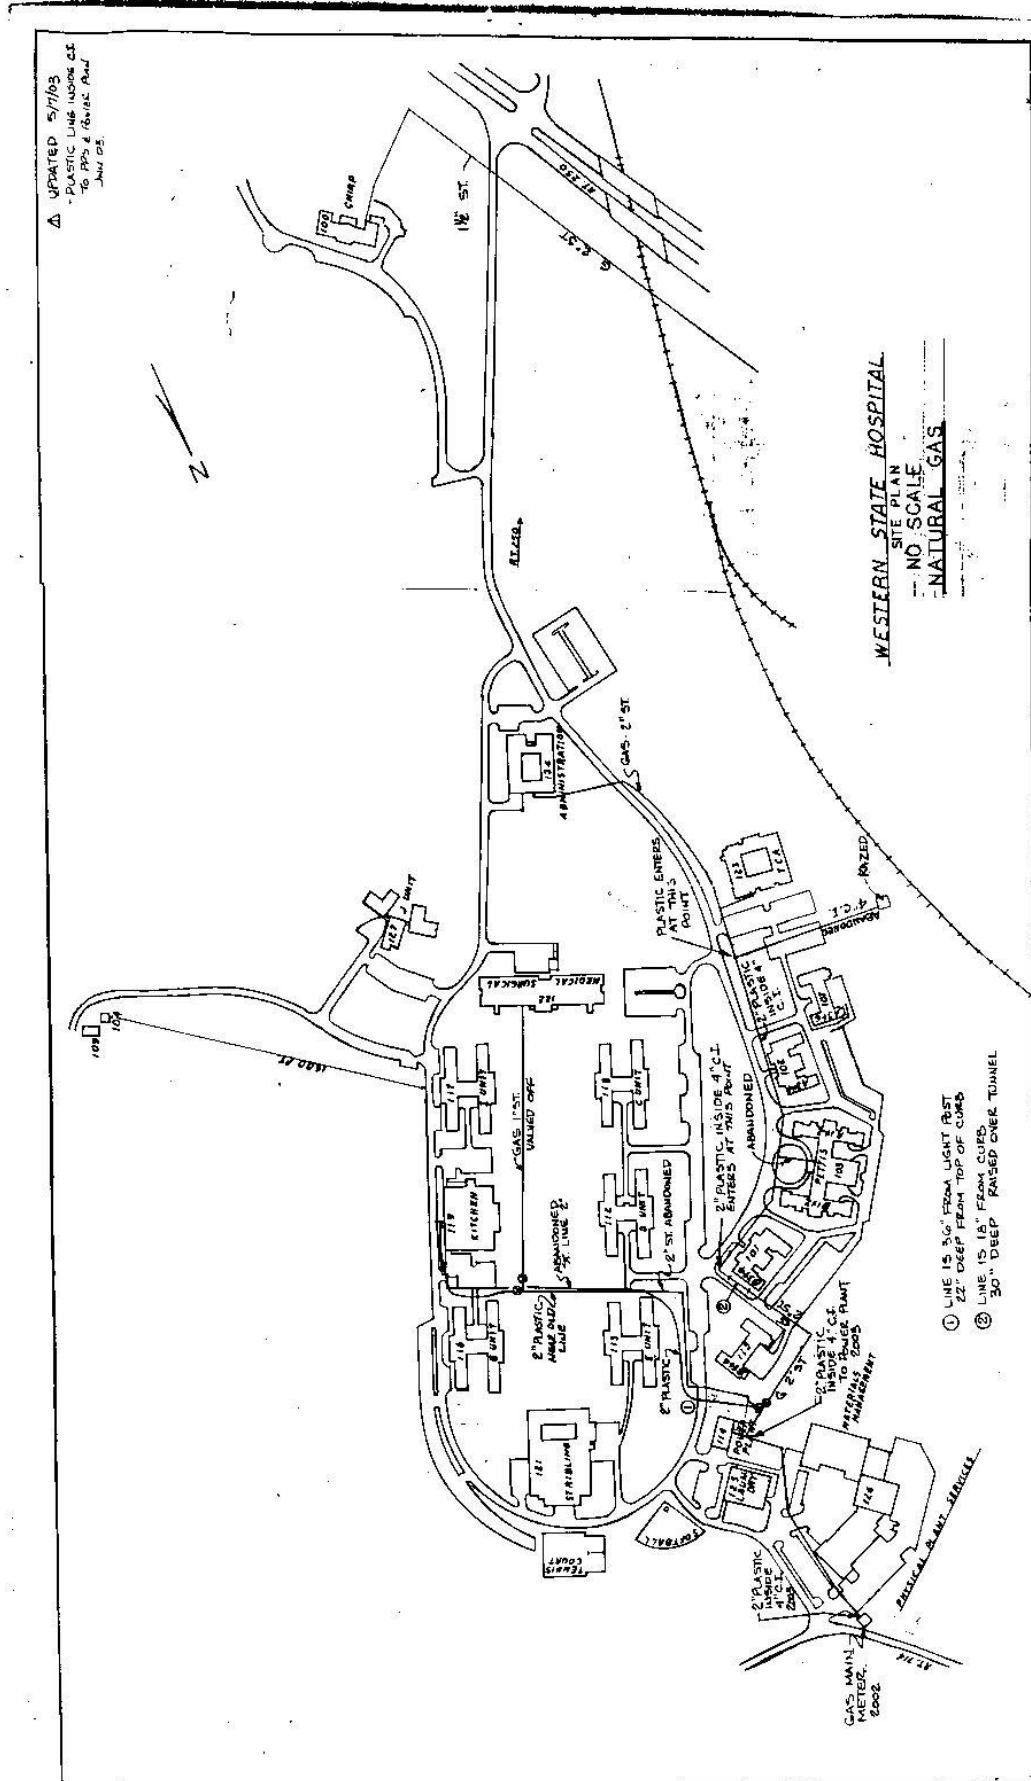
## GAS DISTRIBUTION SYSTEM

In 1982, before the construction of building 126, the gas line to the Power Plant had to be rerouted so it wouldn't be under building 126. Presently, the line runs north along National Avenue to a point in front of building 126, Physical Plant Services, east under the parking lot of building 126 to the road west of the Laundry, building 125, then southeast to the Power Plant, building 114. When this line was rerouted, more magnesium blocks were attached to the aforementioned steel line.

In November of 2002, a puncture in the natural gas line behind the Laundry forced the replacement of the gas line from the gas meter cage to the Power Plant. This replacement line was a 2" plastic line which was threaded through the existing 4" line.

Presently, all pipes are in good condition and are adequate for their demand. In the future, periodic checks for gas leaks will be conducted, and pipes will be replaced as necessary.
