# Augusta County Courthouse

Feasibility Study  
Vol. I

October, 2012

For:  
AUGUSTA COUNTY, VIRGINIA

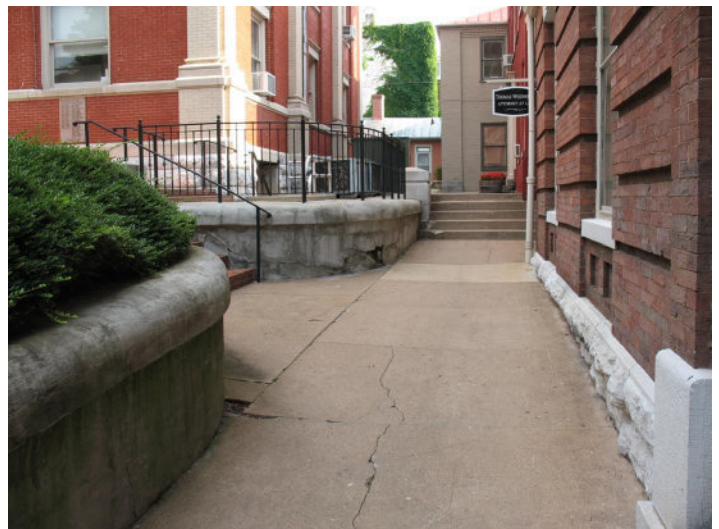
Concrete sidewalk and retaining walls between courthouse and Lawyers Row.

a better location that does not detract from the pedestrian experience around the building. The concrete sidewalks on this side of the building are severely deteriorated.

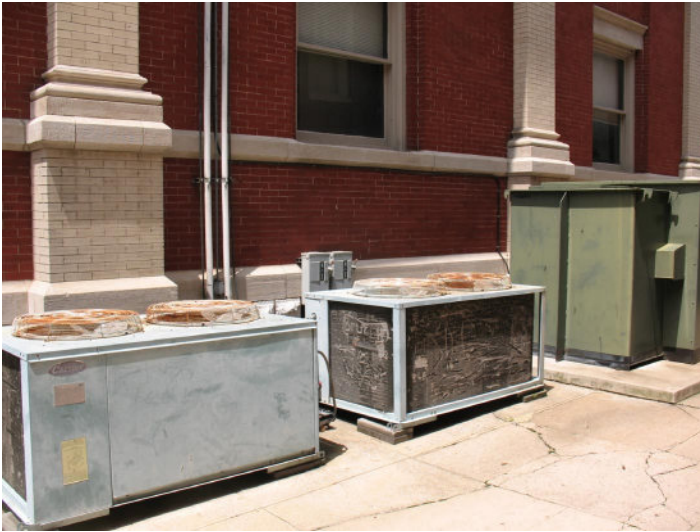
Mechanical units and transformer located on the east side of the building.

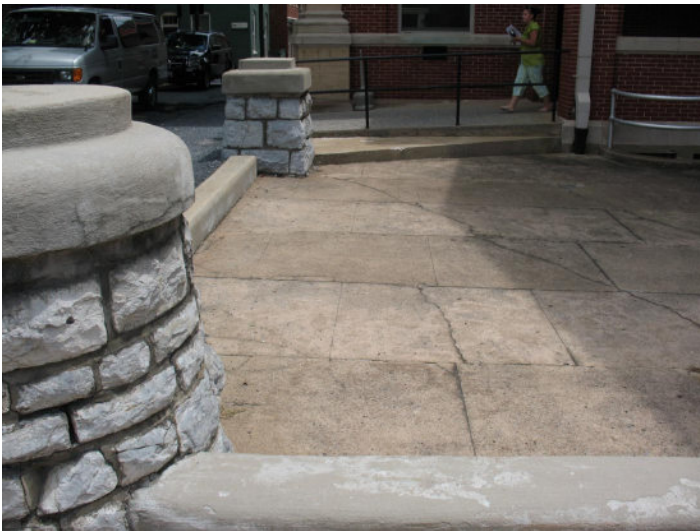
Limestone piers and concrete plaza at the northeast corner of the building.

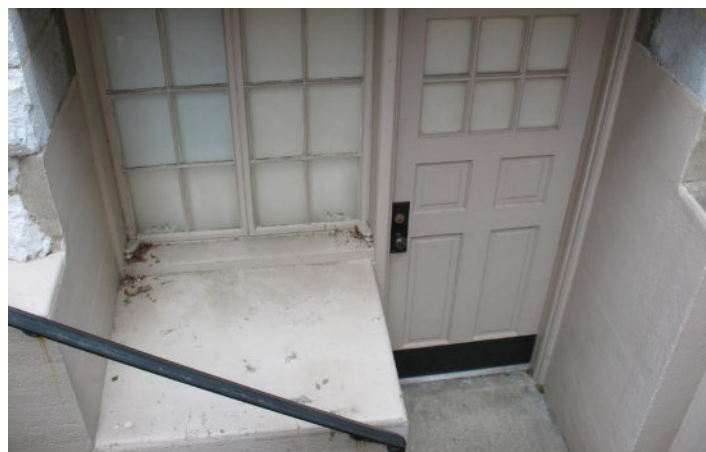
A basement entrance is located at the south end of the east elevation of the building. The partially glazed (frosted) door in this opening has six small panes of glass over four recessed panels in a typical Colonial Revival style arrangement consistent with the 1939 remodeling. At that time, this opening was apparently converted from a window to a door. This door and adjacent window have been boarded over on the interior, apparently for security purposes. Similar basement entrances on the north elevation traditionally provided access to public toilets. The stairs are in good condition but will need to have their drains periodically maintained to prevent flooding of the building.

Detail view of exterior stair to basement on the east side of the building.

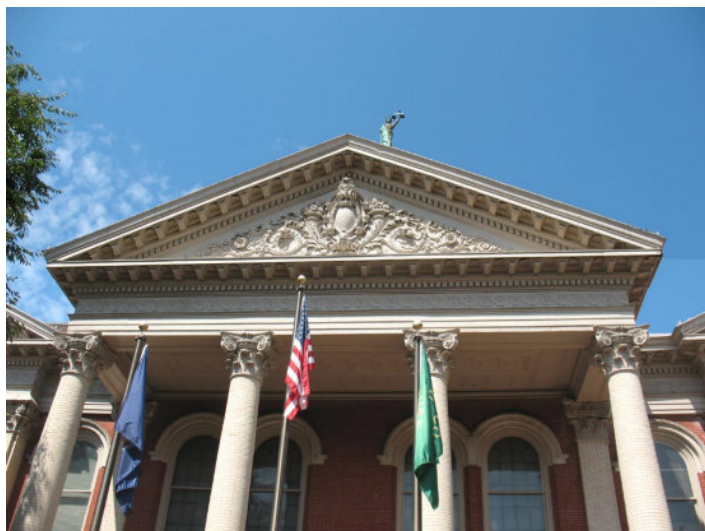
Photo of pediment above front portico showing decorative sheet metal cornices.

This decorative sheet metal entablature is showing signs of deterioration with rust at gaps that are opening up. Missing floral details were observed between the modillion blocks in some locations. There is what appears to be a wood cornice, in fair condition, on the flat roof sections of the rear addition.

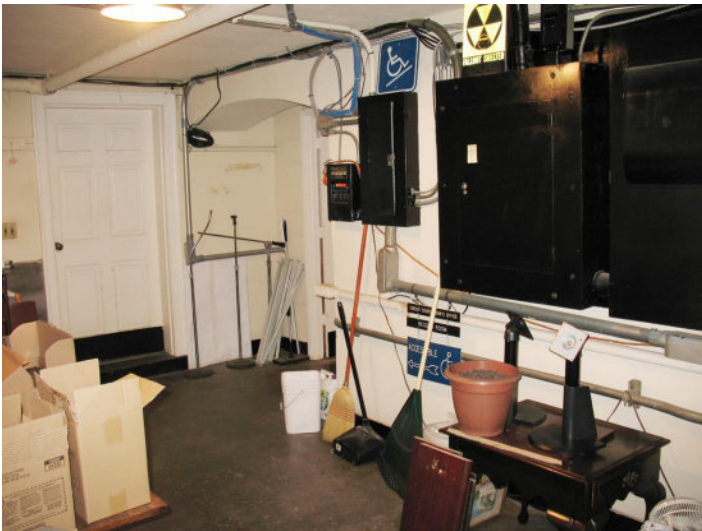
Electrical service and panels in the basement are outdated and would be upgraded in any future renovation..

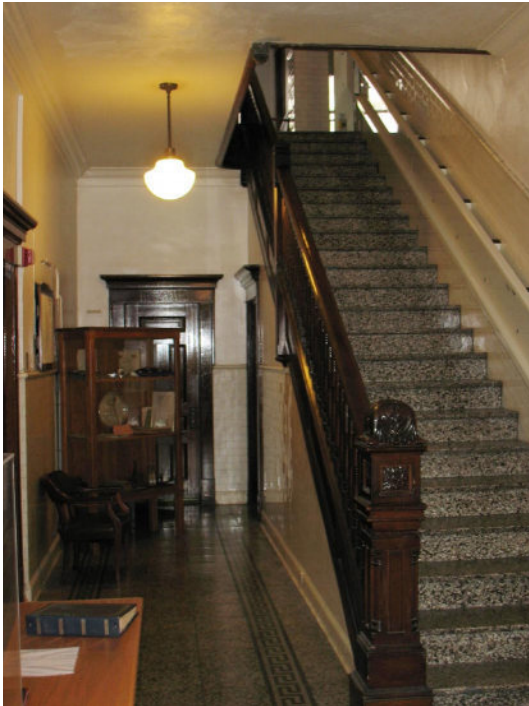
Original stairway in the east corridor of the first floor.

The identical staircases in each cross-axial hall feature turned balusters and elaborately carved newel posts. The treads and risers are clad in the same terrazzo as the hall floors. Earlier damage to the terrazzo treads have been patched with a material that doesn't match but which appears to be holding up.

The condition of the stairway materials is good to fair with some damage and wear and tear evident. These conditions should be addressed as part of any comprehensive rehabilitation of the building.

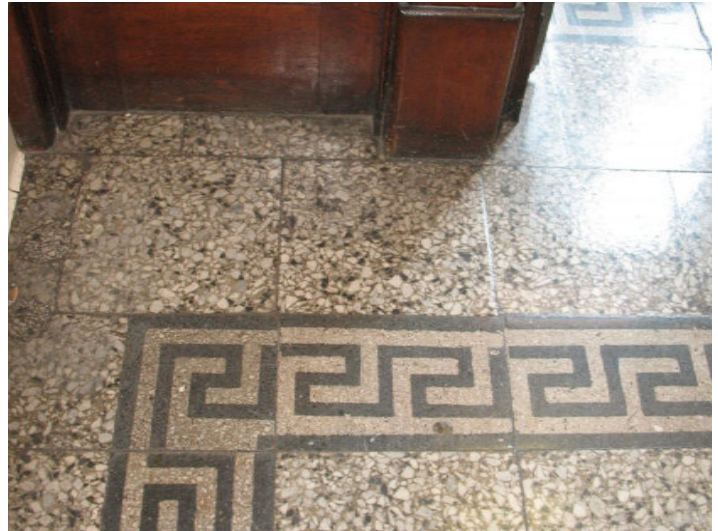
The floors of the hallways located in the hyphens retain their original 12" gray, beige, and black terrazzo bordered with a black Greek key design. The same floor is found in the office portion of the large records room. The area containing deed books has been covered in carpet, as have the rooms in each wing. This flooring is typically holding up well and appears to be in serviceable condition.

Detail of terrazzo tile finish in first floor corridors.

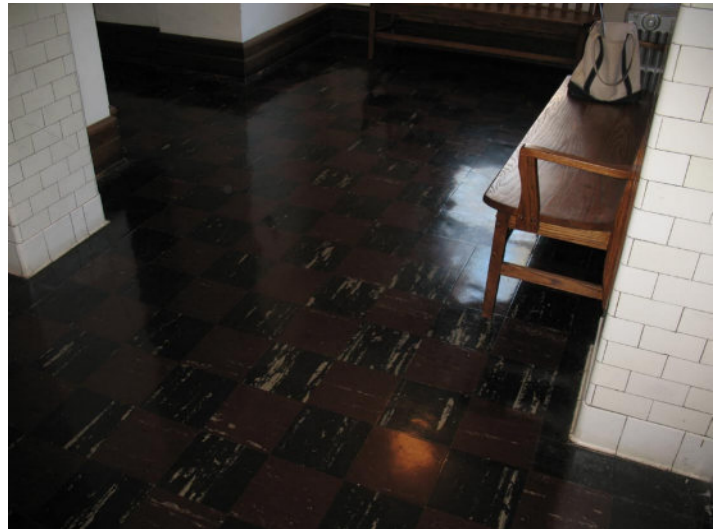
Exposed floor surfaces on the second floor are brown and black 9" by 9" vinyl asbestos tile (refer to the hazardous materials section of the report for asbestos content of these tiles). In general, the vinyl tile and carpeting are both worn and dated.

Typical vinyl asbestos tile used in second floor corridor.

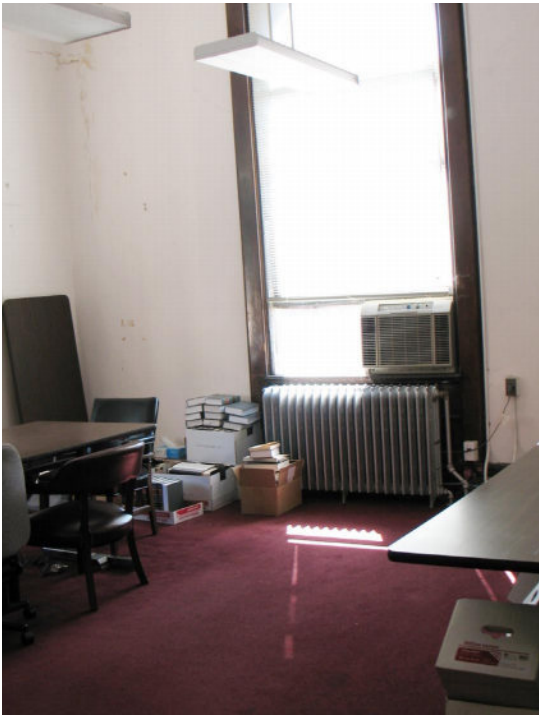
Based on limited investigations and information in the original plans, there appears to be a hardwood floor beneath these more modern floor finishes. The condition of this floor is unknown. The damage done to these wood floors may be limited if an underlayment was installed beneath the carpeting and tile layered on top of it.

Carpet has been installed over the original floors in several locations.

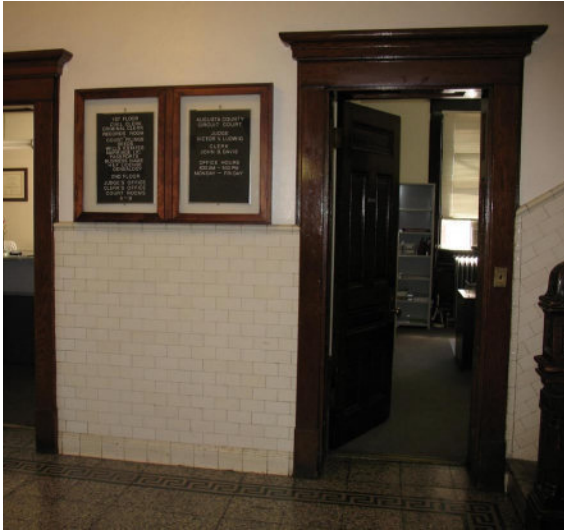
Historic door surround and tile wainscot in the first floor corridor.

The original hallway walls on both floors are clad in white 3" by 6" subway tile to a height of approximately 4'0", above which the walls are painted plaster. This tile wainscot is capped with a molded bullnose cap and has a molded base. While tiles show some crazing and minor chipping, they are in serviceable condition.

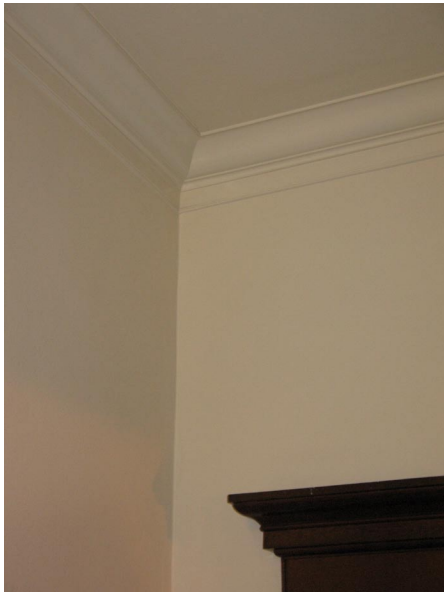
Detail of plaster crown molding in first floor corridor.

A significant painted plaster crown molding is found in the halls and in the former corridor that now bisects the large records room.

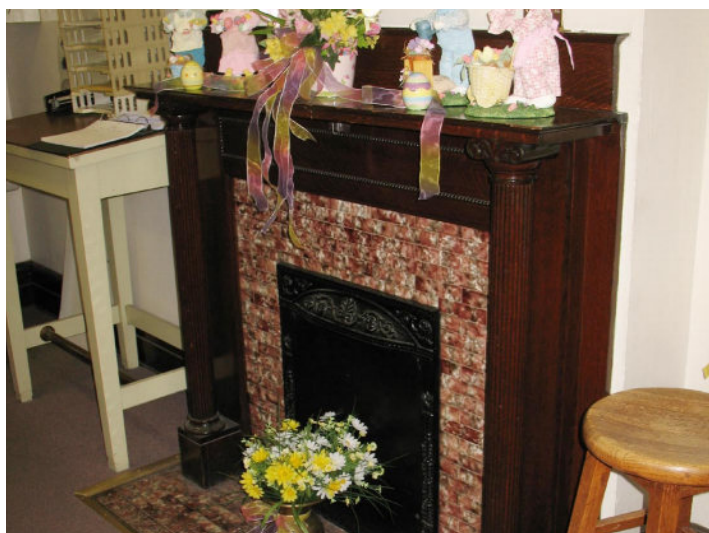
Original fireplace and hearth in first-floor office space.

The only surviving original fireplace is located in the front office on the east side of the first floor. The firebox contains a cast iron insert. The surround is clad in a mottled narrow rectangular tile in shades of brick red, brown, and white. This tile also clads the hearth. The mantelpiece is constructed of dark-stained oak to match other trim in the building. The mantel shelf is supported by Ionic ribbed columnettes which rest on simple boxed bases. The frieze under the shelf is simply adorned with a rope motif border.

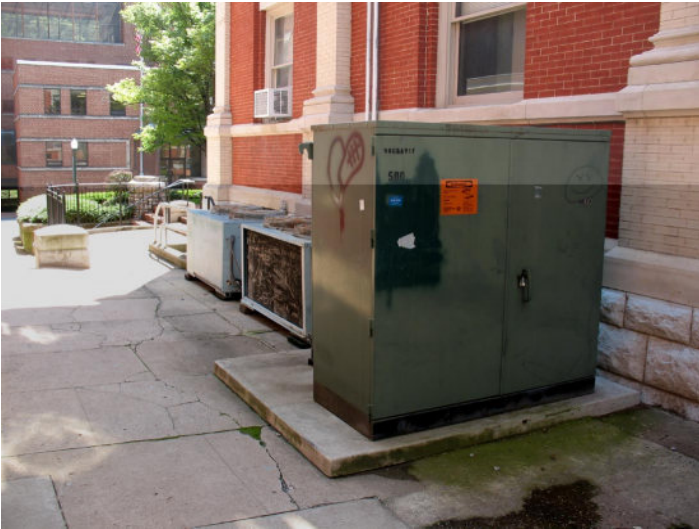
View of transformer and mechanical units on the east side of the building.

In general, the mechanical, electrical and plumbing systems for the building are antiquated, inadequate, and do not meet current standards for efficiency. Only the courtrooms have central air-conditioning with windows units used for the rest of the building. Any rehabilitation of the building would require replacement and upgrading of most or all of the building's mechanical, electrical and plumbing infrastructure.

- d. Remove damaged concrete sidewalks along east side of the building and replace with new unmortared brick paving. Provide new site drainage along this side and relocate HVAC equipment to flat roof of proposed addition (refer also to MEP report in Appendix).

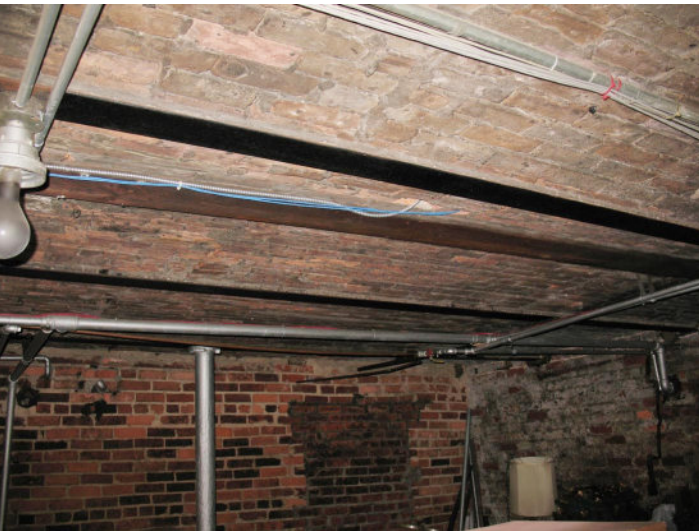
Much of the structure of the building was not visible or available for inspection for this report. In general, it appears to be in good condition with few cracks or signs of settlement evident. Some remedial work to the attic framing is recommended. Refer to the structural report in the appendix for more information.

View of first floor brick vault floor structure as seen in the basement.

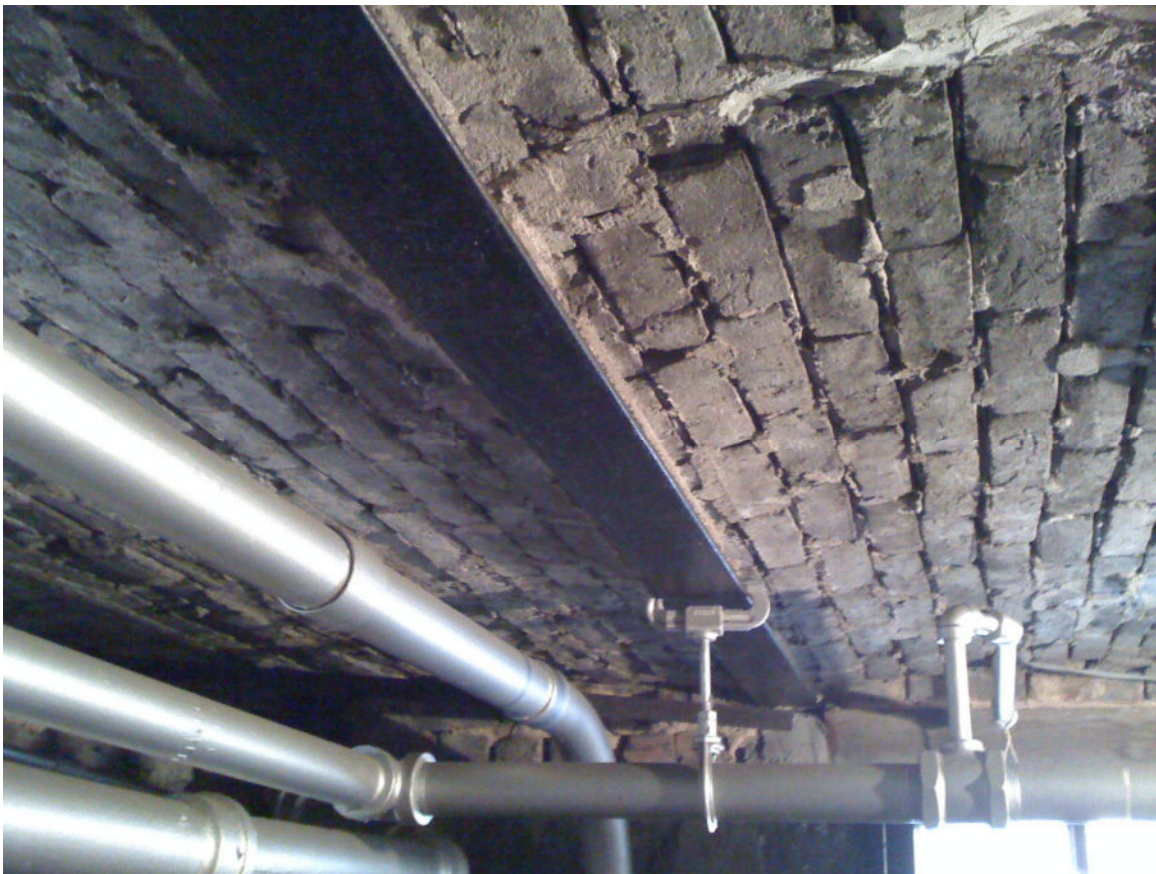
According to the existing structural drawings dated February, 1901, the primary floor structure of the building consists of 6-inch and 10-inch deep steel beams spaced at 4-foot 4-inches and 4-foot 9-inches on center which support a series of brick masonry arches. Two steel tie rods are used at 1/3 points along the length of the beams to provide lateral support to resist the thrust of the arches. Each beam line is supported by the interior and/or exterior loading bearing transverse masonry walls. Our building survey confirmed the information contained in the drawings at the visually accessible portions of the existing ceiling structure in the basement level of the building. See Photo #1.

**Photo #1: Existing beam and brick vault floor structure.**

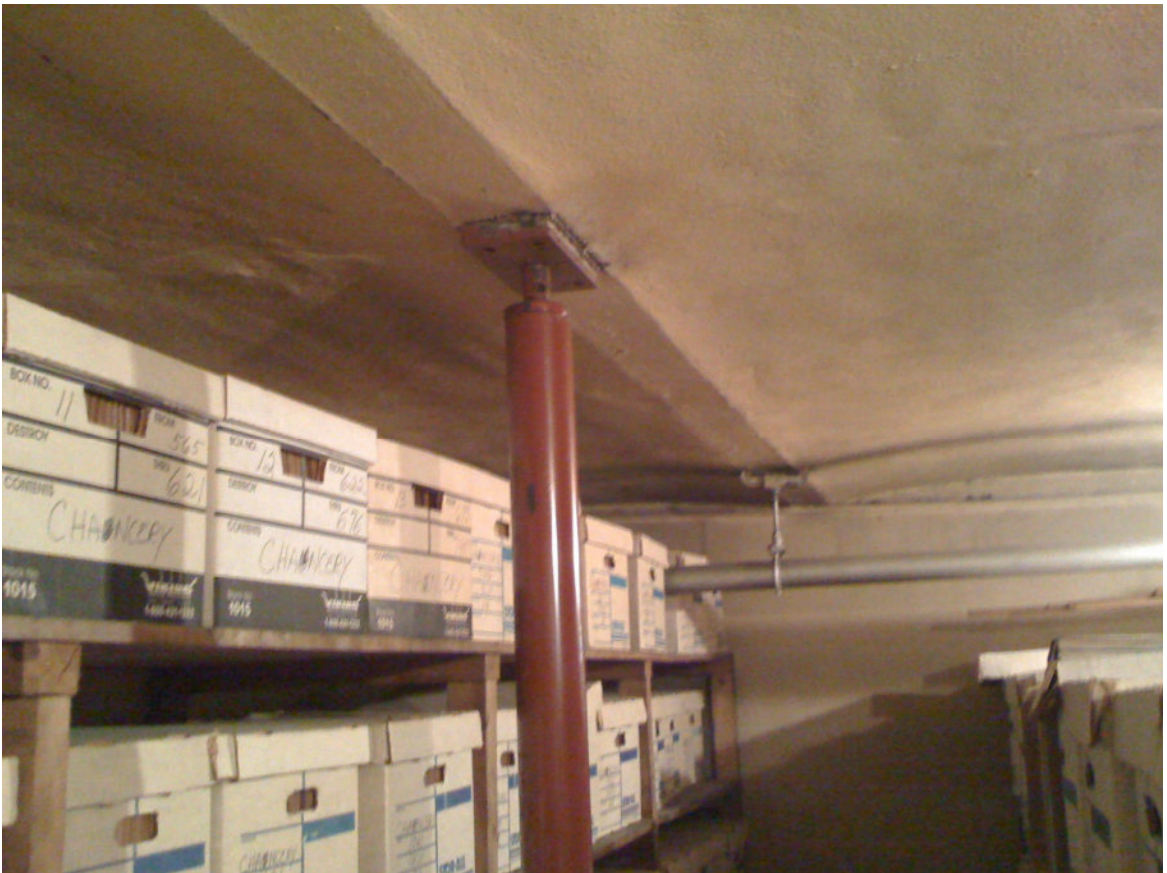
- Several of the existing floor beams where strengthening by the addition of new adjustable steel column shoring posts. It was observed at the floor above that the high density files were added on to the floor requiring the addition of the posts. See Photo #4. The additional support structure appears to be performing adequately.

**Photo #4: Adjustable steel column shoring post under steel beam supporting HD files above**

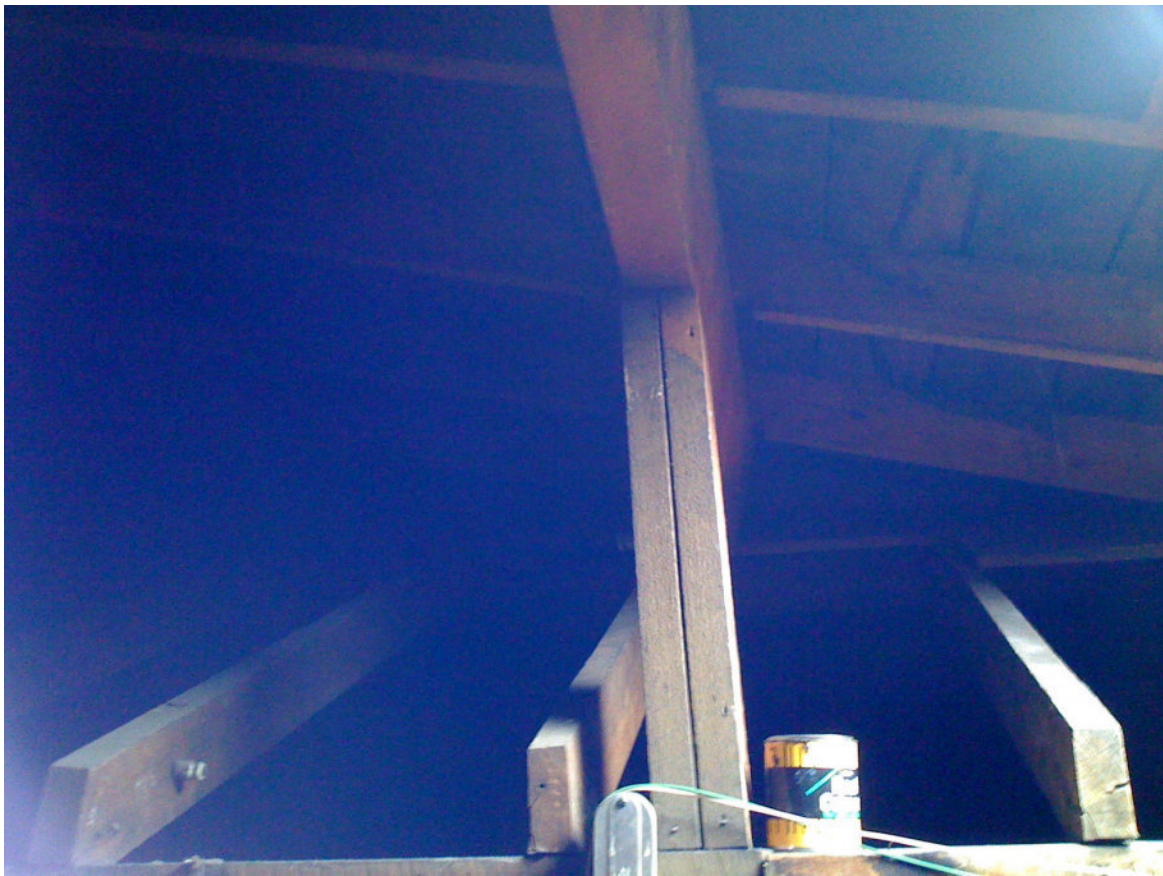
- During the inspection of the attic area, it was observed that several of the wood purlin beams have twisted to the extent that the bearing length of the rafters has been reduced. The location of the rafter notch is no longer located where the rafters meet the top of the beam. See Photo #5. Diagonal braces have been added at other purlin beam locations to mitigate the twisting and warping that is occurring at these beam locations.

**Photo #5: Twisted attic beam rotated away from ends of rafters**

- The two existing chimneys above the roof level of the building need to be repointed with a lime based repair mortar. All loose bricks need be reset securely within the face of the chimney.
- The existing hardscape surrounding the perimeter of the building should be removed and replaced in its entirety. The existing sub-soil should be re-compacted to prevent future additional settlement.
- The existing exterior wall crack below the 2<sup>nd</sup> floor window should be filled with an appropriate lime-base repair mortar.
- Lateral wood bracing members should be added in the attic structure to securely brace all of the existing purlin beams. The existing rotated purlin beams should be reset to provide full bearing support to the existing roof rafters.

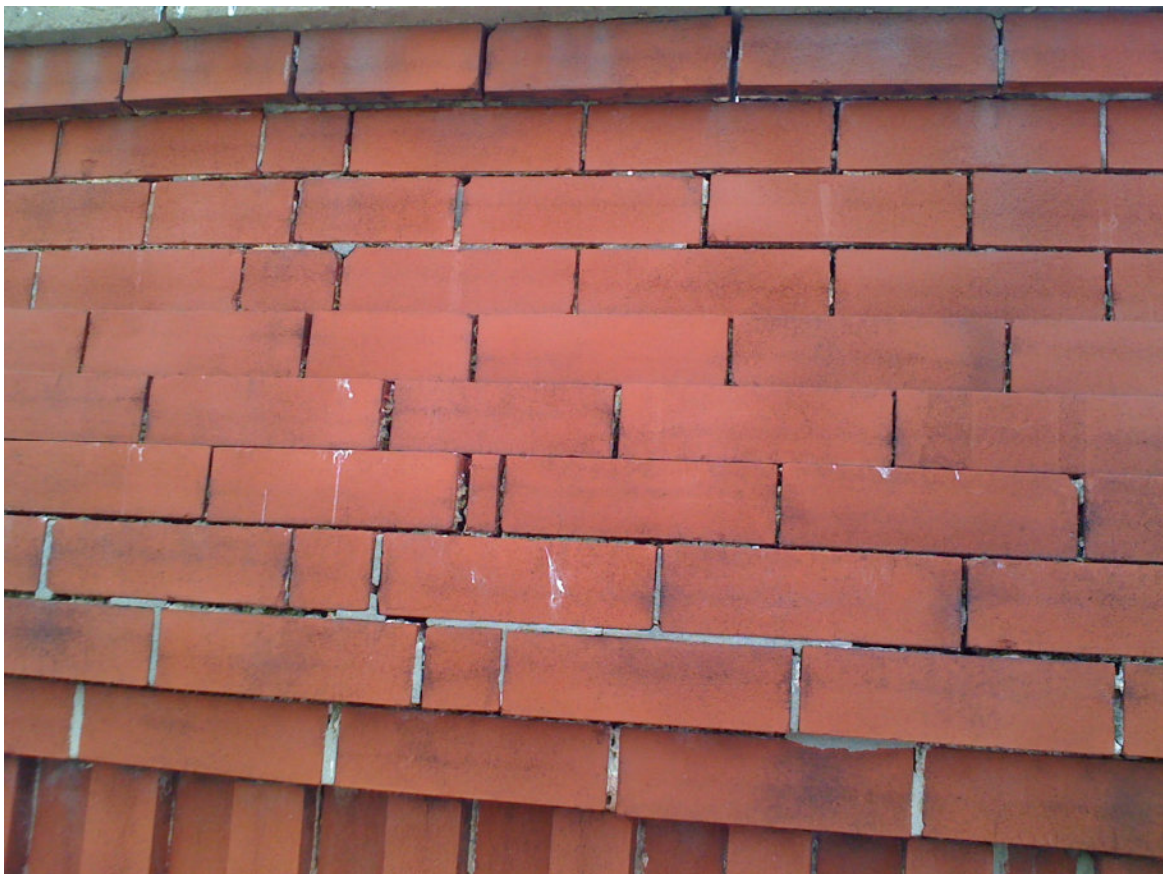
- Repointing is needed at the top of both of the chimneys. See Photo #6. At one location on the face of one of the chimneys loose bricks have partially displaced slightly from the face of the chimney. See Photo #7.

**Photo #6: Open mortar joints at top of chimney**
