# Augusta County Courthouse

Feasibility Study  
Vol. I

October, 2012

**FRAZIER ASSOCIATES**  
ARCHITECTURE ■ URBAN PLANNING ■ WAYFINDING

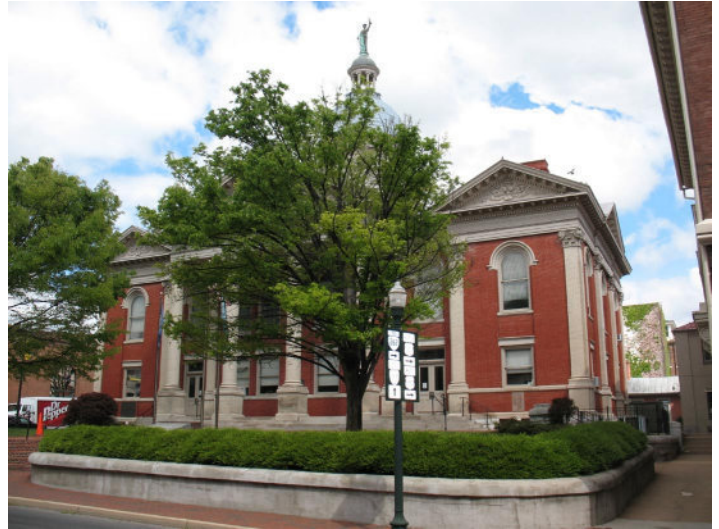
View of courthouse from E. Johnson Street showing sidewalk and retaining wall.

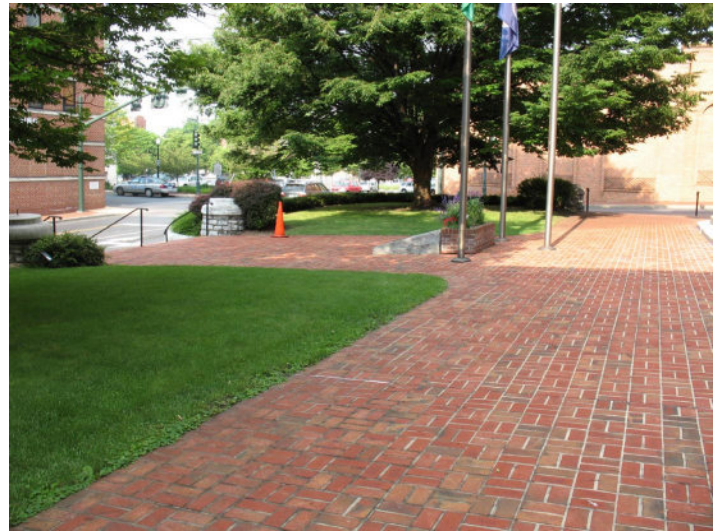
The mortared brick paving of the plaza is laid in a basket-weave pattern. Its condition varies with one section heaving up near the steps leading to the sidewalk. Flood lights located at the top of the steps illuminate the front facade.

Brick plaza in front of building.

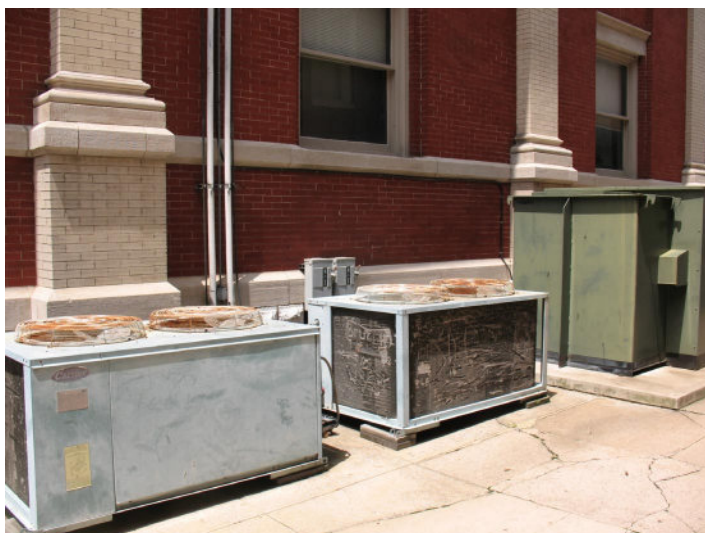
There are poured concrete pads on either side of the 1939 addition at the rear of the building. These pads are currently used as a location for HVAC equipment. Unsightly exposed refrigerant piping serving this equipment is mounted on the exterior walls of the building. Given the limited space available on site, the location of the HVAC equipment is understandable, but future plans to upgrade the HVAC systems should include efforts to find

Mechanical units and transformer located on the east side of the building.

a better location that does not detract from the pedestrian experience around the building. The concrete sidewalks on this side of the building are severely deteriorated.

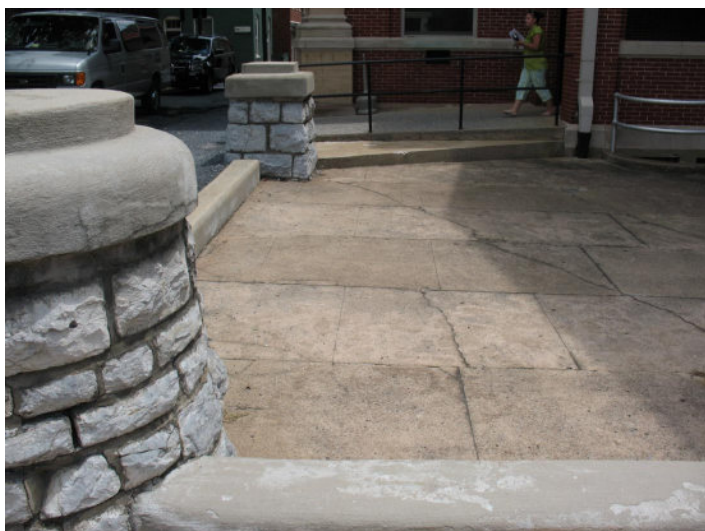
Limestone piers and concrete plaza at the northeast corner of the building.

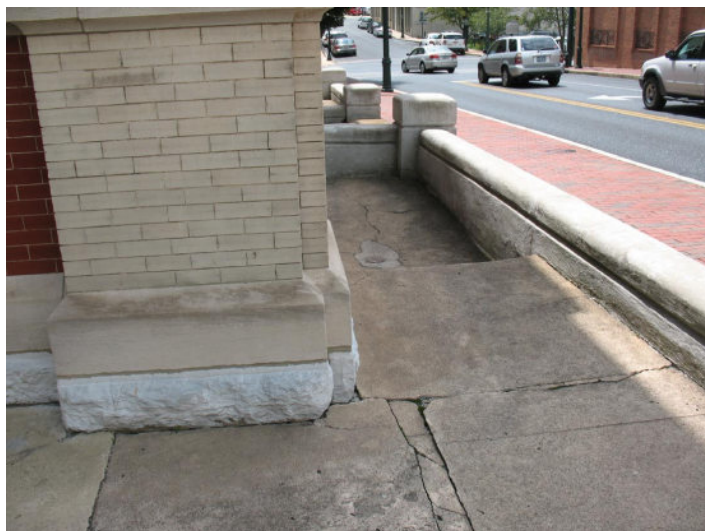
Low site walls along Augusta Street.

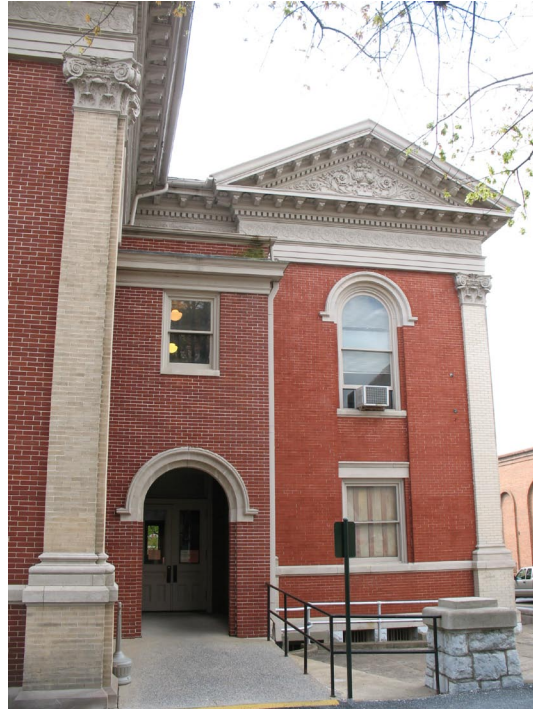
The existing concrete handicap ramp leads from Barristers Row Alley to the northwestern entrance to the courthouse.

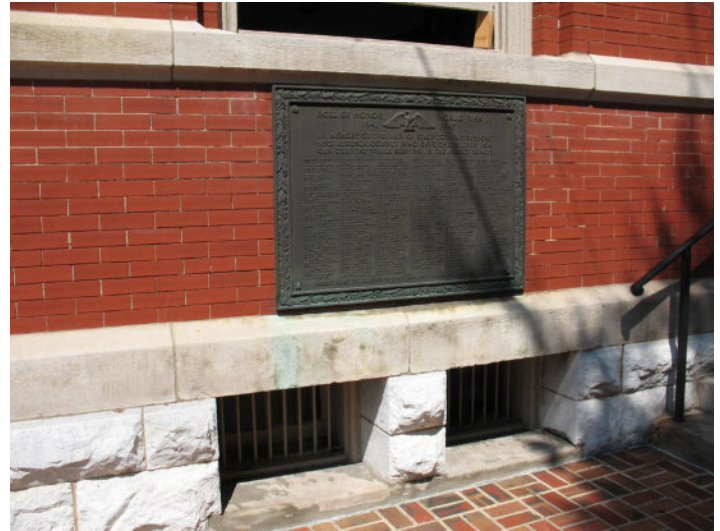
Below grade level (as taken from the rear of the building), the foundation of the building is coursed ashlar limestone with a rusticated surface where visible to the exterior and more random/rubble coursing as viewed from the boiler room in the basement of the building. This may indicate the reuse of stone and or walls from the 1835 courthouse formerly on the site. The exposed limestone foundation is capped by a cast stone sill upon which the red pressed-brick raised foundation rests. This portion of the foundation is in turn capped by a smaller cast stone belt course that bisects and forms a cap for the yellow brick piers upon which the pilasters rest. The foundation is generally in good condition.

View of rusticated native limestone foundation and dressed Indiana limestone water table.

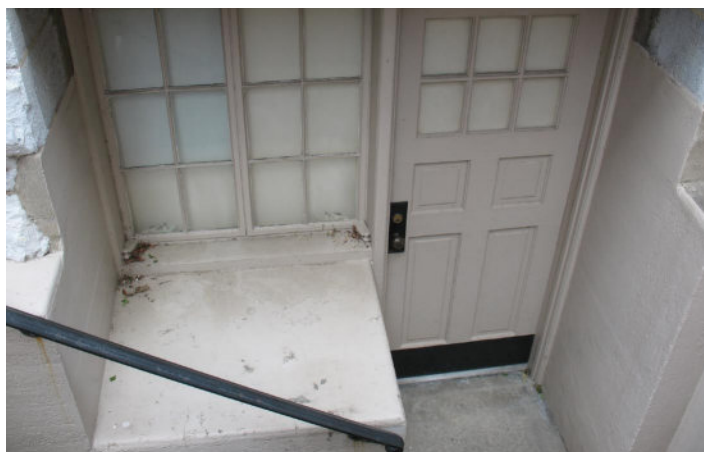
A basement entrance is located at the south end of the east elevation of the building. The partially glazed (frosted) door in this opening has six small panes of glass over four recessed panels in a typical Colonial Revival style arrangement consistent with the 1939 remodeling. At that time, this opening was apparently converted from a window to a door. This door and adjacent window have been boarded over on the interior, apparently for security purposes. Similar basement entrances on the north elevation traditionally provided access to public toilets. The stairs are in good condition but will need to have their drains periodically maintained to prevent flooding of the building.

Detail view of exterior stair to basement on the east side of the building.

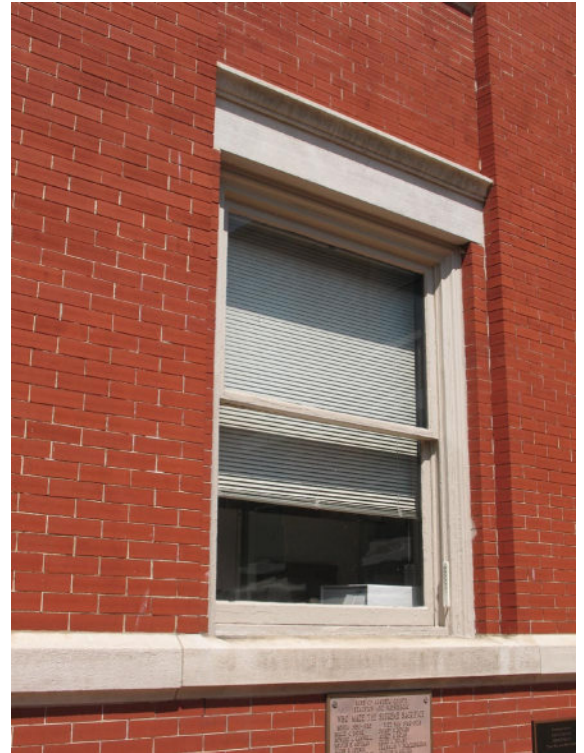
While the windows are typically in good to fair condition, they will need periodic maintenance. The single pane construction of the windows makes them candidates for improved weatherization including storm windows. Current courthouse guidelines recommend security windows and bulletproof glass in several areas and this should be considered as part of any future renovations.

Detail of original first floor window.

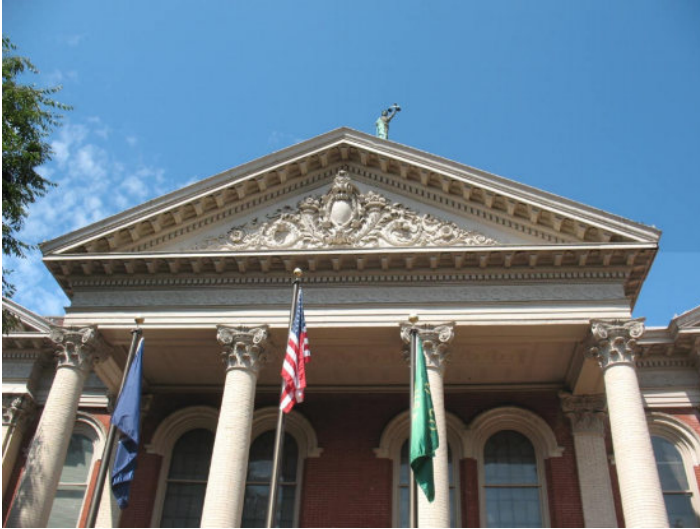
Photo of pediment above front portico showing decorative sheet metal cornices.

This decorative sheet metal entablature is showing signs of deterioration with rust at gaps that are opening up. Missing floral details were observed between the modillion blocks in some locations. There is what appears to be a wood cornice, in fair condition, on the flat roof sections of the rear addition.

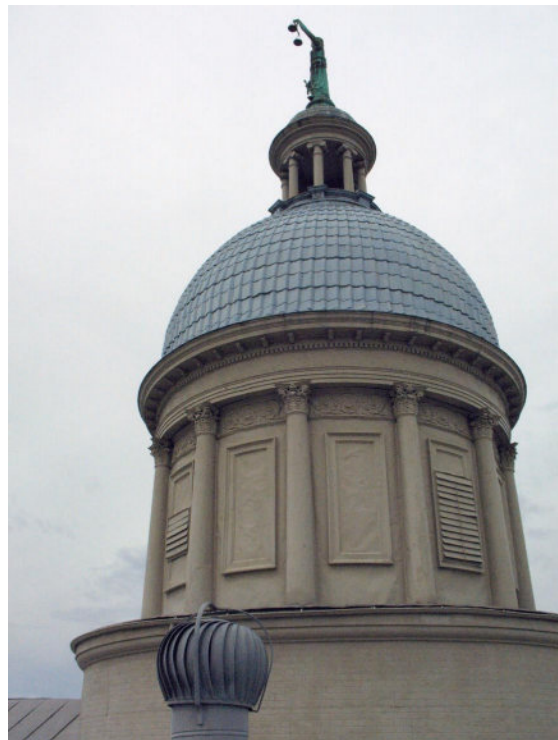
The cupola's lower dome has a ribbed metal shingle roof, which, like the main roof, is painted gray/silver. No leaks are reported from this roof, but given its age, it should be a candidate for replacement as part of any major rehabilitation. Atop the main dome is a secondary dome with copper shingles that rests on Ionic columns and is capped by a bronze statue of Justice, draped and holding scales and a sword. Almost the entire surface of the statue is covered with the typical pale green products of corrosion. Deterioration of this important feature will continue without conservation efforts.

View of cupola showing decorative sheet metal work, ribbed metal shingle roof and bronze statue.

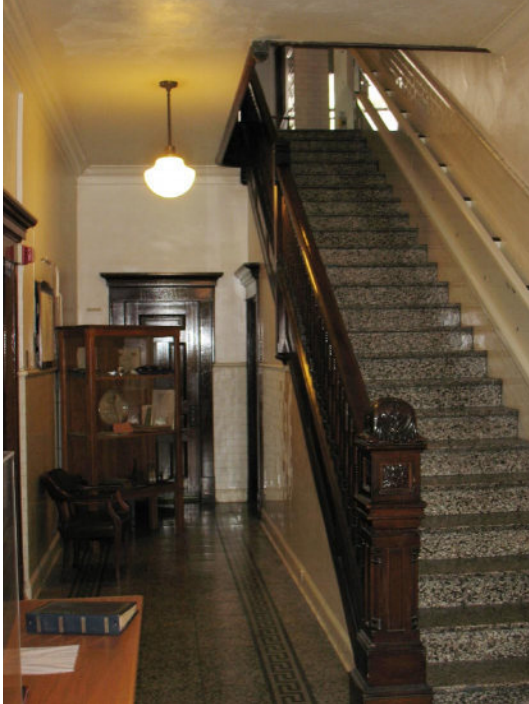
Original stairway in the east corridor of the first floor.

The identical staircases in each cross-axial hall feature turned balusters and elaborately carved newel posts. The treads and risers are clad in the same terrazzo as the hall floors. Earlier damage to the terrazzo treads have been patched with a material that doesn't match but which appears to be holding up.

The condition of the stairway materials is good to fair with some damage and wear and tear evident. These conditions should be addressed as part of any comprehensive rehabilitation of the building.

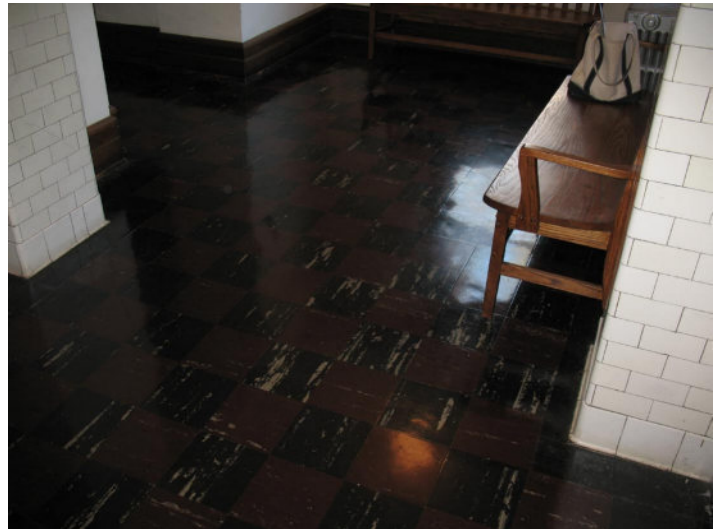
Exposed floor surfaces on the second floor are brown and black 9" by 9" vinyl asbestos tile (refer to the hazardous materials section of the report for asbestos content of these tiles). In general, the vinyl tile and carpeting are both worn and dated.

Typical vinyl asbestos tile used in second floor corridor.

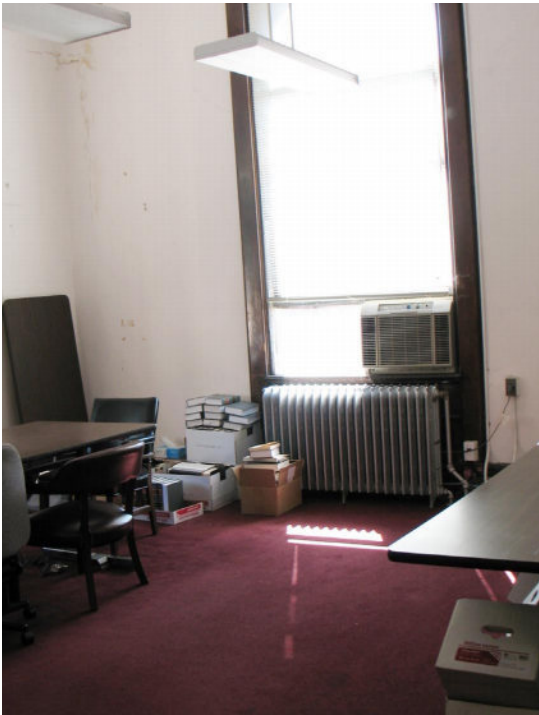
Based on limited investigations and information in the original plans, there appears to be a hardwood floor beneath these more modern floor finishes. The condition of this floor is unknown. The damage done to these wood floors may be limited if an underlayment was installed beneath the carpeting and tile layered on top of it.

Carpet has been installed over the original floors in several locations.

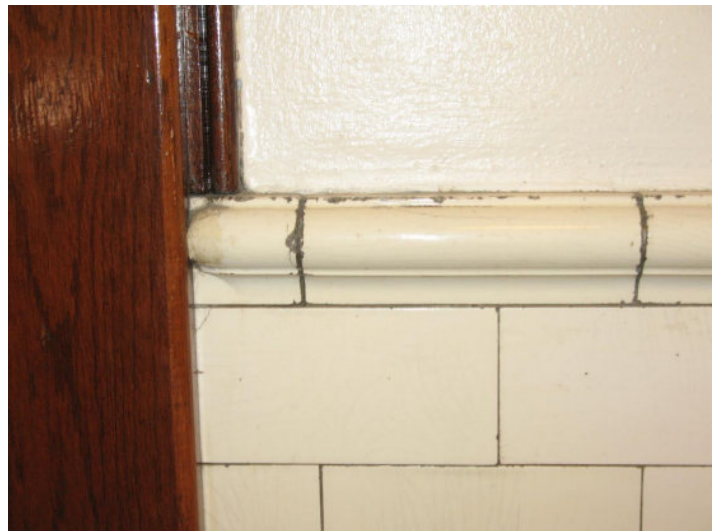
The original hallway walls on both floors are clad in white 3" by 6" subway tile to a height of approximately 4'0", above which the walls are painted plaster. This tile wainscot is capped with a molded bullnose cap and has a molded base. While tiles show some crazing and minor chipping, they are in serviceable condition.

Given that many of the original partitions remain in their original locations, it may be assumed that they retain much of their original plaster finish which remains in serviceable condition. Many of the later partitions are assumed to be gypsum board. In general, the plaster is in good condition with only minor damage evident.

Detail of plaster, ceramic tile wainscot and wood trim in first floor corridor.

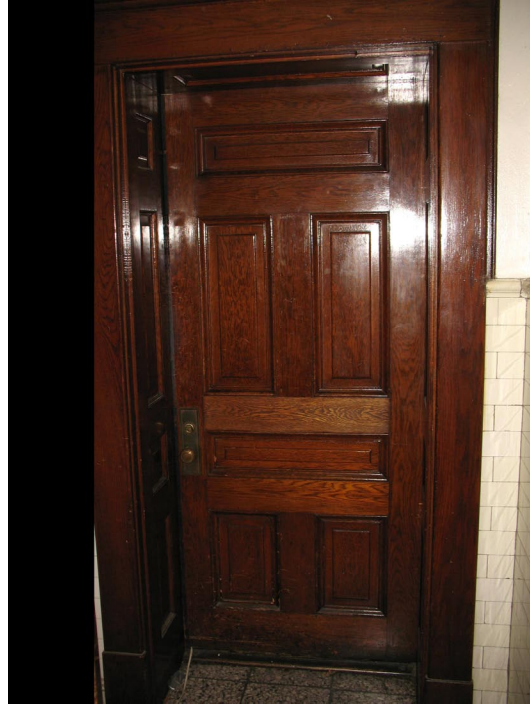
Original oak doors throughout the building are of a six-panel design, many with a three-light transom above. While showing dents and scratches accumulated over time, these character-defining features are in serviceable condition. The doors into the large records room are fully glazed double-doors.

Original door showing typical 6-panel configuration of raised panels.

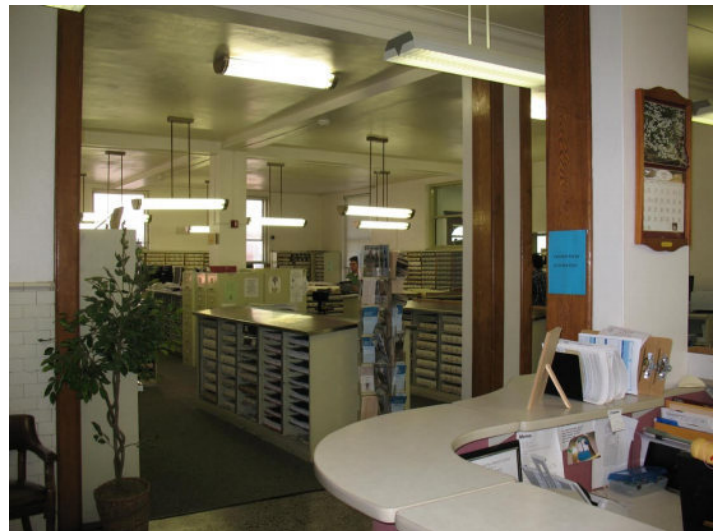
Much of the first floor is lighted with suspended fluorescent fixtures with exposed tubes that probably dates to the mid- to late-twentieth century. Various other fixtures are seen in the building, including more contemporary surface-mounted fluorescent fixtures.

Suspended fluorescent fixtures in the Deed Room.

Given their age, any historic fixtures that are retained, would need to be refurbished as part of a building rehabilitation.

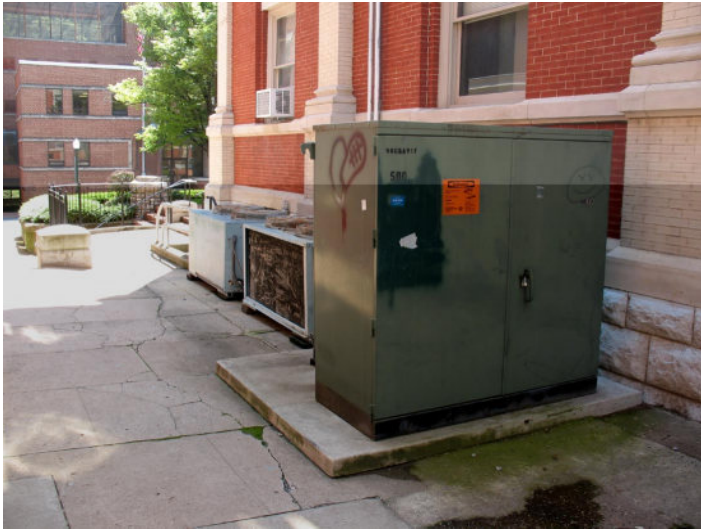
View of transformer and mechanical units on the east side of the building.

- d. Remove damaged concrete sidewalks along east side of the building and replace with new unmortared brick paving. Provide new site drainage along this side and relocate HVAC equipment to flat roof of proposed addition (refer also to MEP report in Appendix).

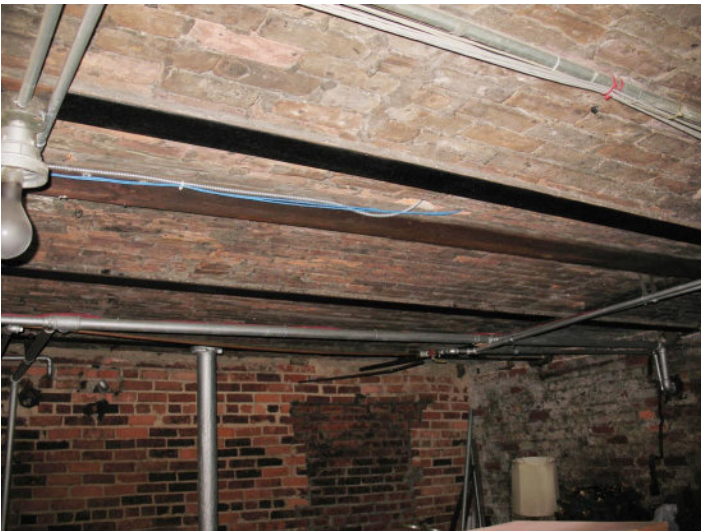
Much of the structure of the building was not visible or available for inspection for this report. In general, it appears to be in good condition with few cracks or signs of settlement evident. Some remedial work to the attic framing is recommended. Refer to the structural report in the appendix for more information.

View of first floor brick vault floor structure as seen in the basement.

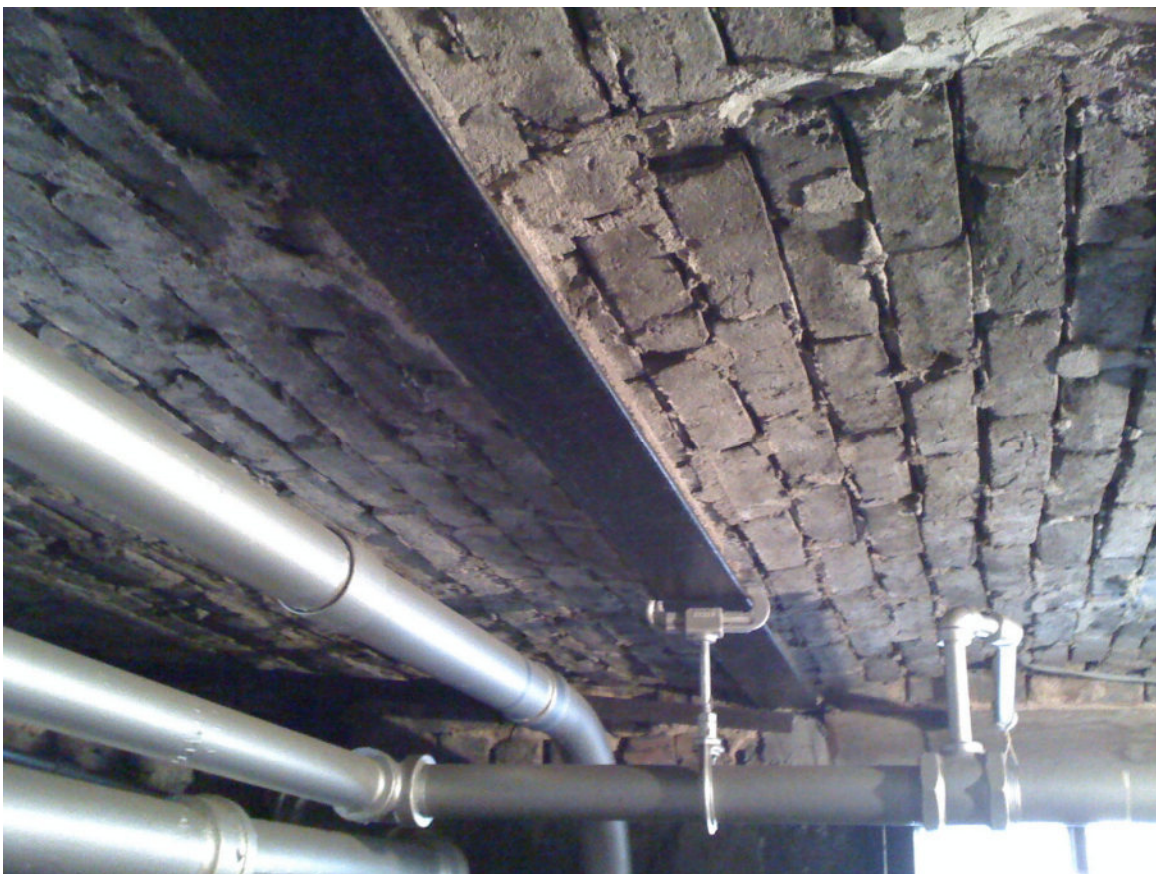
According to the existing structural drawings dated February, 1901, the primary floor structure of the building consists of 6-inch and 10-inch deep steel beams spaced at 4-foot 4-inches and 4-foot 9-inches on center which support a series of brick masonry arches. Two steel tie rods are used at 1/3 points along the length of the beams to provide lateral support to resist the thrust of the arches. Each beam line is supported by the interior and/or exterior loading bearing transverse masonry walls. Our building survey confirmed the information contained in the drawings at the visually accessible portions of the existing ceiling structure in the basement level of the building. See Photo #1.

**Photo #1: Existing beam and brick vault floor structure.**

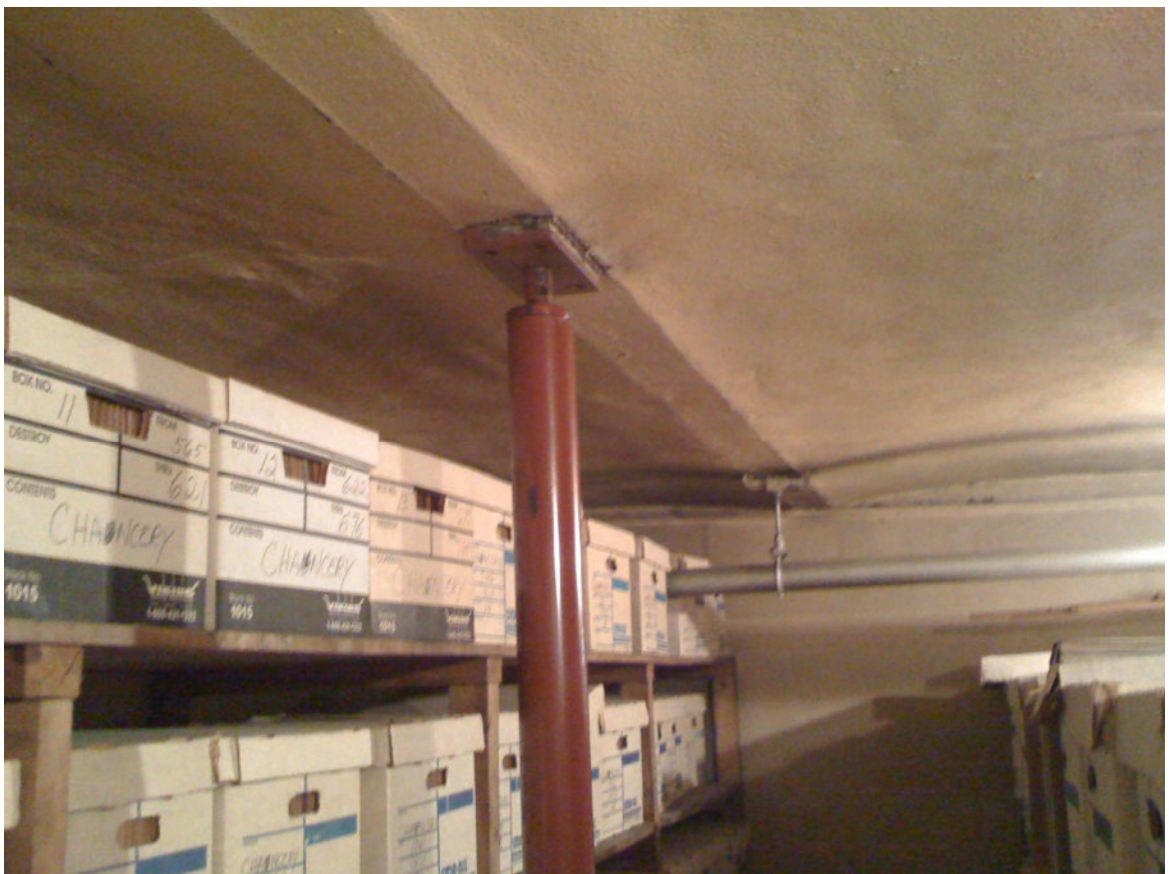
- Several of the existing floor beams where strengthening by the addition of new adjustable steel column shoring posts. It was observed at the floor above that the high density files were added on to the floor requiring the addition of the posts. See Photo #4. The additional support structure appears to be performing adequately.

**Photo #4: Adjustable steel column shoring post under steel beam supporting HD files above**

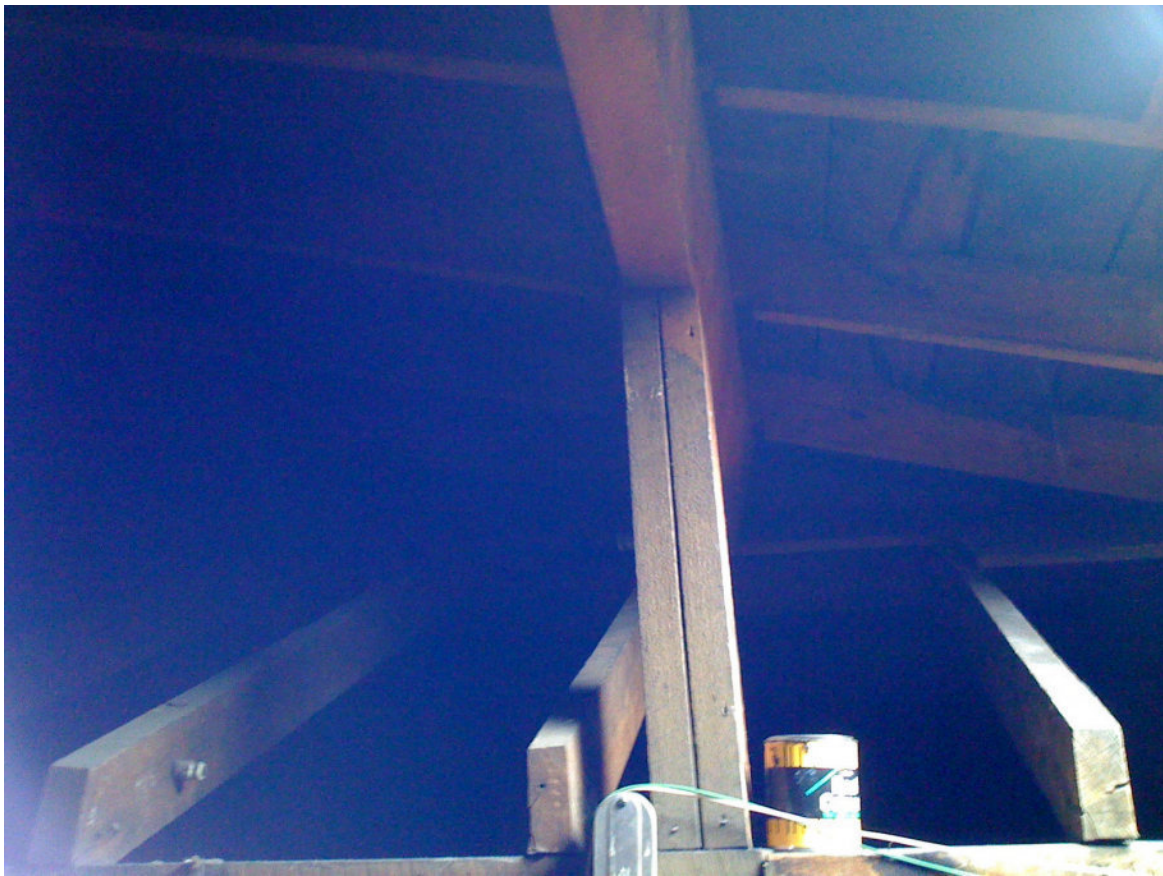
- During the inspection of the attic area, it was observed that several of the wood purlin beams have twisted to the extent that the bearing length of the rafters has been reduced. The location of the rafter notch is no longer located where the rafters meet the top of the beam. See Photo #5. Diagonal braces have been added at other purlin beam locations to mitigate the twisting and warping that is occurring at these beam locations.

**Photo #5: Twisted attic beam rotated away from ends of rafters**

- The two existing chimneys above the roof level of the building need to be repointed with a lime based repair mortar. All loose bricks need be reset securely within the face of the chimney.
- The existing hardscape surrounding the perimeter of the building should be removed and replaced in its entirety. The existing sub-soil should be re-compacted to prevent future additional settlement.
- The existing exterior wall crack below the 2<sup>nd</sup> floor window should be filled with an appropriate lime-base repair mortar.
- Lateral wood bracing members should be added in the attic structure to securely brace all of the existing purlin beams. The existing rotated purlin beams should be reset to provide full bearing support to the existing roof rafters.

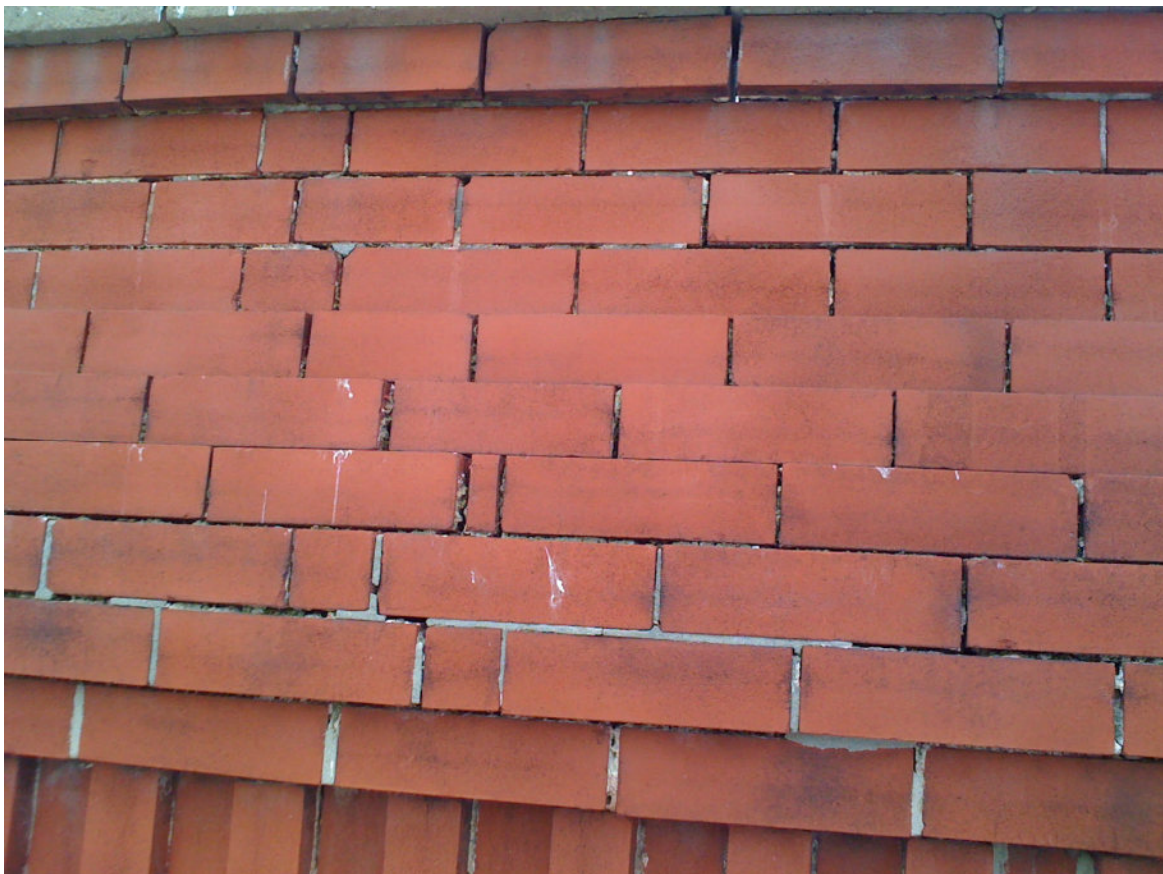
- Repointing is needed at the top of both of the chimneys. See Photo #6. At one location on the face of one of the chimneys loose bricks have partially displaced slightly from the face of the chimney. See Photo #7.

**Photo #6: Open mortar joints at top of chimney**
