**Phase I Environmental Site Assessment  
of the  
Western State Hospital  
Staunton, Virginia**

Prepared for  
City of Staunton, Virginia

Wiley|Wilson Comm. No. 209161.00

August 31, 2009

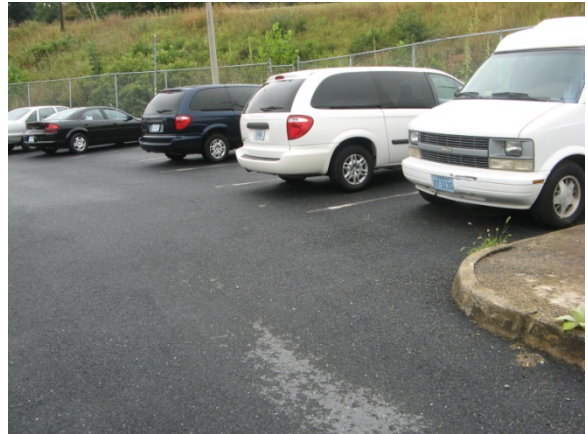
Location of USTs at Physical Plant Services/Materials Management Building

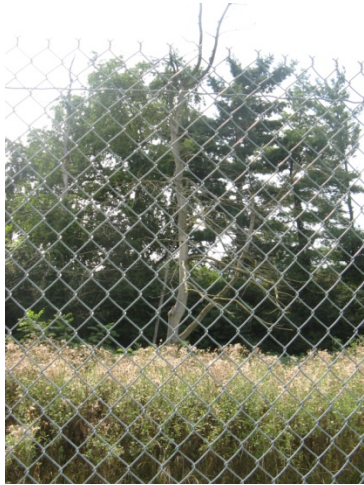
Stressed  
Vegetation at  
Western Property  
Line

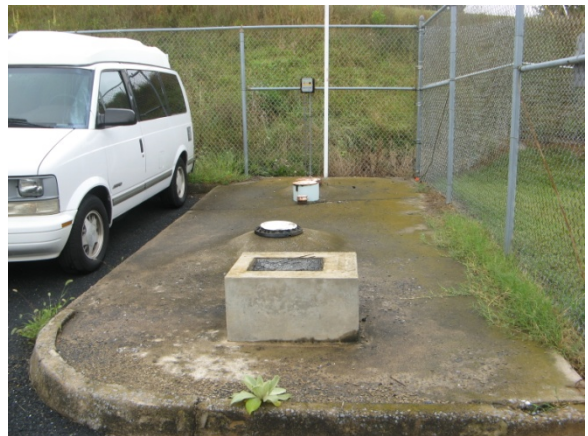
Fill Ports for USTs at Physical Plant Services/Materials Management Building

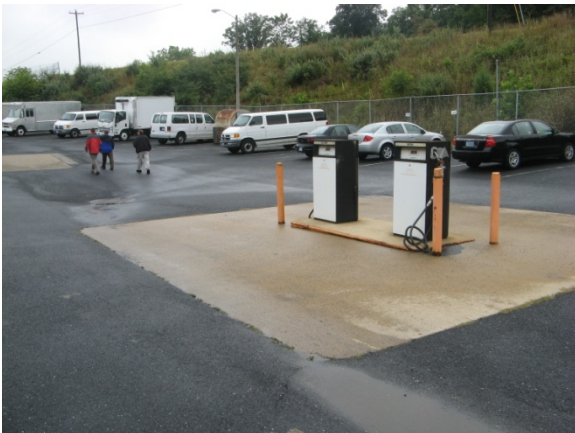
Fuel Pumps at Physical Plant Services/Materials Management Building

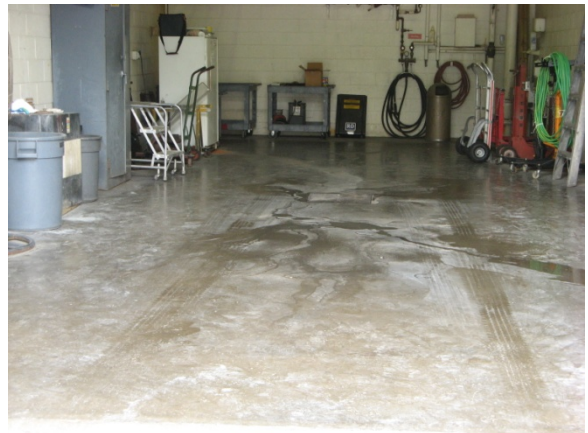
Service Bay at Physical Plant Services/Materials Management Building

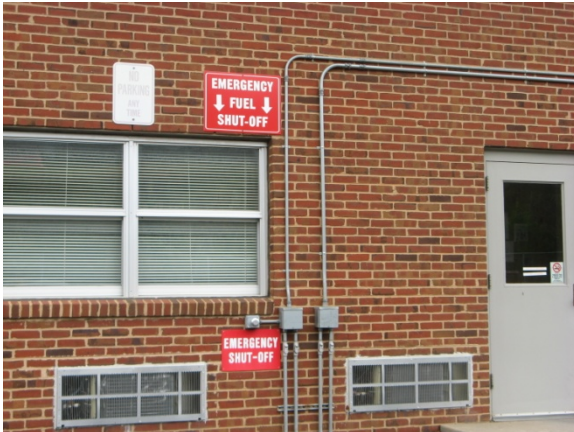
Emergency Fuel Shutoff at Physical Plant Services/Materials Management Building

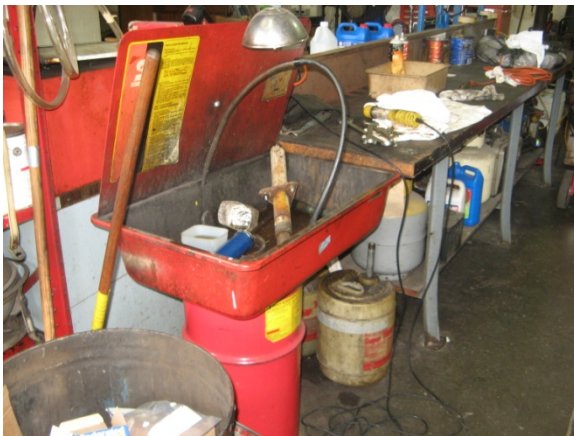
Parts Wash Station in Physical Plant Services/Materials Management Building

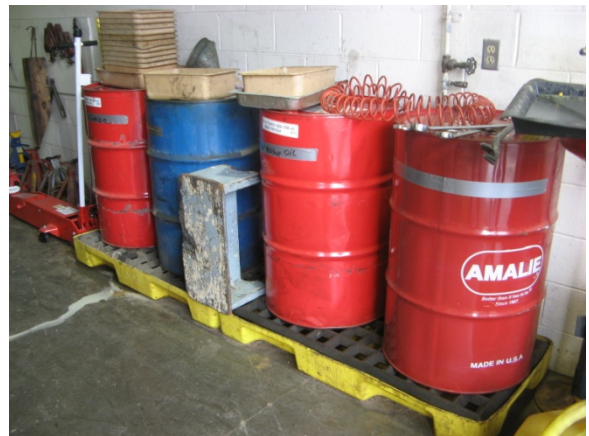
Waste Fluid Containers in Physical Plant Services/Materials Management Building

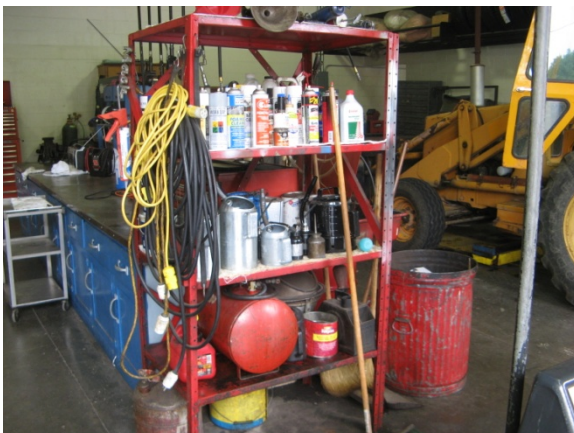
Maintenance Fluid Storage in Physical Plant Services/Materials Management Building

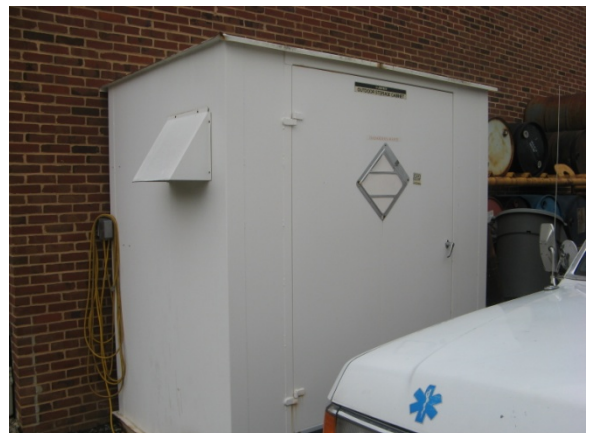
Maintenance Fluid Storage Outside of Physical Plant Services/Materials Management Building

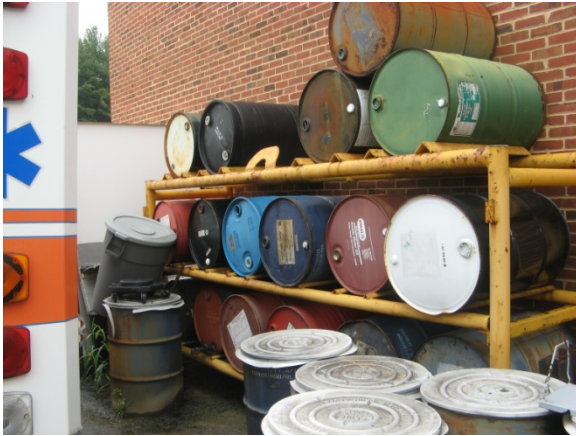
Empty Waste Fluid Containers Outside of Physical Plant Services/Materials Management Building

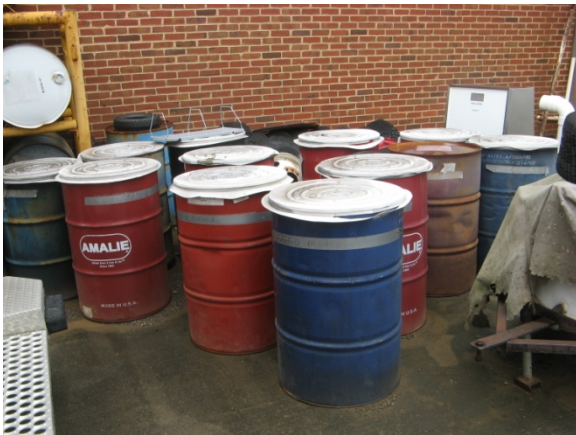
Waste Fluid Containers Outside of Physical Plant Services/Materials Management Building

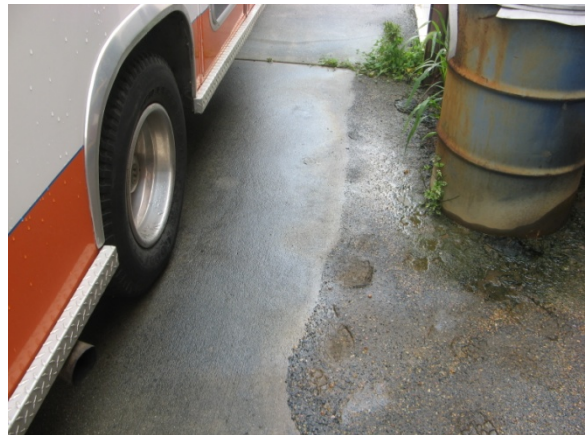
Oily Sheen on Asphalt at Waste Fluid Storage Outside of Physical Plant Services/Materials Management Building

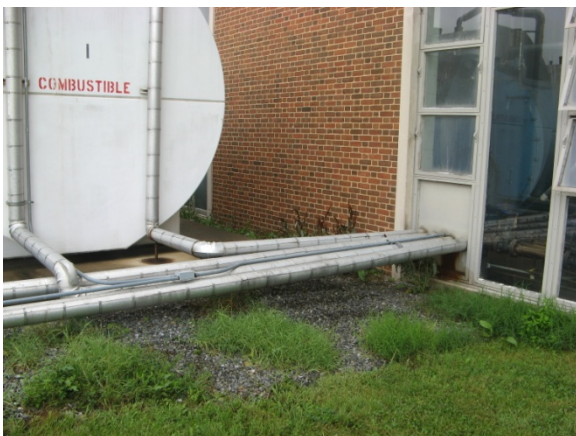
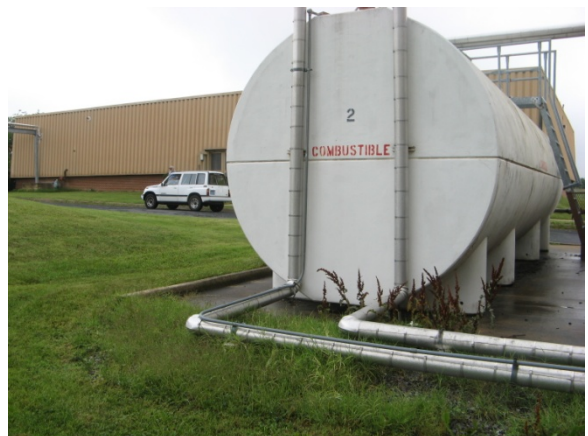
Fuel Feed into Power Plant

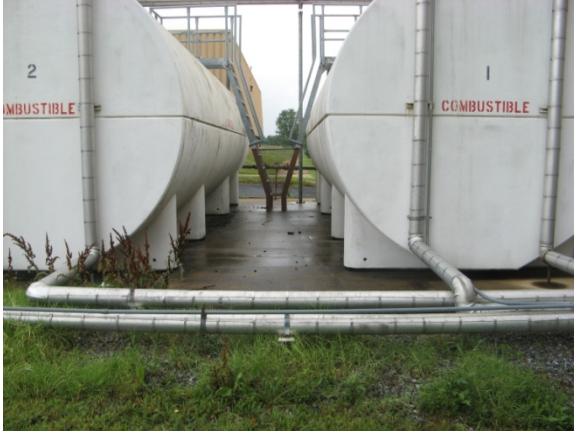
ASTs at Power Plant

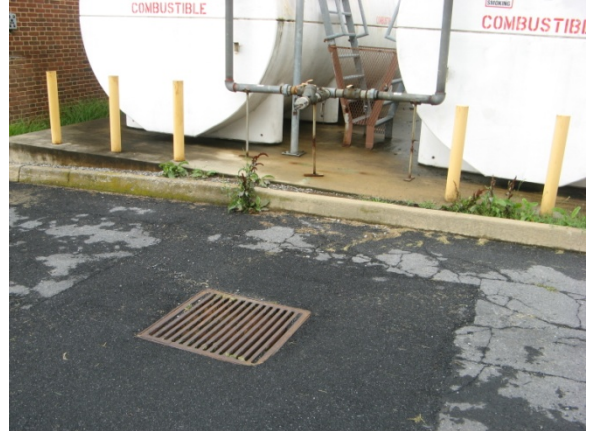
Fill Port of ASTs at Power Plant

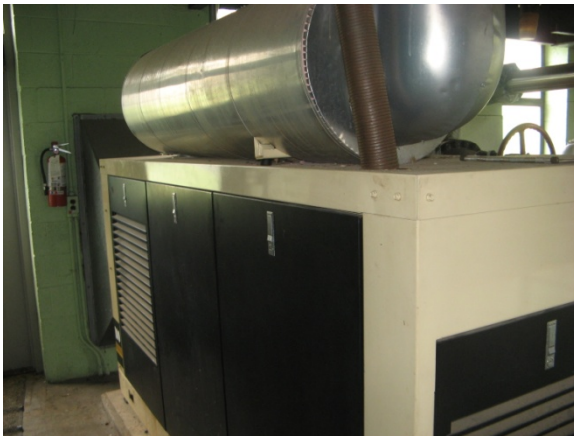
Standby Generator in Power Plant

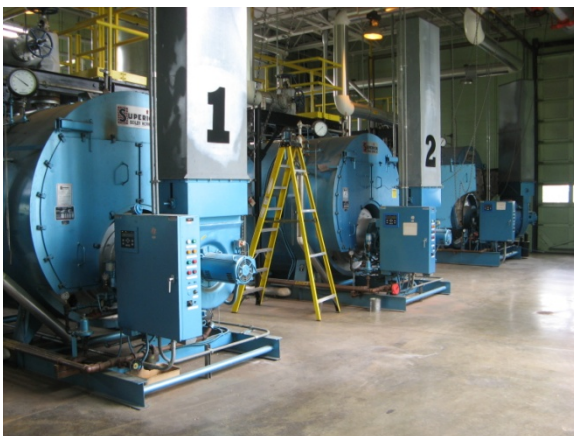
Boilers in Power Plant

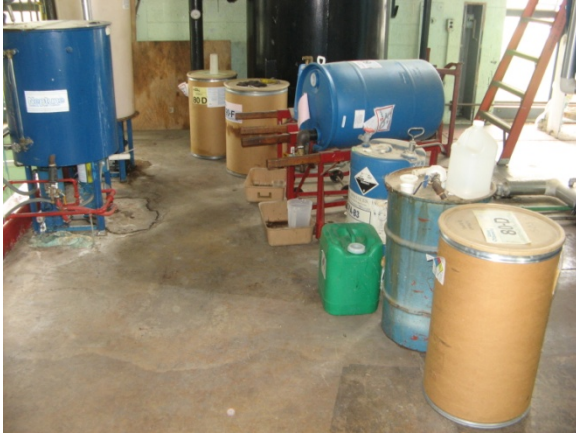
Water Treatment Chemicals in Power Plant

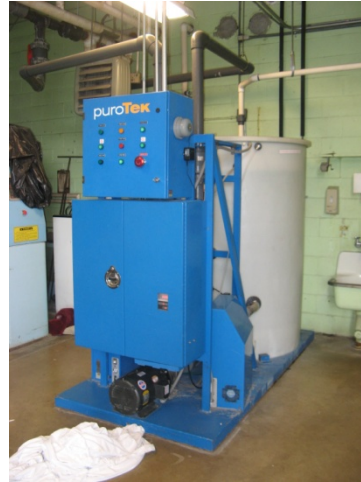
Water Treatment System in Laundry

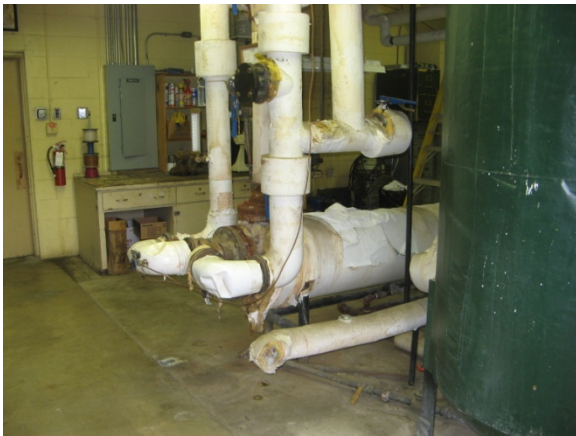
Piping in Laundry

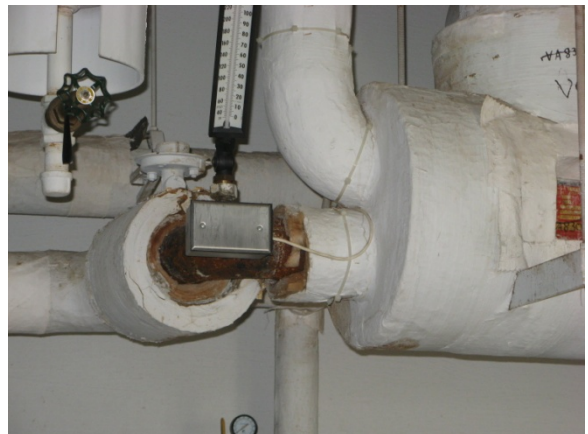
Pipe Insulation in Physical Plant Services/Materials  
Management Building

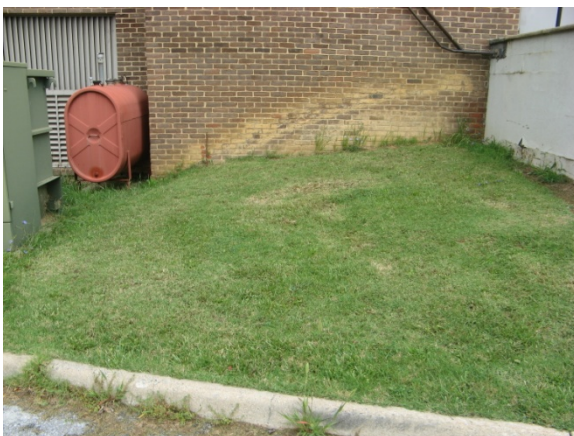
Location of Former UST at Building 127

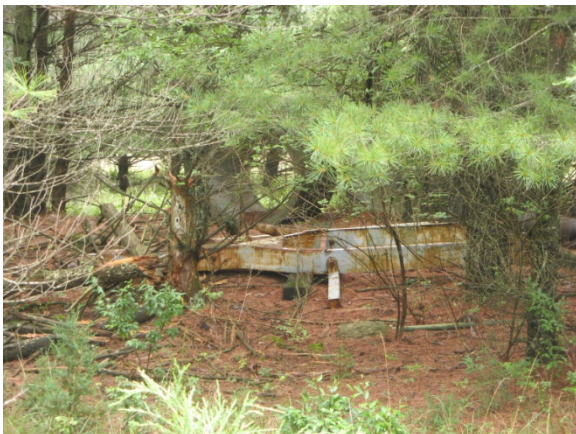
Metal Debris on Ridge North of WWTP Site

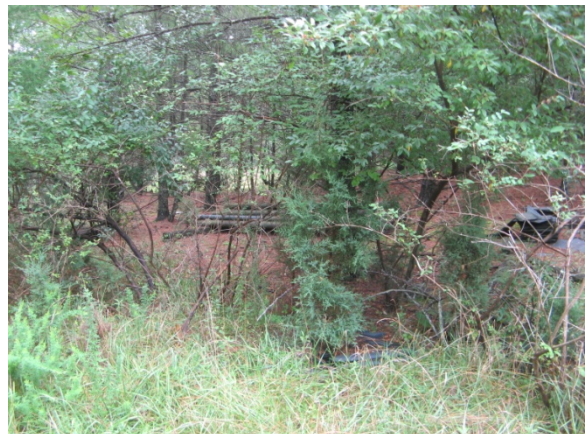
Wood Debris on Ridge North of WWTP Site

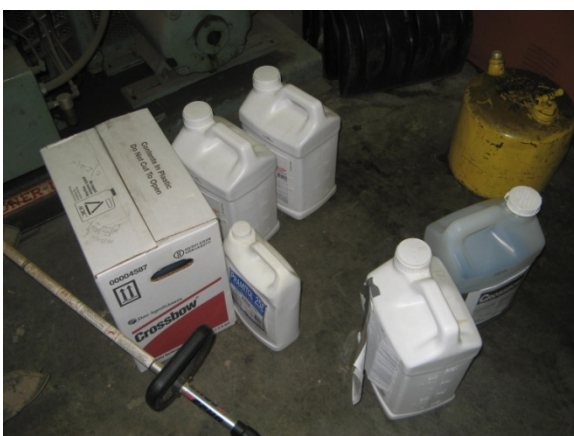
Herbicides in Physical Plant Services/Materials Management Building Landscaping Shop

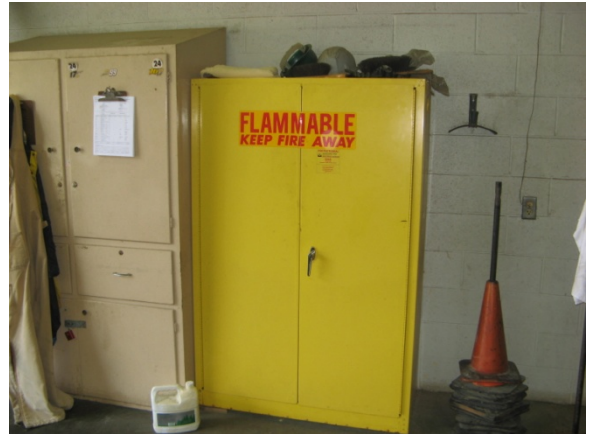
Flammable Liquid Storage in Physical Plant  
Services/Materials Management Building

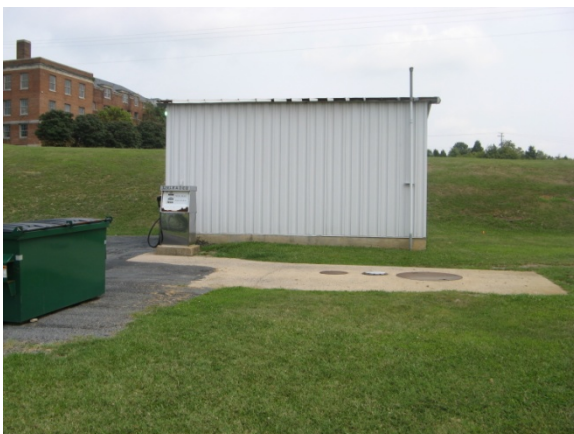
UST at State Police Fueling Station

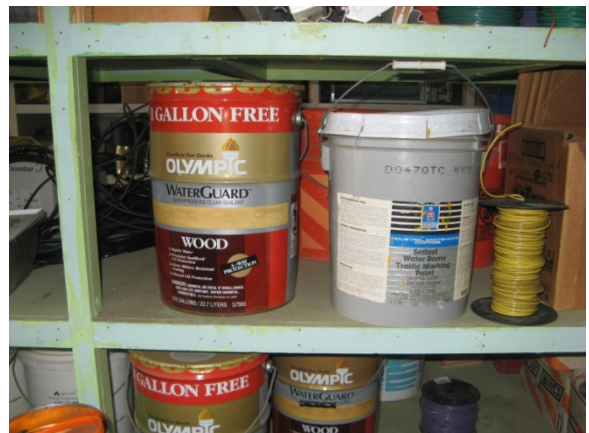
Paint and Sealants in Wood Shop of Physical Plant  
Services/Materials Management Building

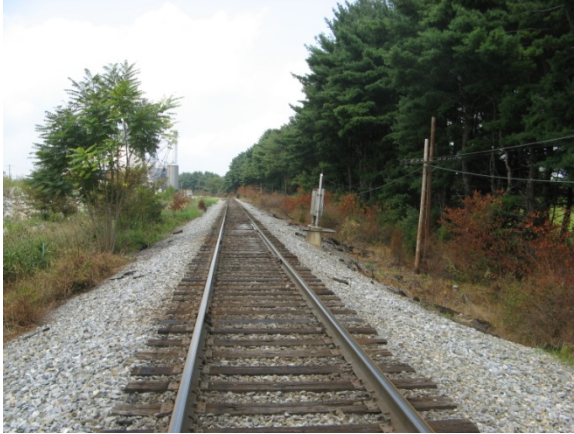
CSX Railroad Along Southwestern Boundary

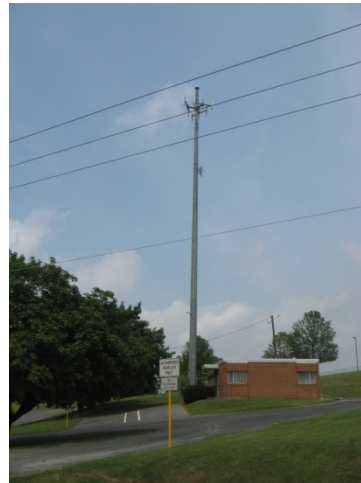
Call Tower at  
State Police  
Refueling Station

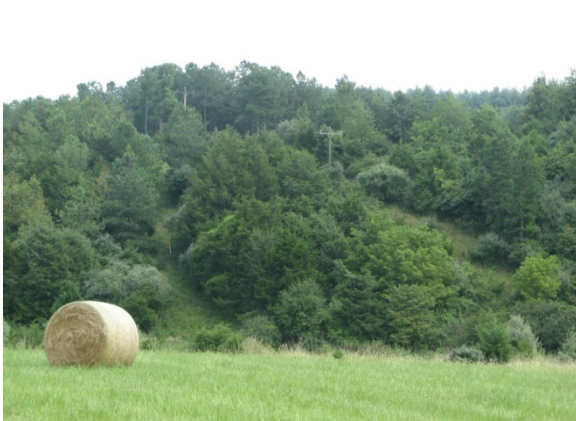
Gas Line and Power Line in Northeast Portion of Site

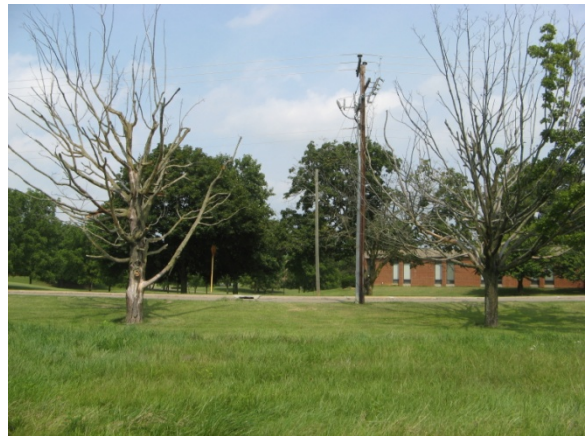
Dying Maples at Entrance Road Near Building 124
