RE: Gypsy Hill Park Stream Restoration – Conceptual Design Submittal

Timmons Group is pleased to submit the conceptual design package for the Gypsy Hill Park Stream Restoration Project along Peyton Branch. We have included the conceptual layout, cost estimate, drainage area map, typical stream structure photographs and an existing tree inventory, along with a report detailing the anticipated nutrient removal based on Chesapeake Bay TMDL Special Conditions Guidance for urban stream restoration.

# CITY OF STAUNTON GYPSY HILL PARK PEYTON BRANCH STREAM RESTORATION BANCS ASSESSMENT MAP

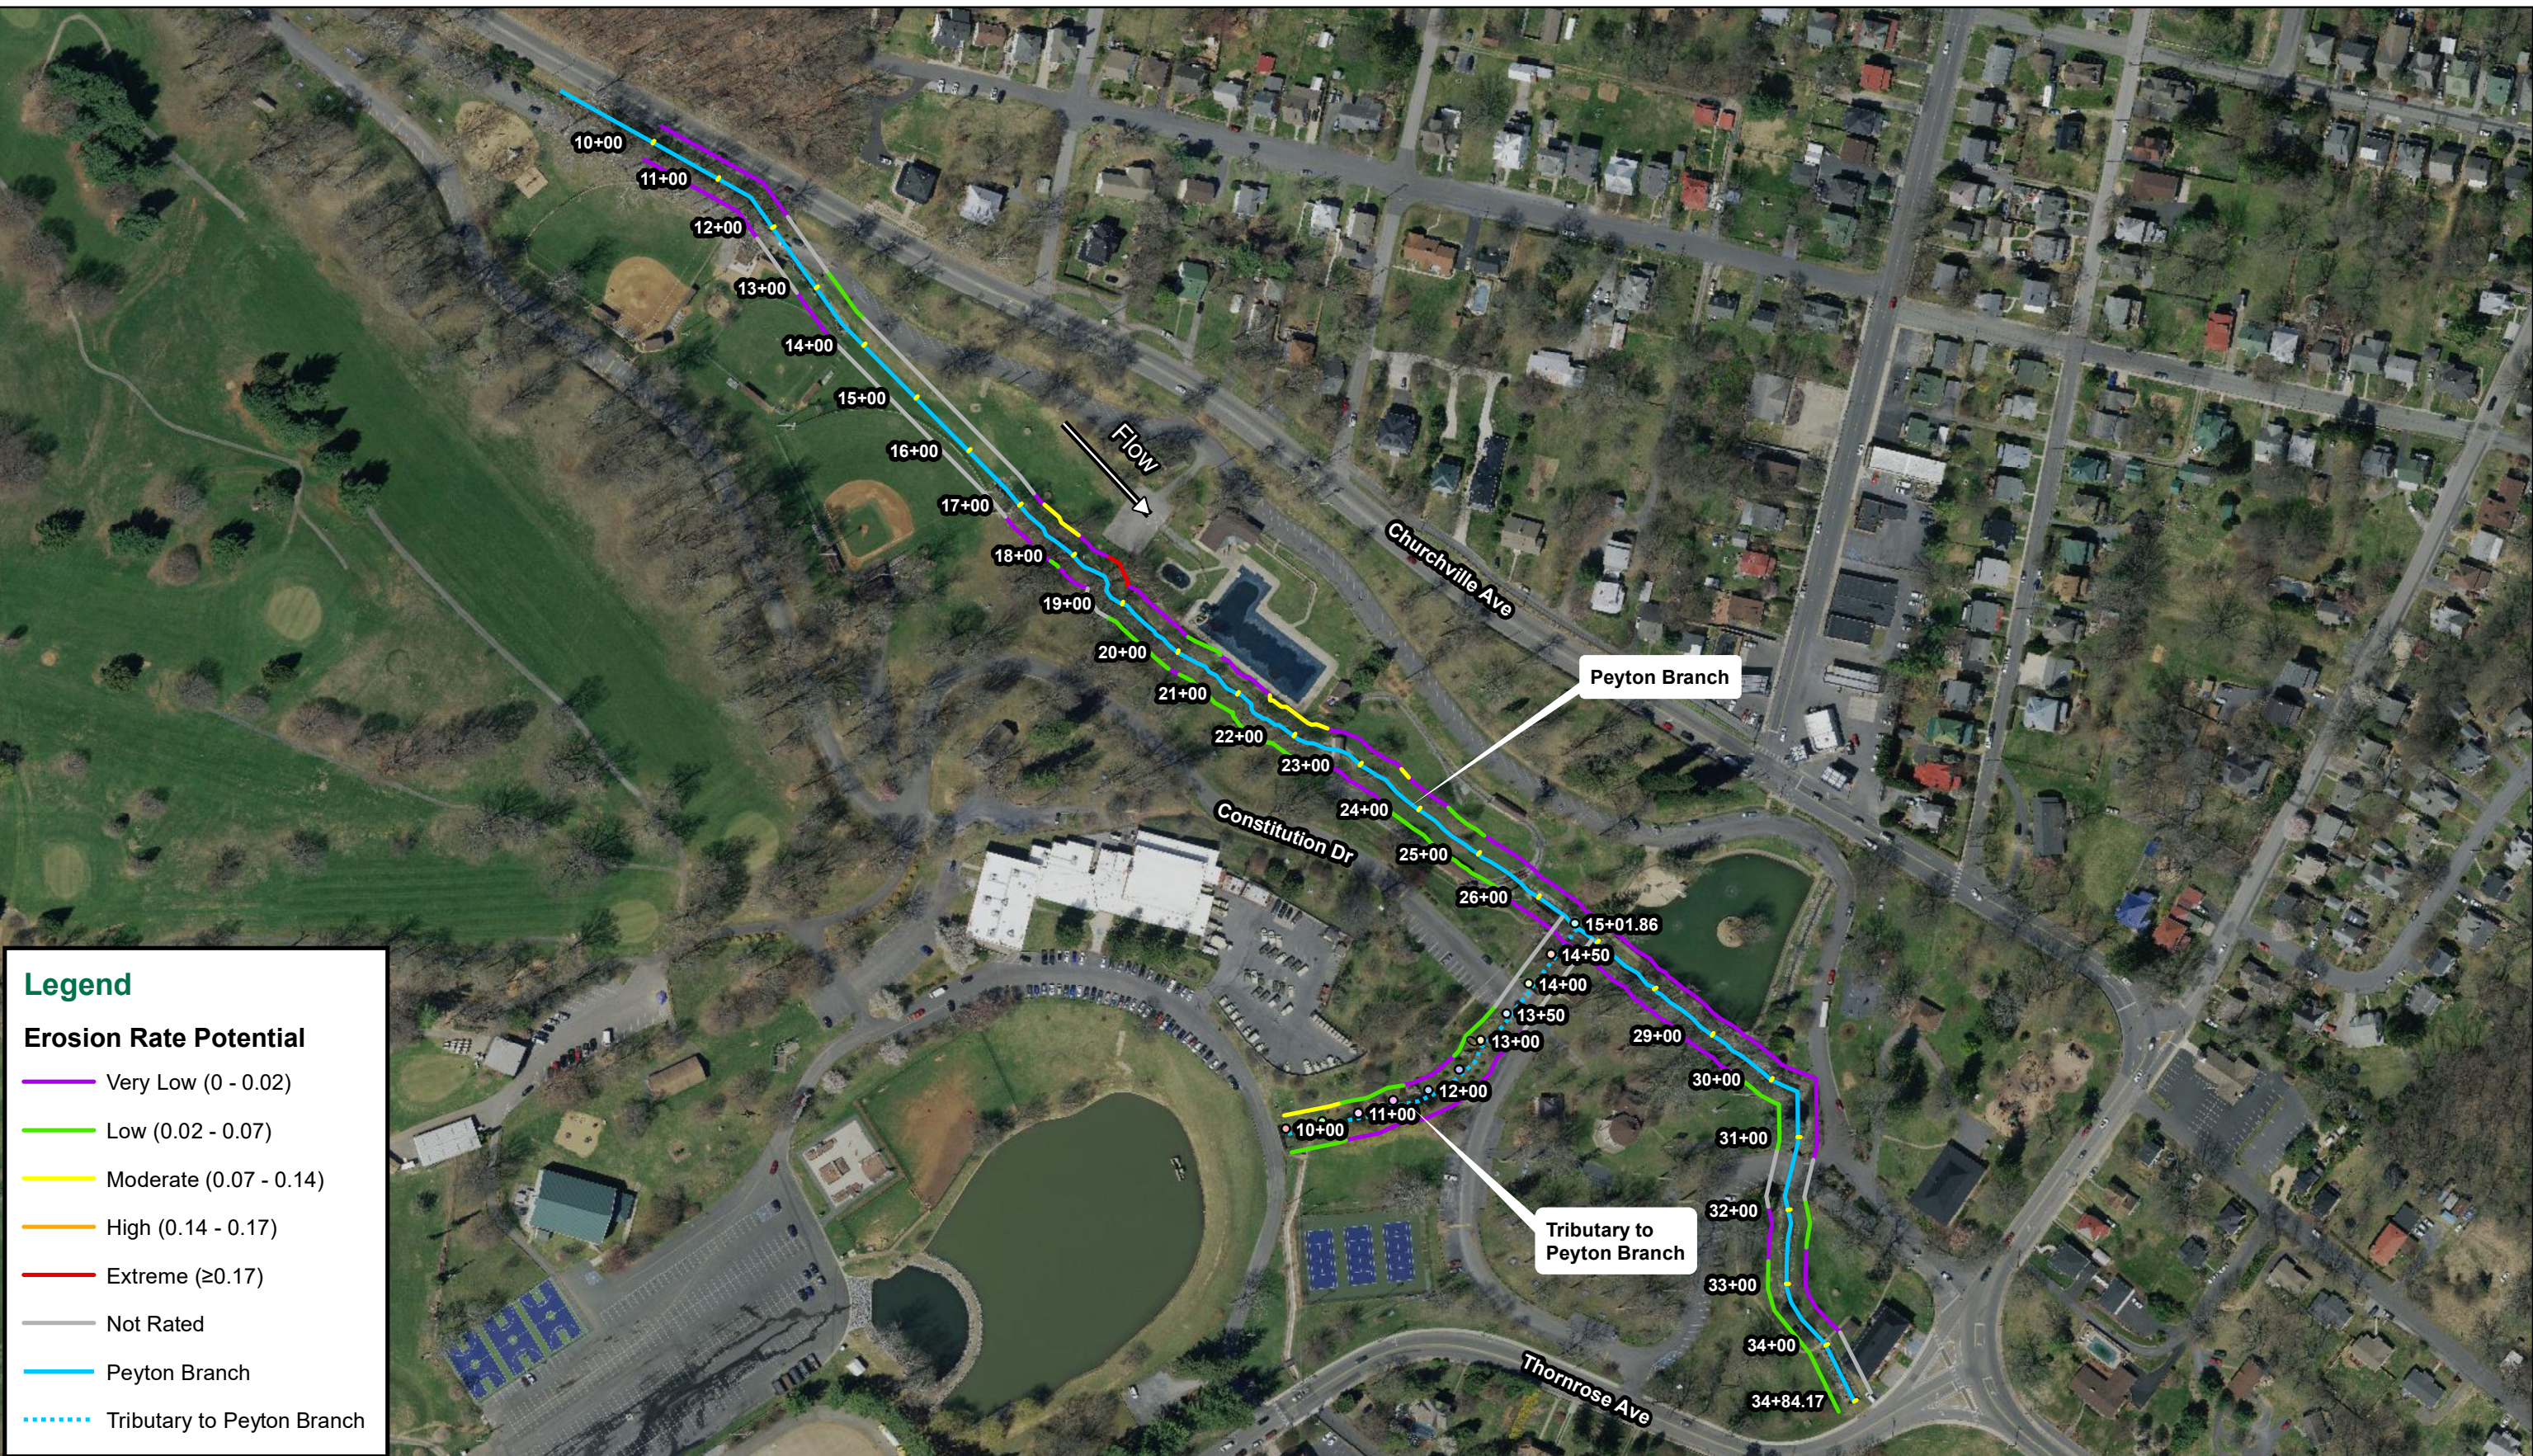
**Erosion Rate Potential**

- Very Low (0 - 0.02)
- Low (0.02 - 0.07)
- Moderate (0.07 - 0.14)
- High (0.14 - 0.17)
- Extreme ( $\geq 0.17$ )
- Not Rated
- Peyton Branch
- Tributary to Peyton Branch

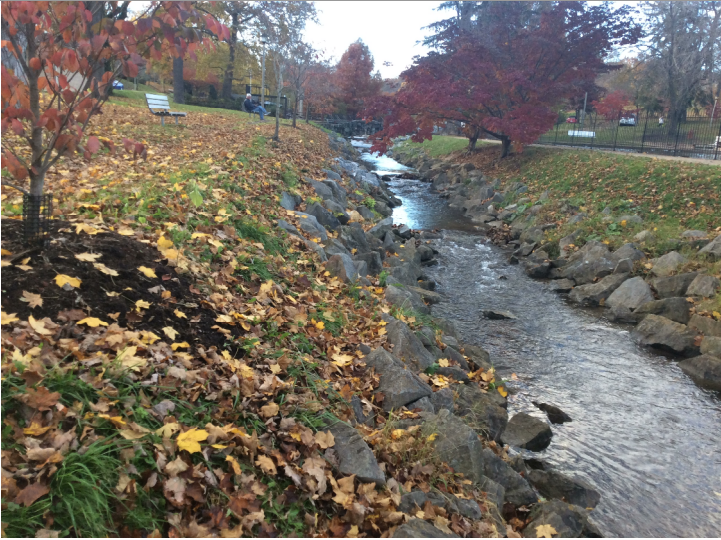
# BANCS Summary Report

| LOCATION & DESCRIPTION | | |
|---|---|---|
| Stream Bank: Right Bank | Start Station: 2950 | End Station: 3125 |

| BEHI SCORES | | | |
|---|---|---|---|
| | | Rating: | Moderate |

| EROSION RATES | | | | | |
|---|---|---|---|---|---|
| Length of Bank (ft): | 175 | Erosion Rate (ft <sup>3</sup> /yr): | 147.137375 | Erosion Rate (ton/yr/ft): | 0.0404822407407407 |

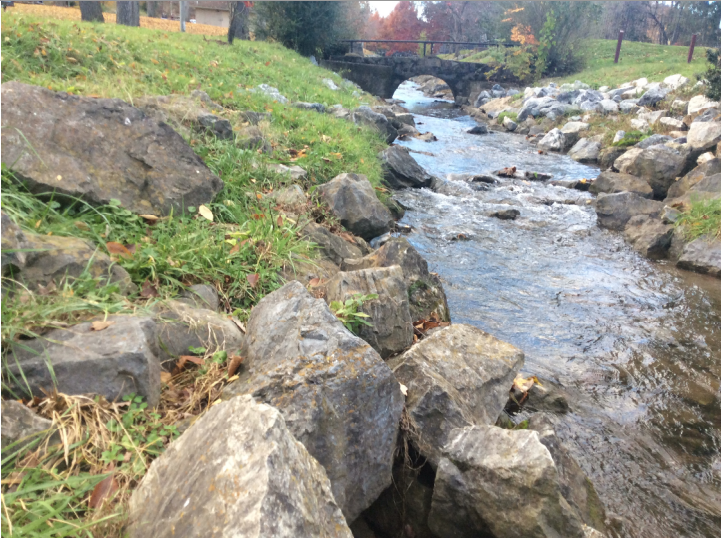
# BANCS Summary Report

| LOCATION & DESCRIPTION | | | |
|---|--|---|---|
| Stream Bank: Right Bank | | Start Station: 3190 | End Station: 3270 |

| BEHI SCORES | | | |
|---|---|---|---|
| Stratification Adjustment: | 0 | Total Score: 21 | Rating: Moderate |

| EROSION RATES | | | | | |
|---|---|---|---|---|---|
| Length of Bank (ft): | 80 | Erosion Rate (ft <sup>3</sup> /yr): | 28.12808 | Erosion Rate (ton/yr/ft): | 0.016928937037037 |

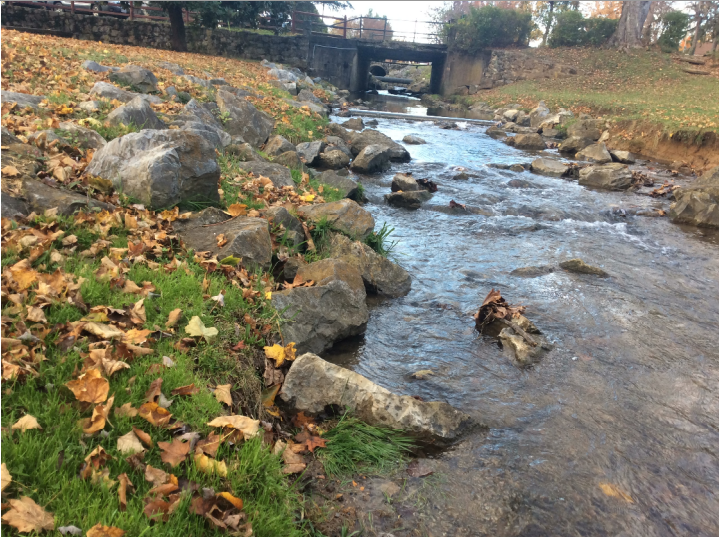
# BANCS Summary Report

| LOCATION & DESCRIPTION | | |
|---|---|---|
| Stream Bank: Right Bank | Start Station: 3270 | End Station: 3400 |

| BEHI SCORES | | | |
|---|---|---|---|
| | | Rating: | Low |

| NEAR-BANK STRESS DATA | | | |
|---|---|---|---|
| Methods for Estimating NBS: | Method I | Near Bank Stress: | Very High |

| EROSION RATES | | | | | |
|---|---|---|---|---|---|
| Length of Bank (ft): | 130 | Erosion Rate (ft <sup>3</sup> /yr): | 172.32956 | Erosion Rate (ton/yr/ft): | 0.063825762962963 |

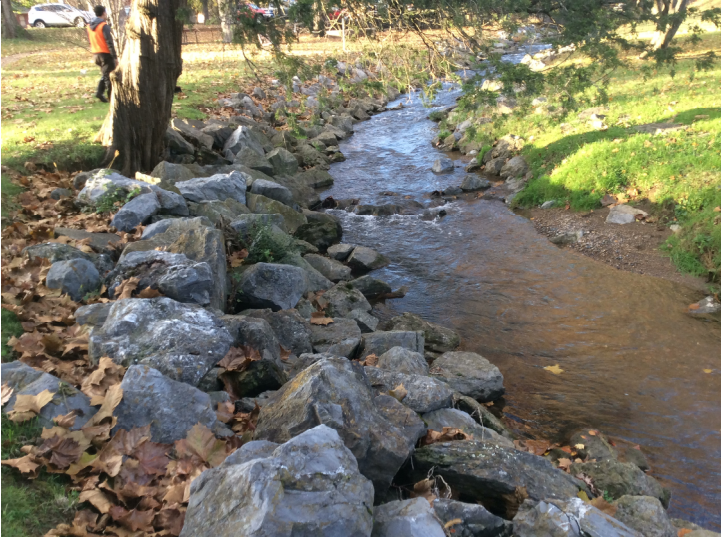
# BANCS Summary Report

| LOCATION & DESCRIPTION | | | |
|---|--|---|---|
| Stream Bank: Right Bank | | Start Station: 3400 | End Station: 3484.17 |

| BEHI SCORES | | | |
|---|---|---|---|
| | | Rating: | Moderate |

| EROSION RATES | | | | | |
|---|---|---|---|---|---|
| Length of Bank (ft): | 84.17000000000001 | Erosion Rate (ft <sup>3</sup> /yr): | 42.46132407 | Erosion Rate (ton/yr/ft): | 0.02428934444444444 |

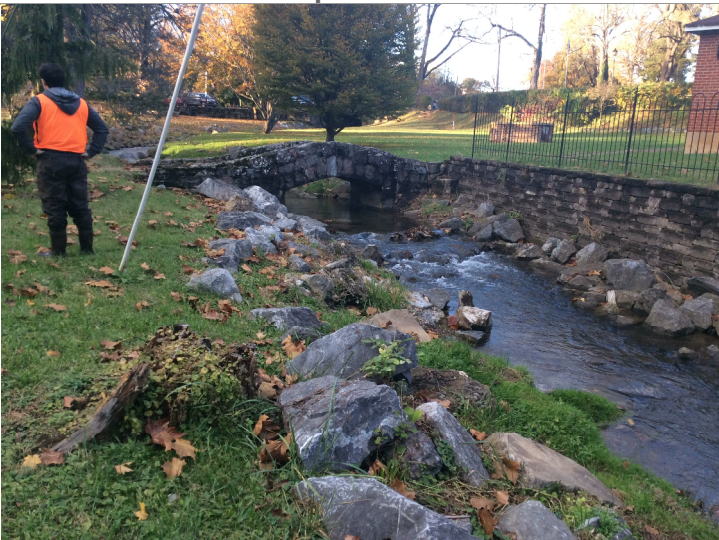
# BANCS Summary Report

| LOCATION & DESCRIPTION | | |
|---|---|---|
| Stream Bank: Left Bank | Start Station: 1000 | End Station: 1075 |

| BEHI SCORES | | | | |
|---|---|---|---|---|
| Stratification Adjustment: | 0 | Total Score: | 20 | Rating: Moderate |

| NEAR-BANK STRESS DATA | | | |
|---|---|---|---|
| Methods for Estimating NBS: | Method I | Near Bank Stress: | Very High |

| EROSION RATES | | | | | |
|---|---|---|---|---|---|
| Length of Bank (ft): | 75 | Erosion Rate (ft <sup>3</sup> /yr): | 182.94 | Erosion Rate (ton/yr/ft): | 0.1174456111111111 |

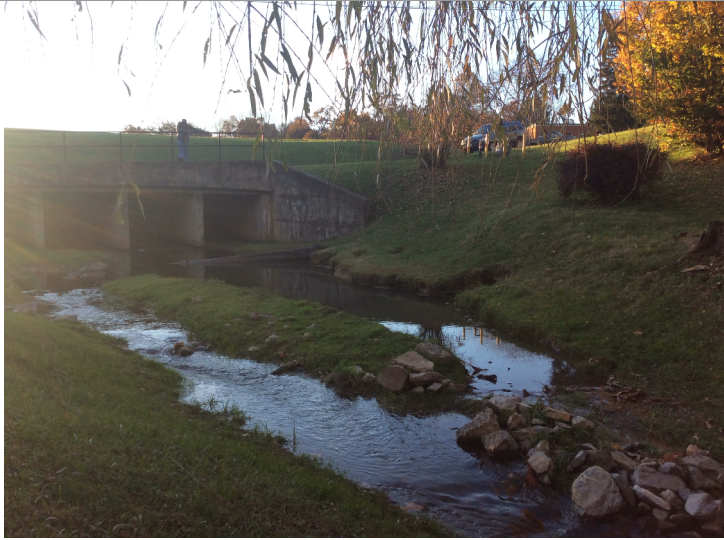
# BANCS Summary Report

| LOCATION & DESCRIPTION | | |
|---|---|---|
| Stream Bank: Left Bank | Start Station: 1075 | End Station: 1165 |

| BEHI SCORES | | | | |
|---|---|---|---|---|
| Stratification Adjustment: | 0 | Total Score: | 30 | Rating: High |

| EROSION RATES | | | | | |
|---|---|---|---|---|---|
| Length of Bank (ft): | 90 | Erosion Rate (ft <sup>3</sup> /yr): | 85.64 | Erosion Rate (ton/yr/ft): | 0.0458175851851852 |

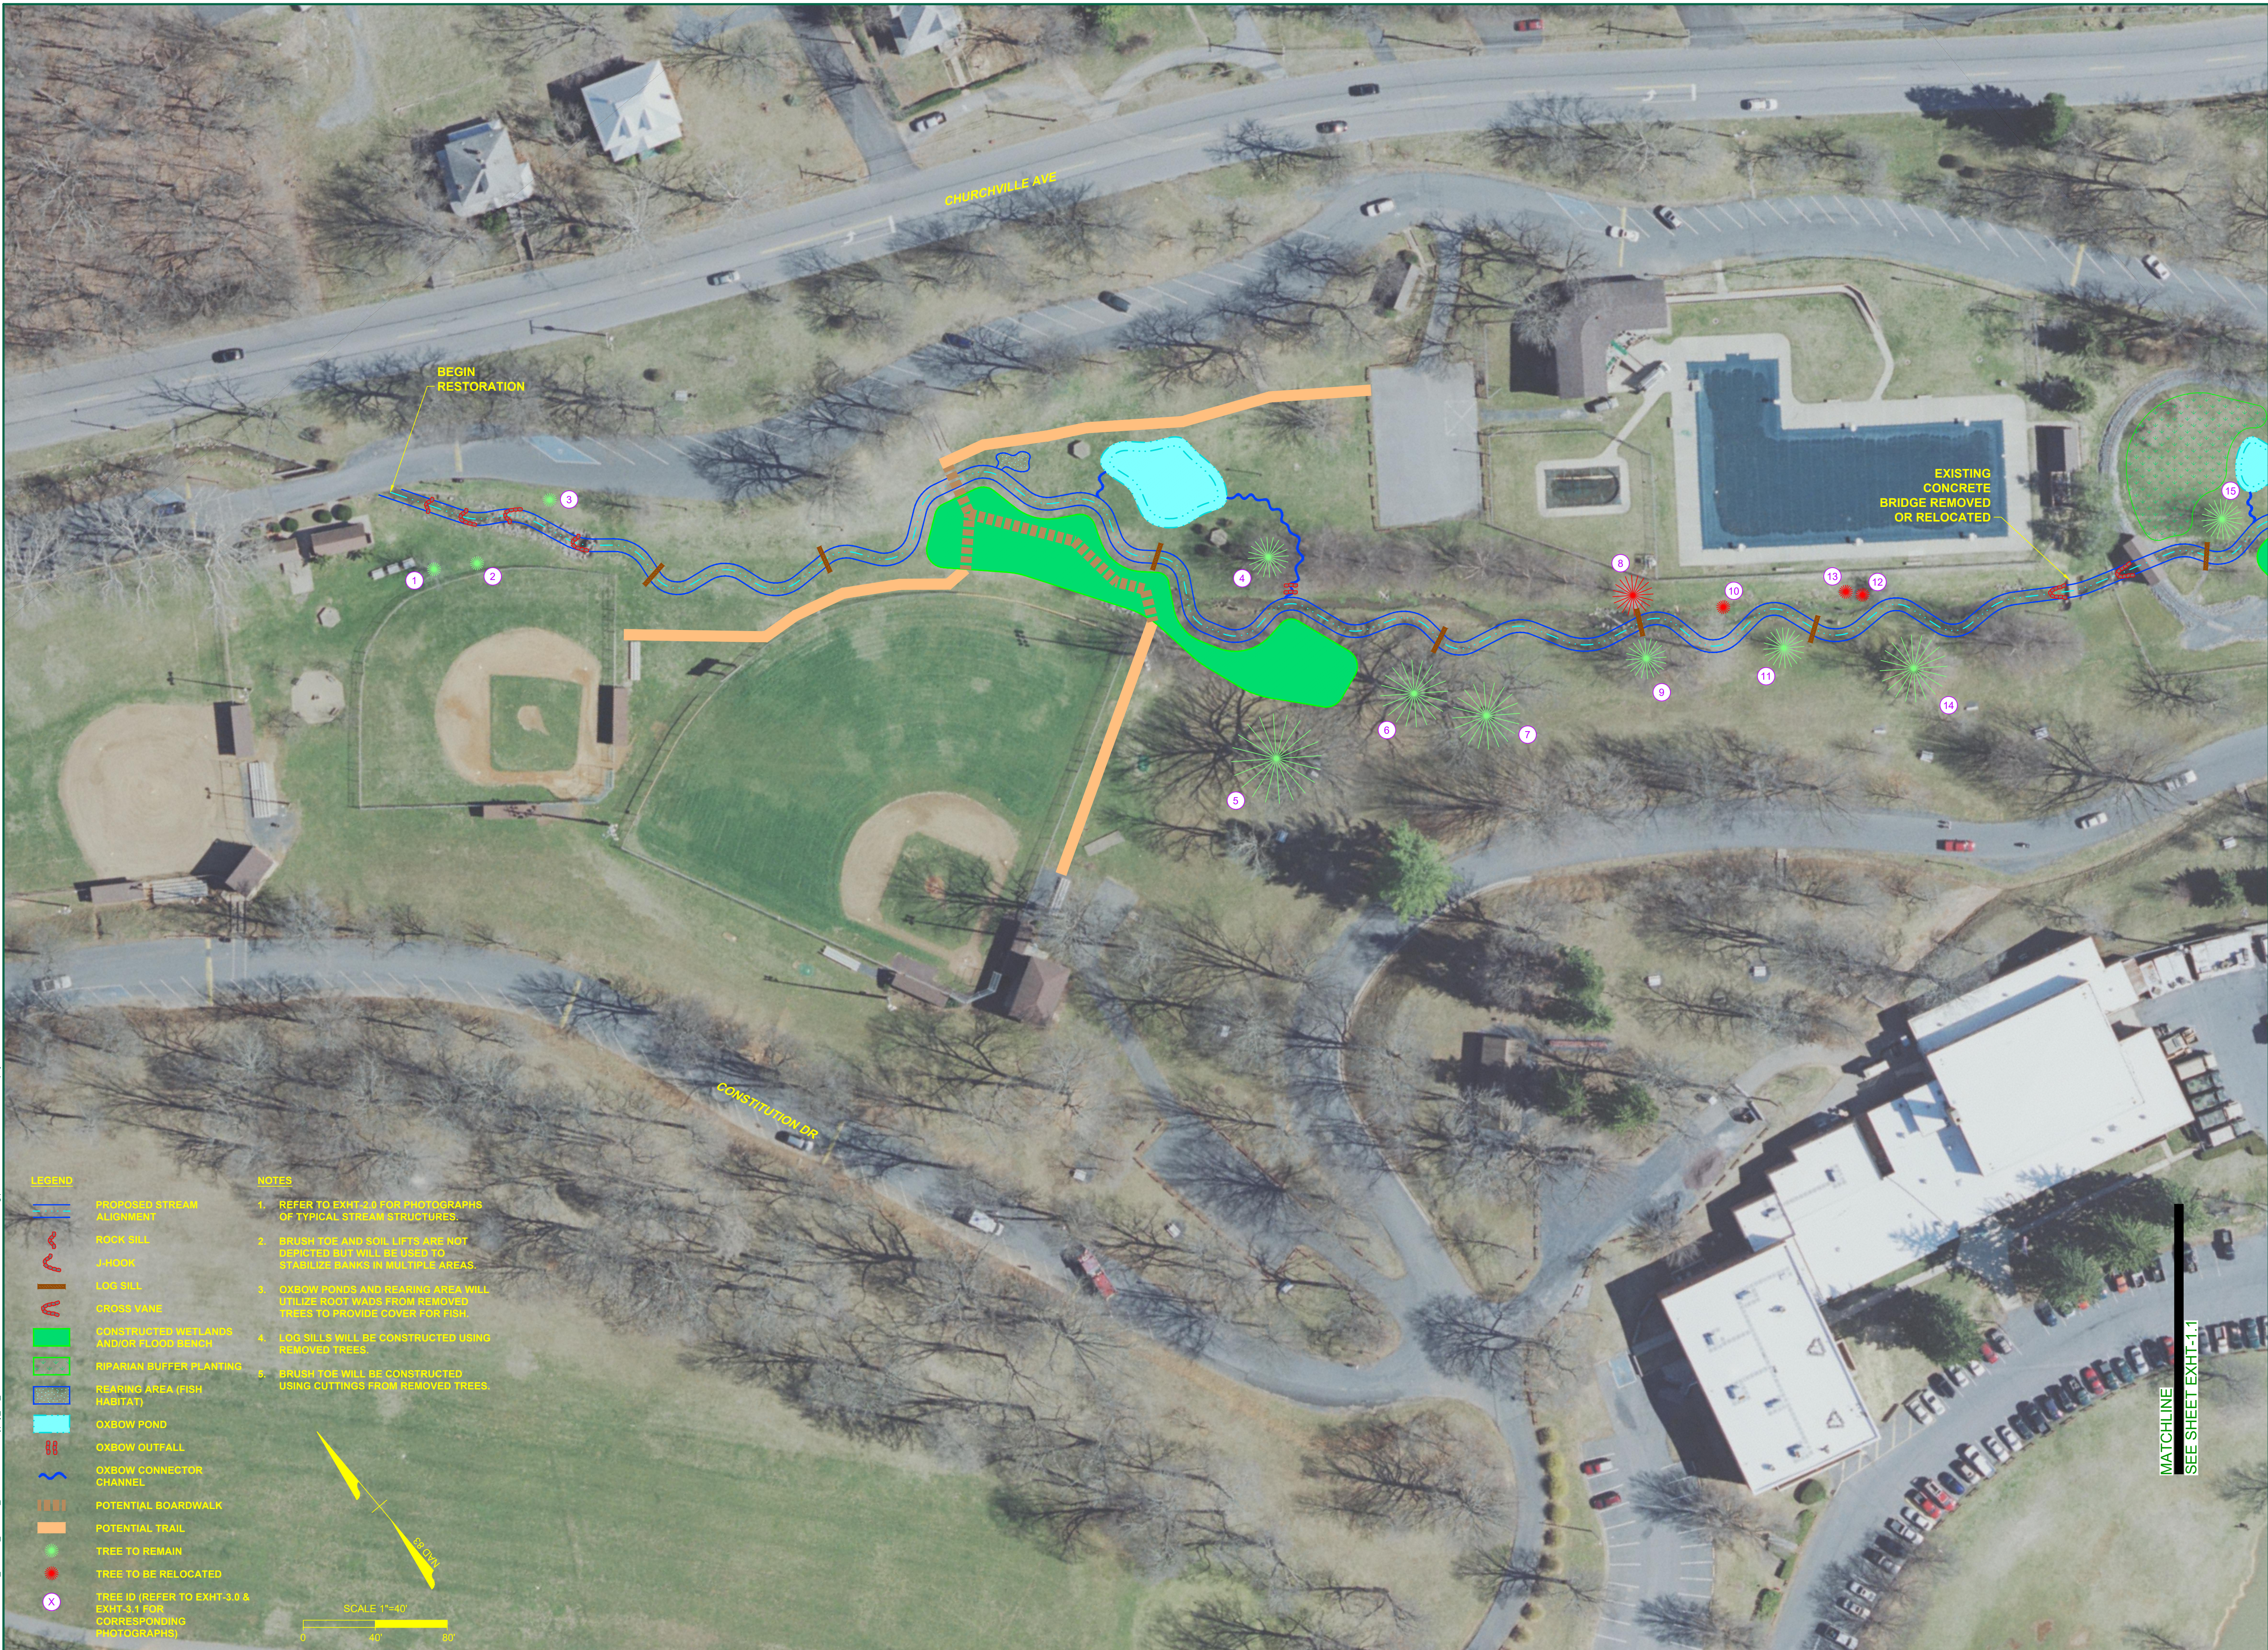
Attachment 3:  
Conceptual Layout, Typical Structures & Features  
and Existing Tree Inventory

- PROPOSED STREAM ALIGNMENT
- ROCK SILL
- J-HOOK
- LOG SILL
- GROSS VANE
- CONSTRUCTED WETLANDS AND/OR FLOOD BENCH
- RIPARIAN BUFFER PLANTING
- REARING AREA (FISH HABITAT)
- OXBOW POND
- OXBOW OUTFALL
- OXBOW CONNECTOR CHANNEL
- POTENTIAL BOARDWALK
- POTENTIAL TRAIL
- TREE TO REMAIN
- TREE TO BE RELOCATED
- TREE ID (REFER TO EXHT-3.0 & EXHT-3.1 FOR CORRESPONDING PHOTOGRAPHS)
