**Phase I Environmental Site Assessment  
of the  
Western State Hospital  
Staunton, Virginia**

Prepared for  
City of Staunton, Virginia

Wiley|Wilson Comm. No. 209161.00

August 31, 2009

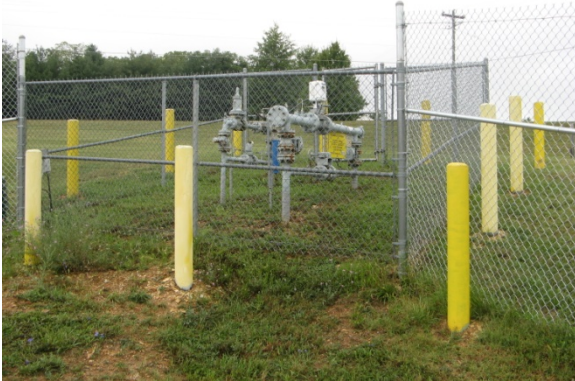
Natural Gas Feed into Western State Hospital

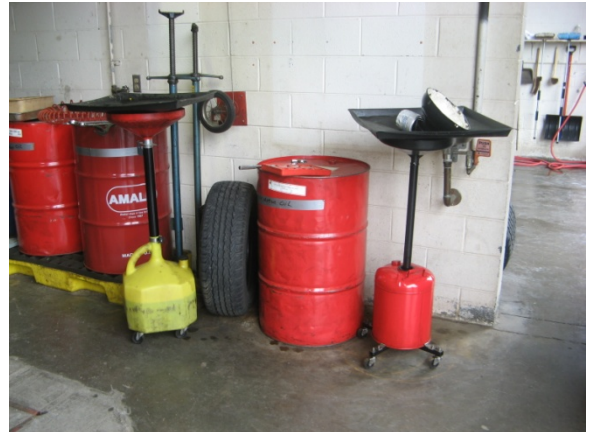
Waste Fluid Containers in Physical Plant Services/Materials Management Building

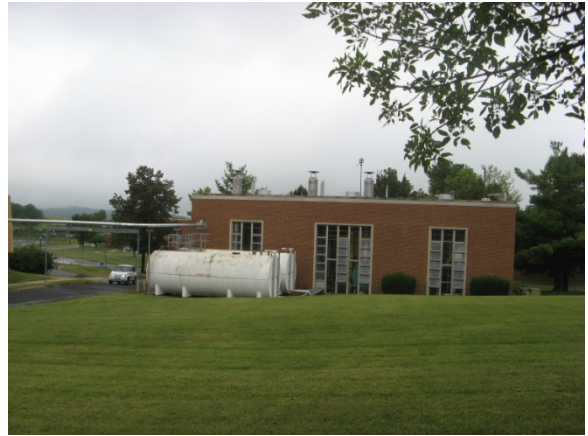
Power Plant

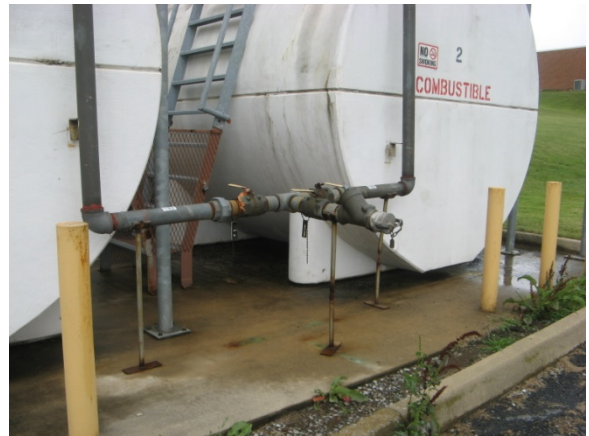
Fill Port of ASTs at Power Plant

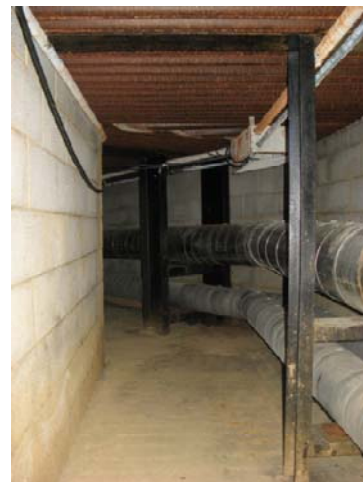
Steam  
Tunnel  
Exiting Power  
Plant

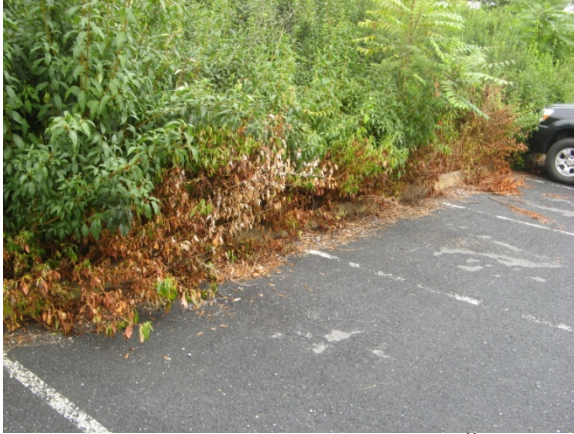
Vegetation Killed by Round Up®

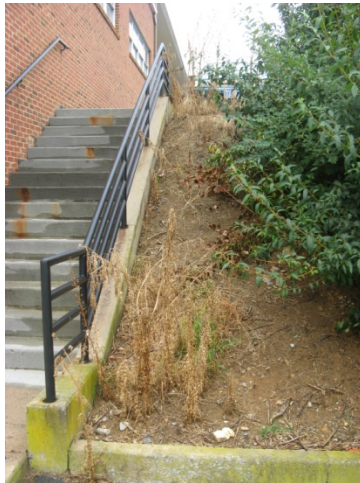
Vegetation Killed  
by Round Up®

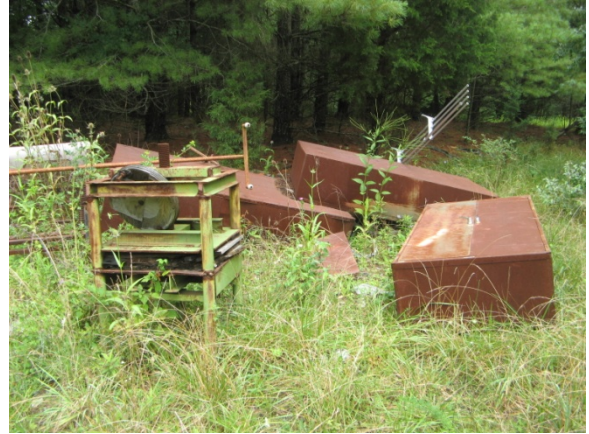
Metal Debris on Ridge North of WWTP Site

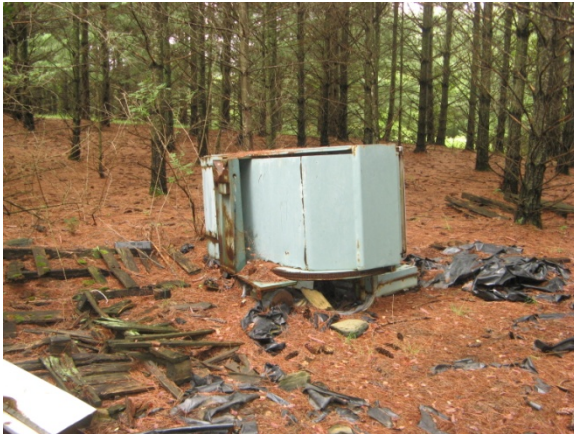
Wood and Metal Debris on Ridge North of WWTP

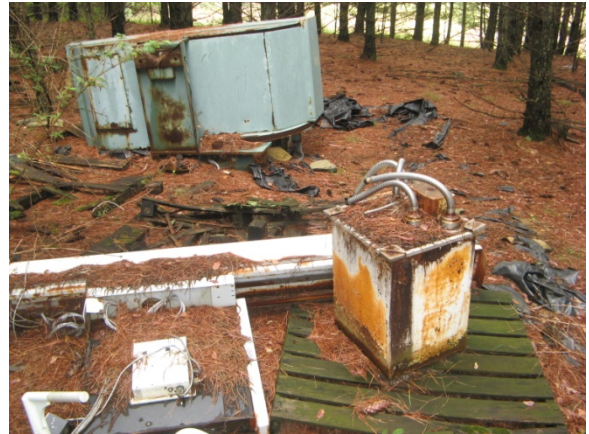
Wood and Metal Debris on Ridge North of WWTP

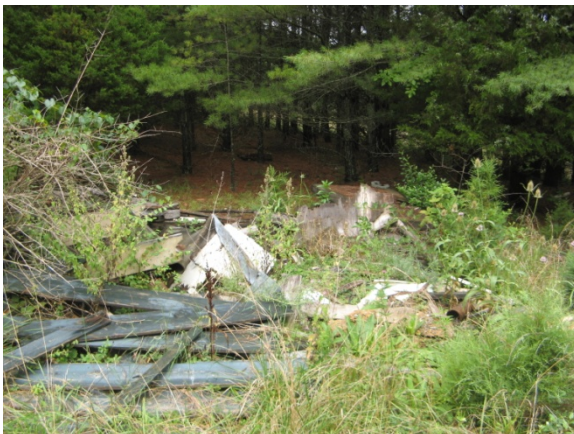
Wood and Metal Debris on Ridge North of WWTP

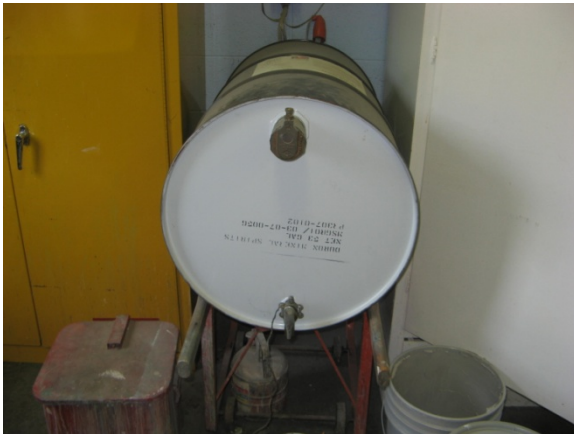
Mineral Spirits Inside of Physical Plant Services/Materials Management Building Paint Shop

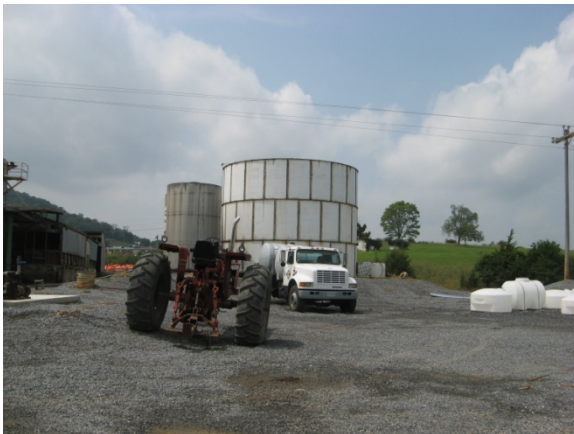
AST's at Augusta Farm Cooperative Bureau, Inc.

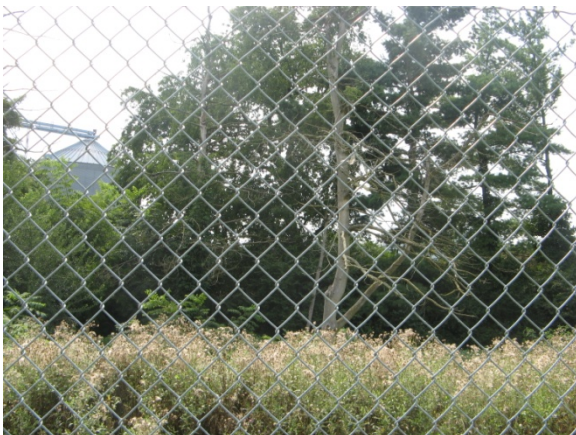
Dying White Pine Between site and Augusta Farm Cooperative Bureau, Inc.
